Four Seasons Elementary School Safe Routes to School Accessibility Study: Existing Conditions and Recommendations

August 17, 2023

Anne Arundel Safe Routes to School Accessibility Study

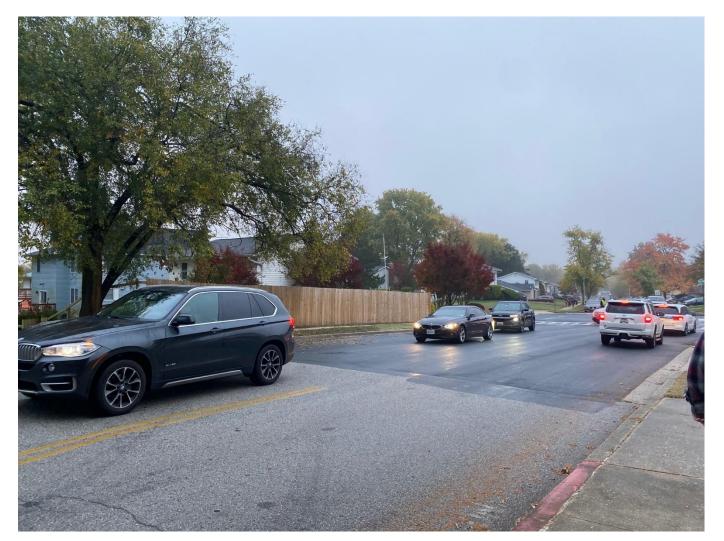
Entering and exiting parent drop-off at the intersection of Maytime Dr and Springhill Way

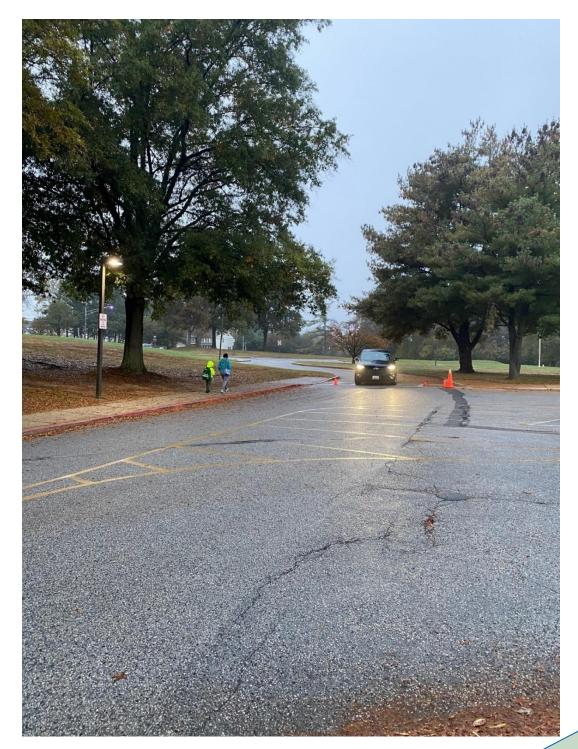
Walkers are seen entering campus from Springhill Way.

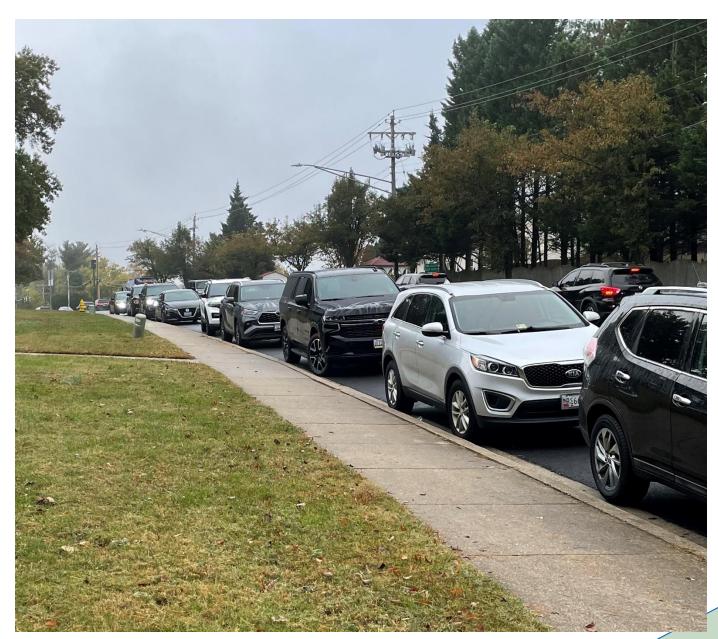
Vehicle drop-off of students occurring along Waugh Chapel Road at school arrival.

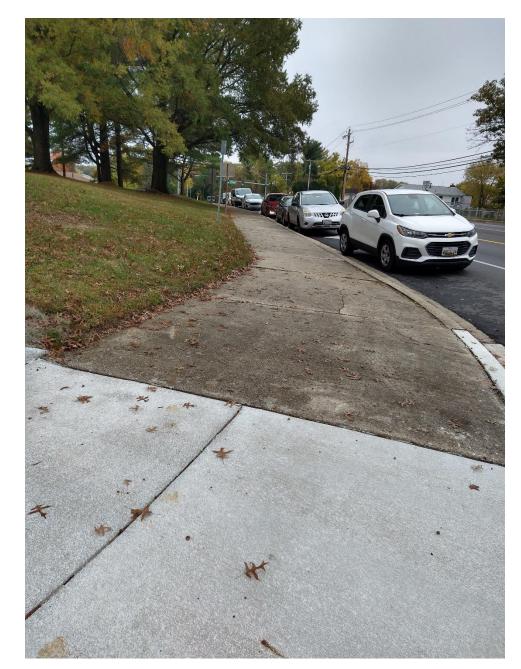
Cars are seen parked along Waugh Chapel Road at dismissal time.

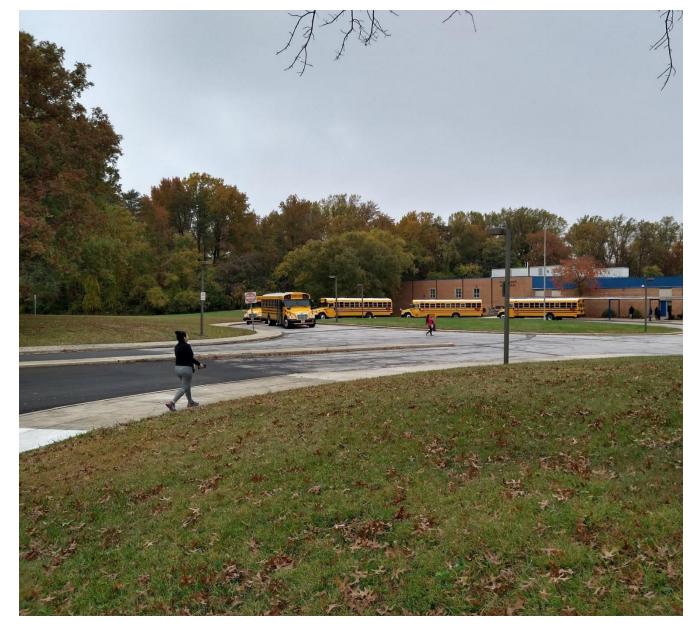
Buses are seen in the bus loop waiting for dismissal.

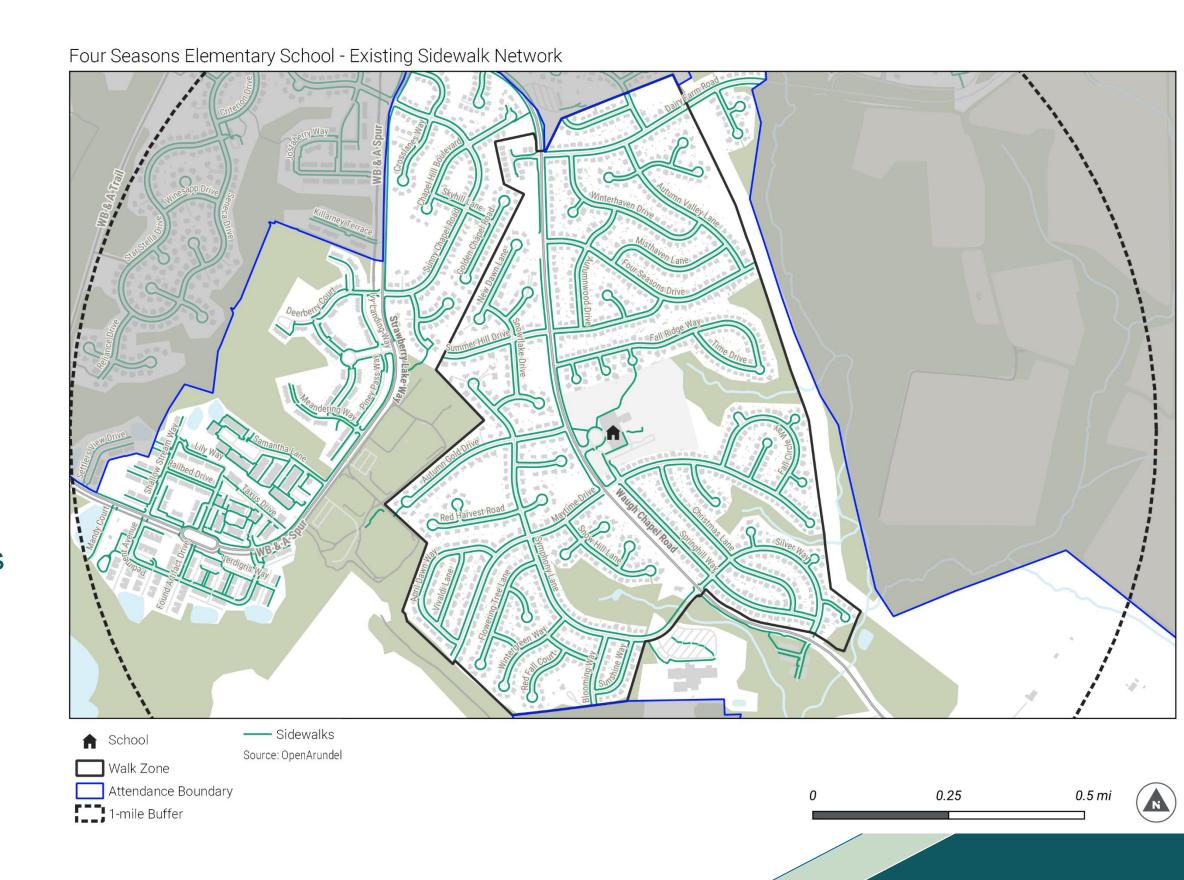
There is one gap in the sidewalk network, on Waugh Chapel Road from Symphony Lane to Maytime Drive.

Sidewalks are present on all other roads within the walk zone.

Note that the gap shown on Waugh Chapel Road across from Four Seasons Drive did not exist at the time of the study.

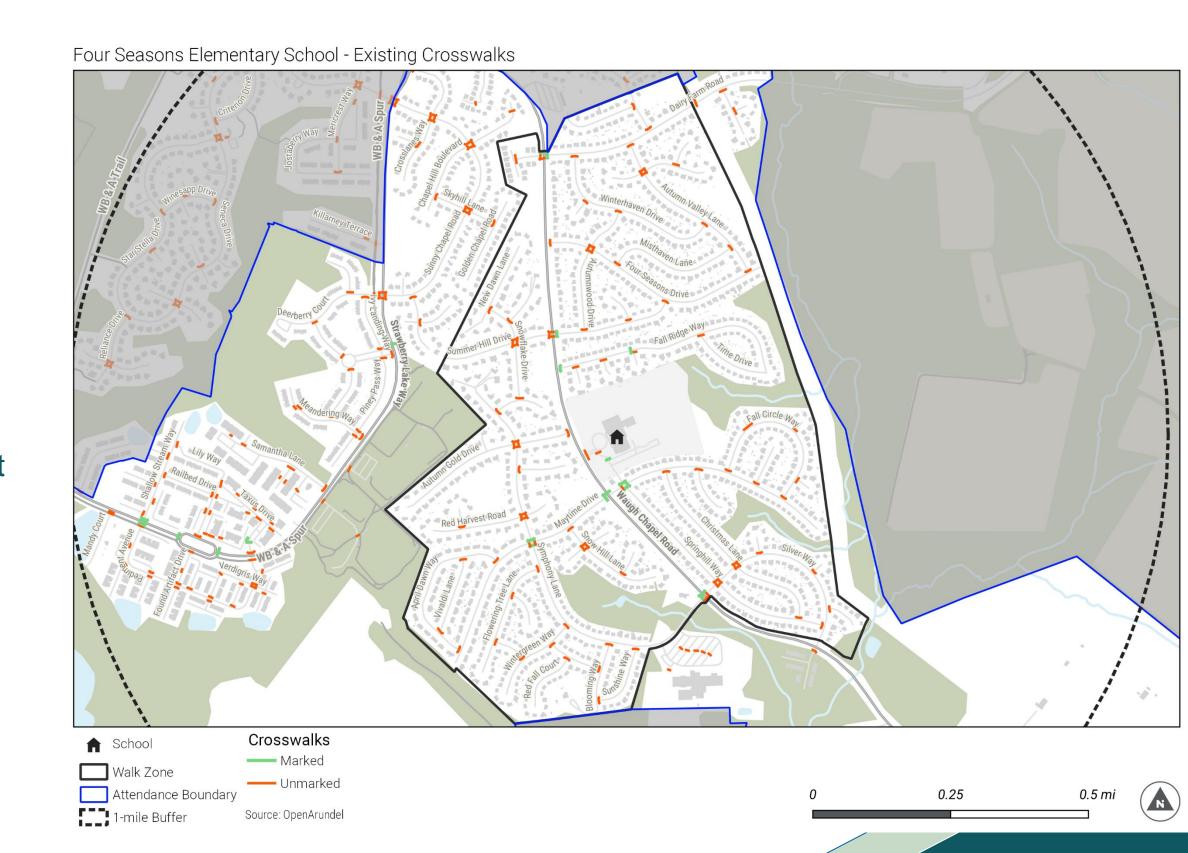
There are marked crossings at the entrance to the staff parking lot/parent drop-off area (at the intersection of Maytime Drive and Springhill Way).

Many crossings at intersections within the walk zone are unmarked.

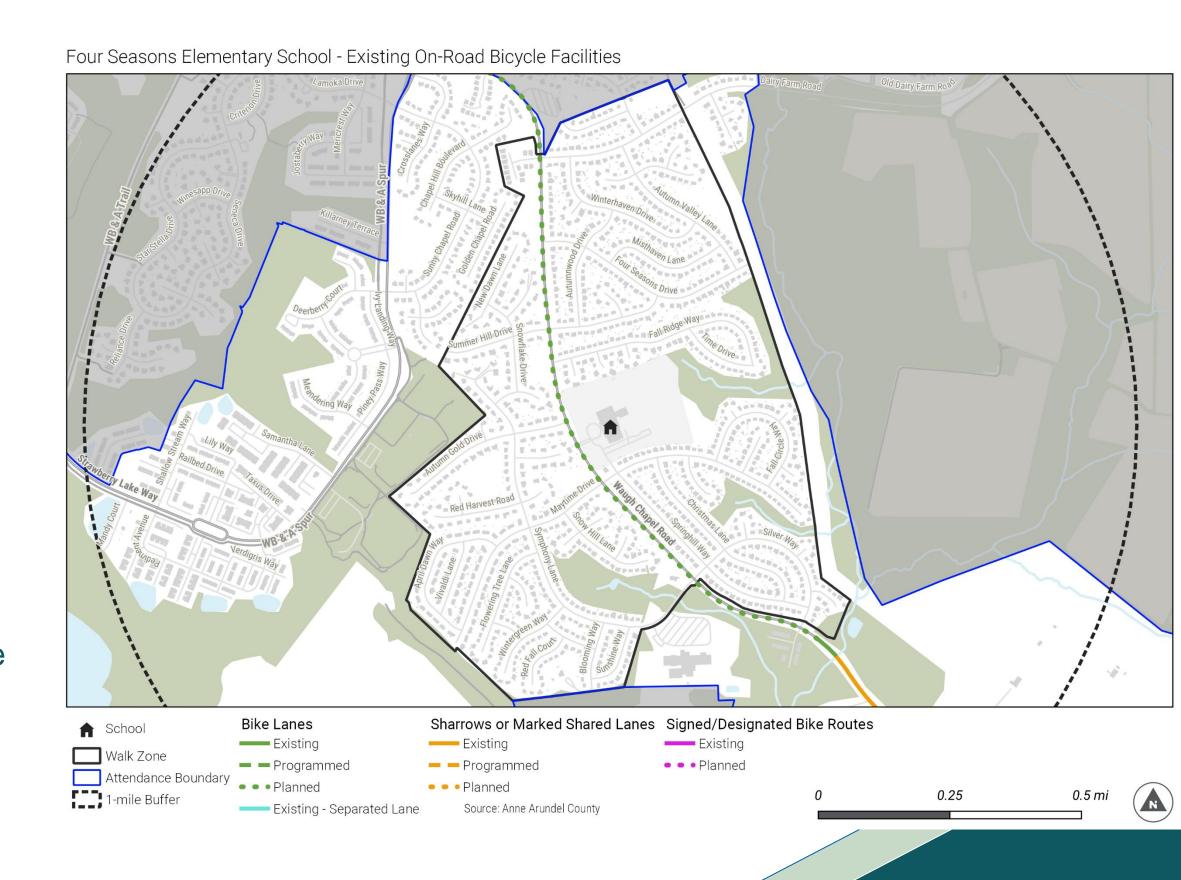
Existing Curb Ramps*

Curb ramps are located at all intersections that have sidewalks; most are ADA compliant.

A bicycle lane is planned* along Waugh Chapel Road, all the way to Route 3.

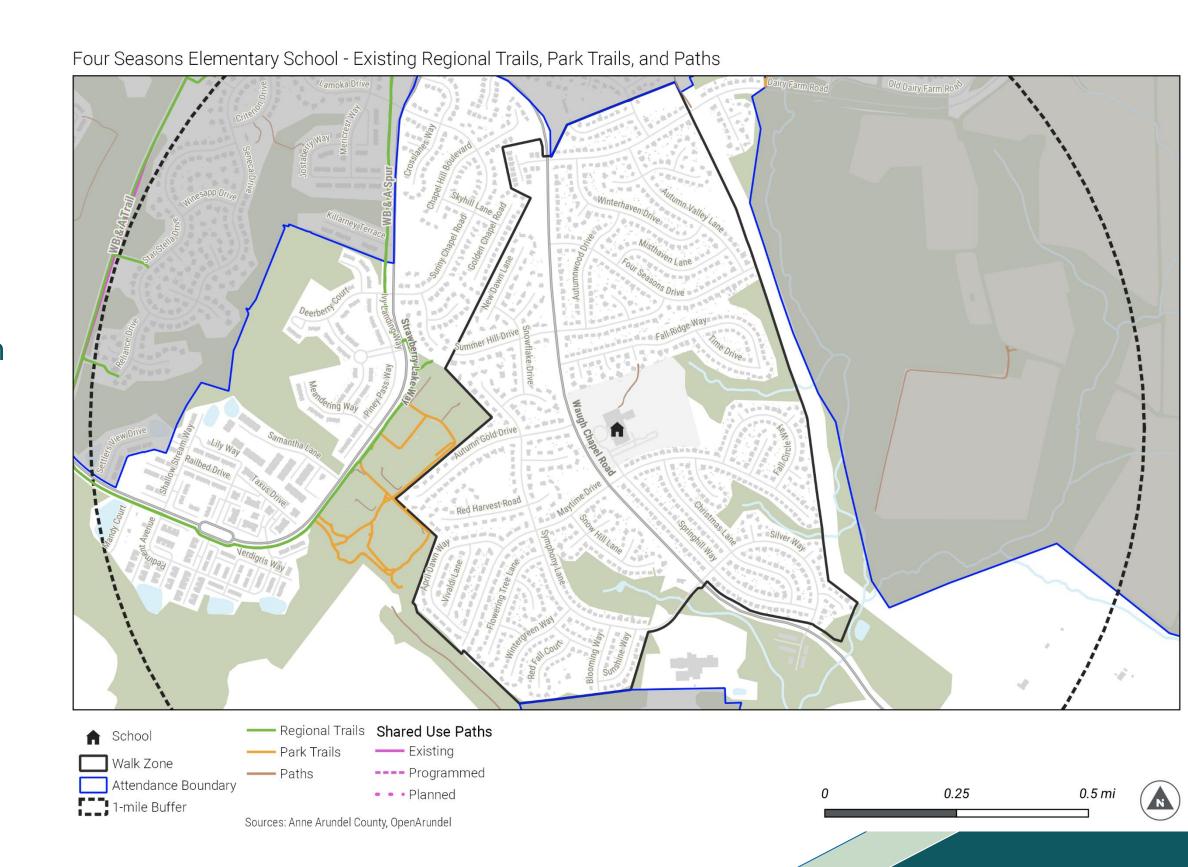
Existing Regional Trails, Park Trails, and Paths

The WB&A trail spur is adjacent to but disconnected from the study area.

No additional trails or paths are currently planned* near the school.

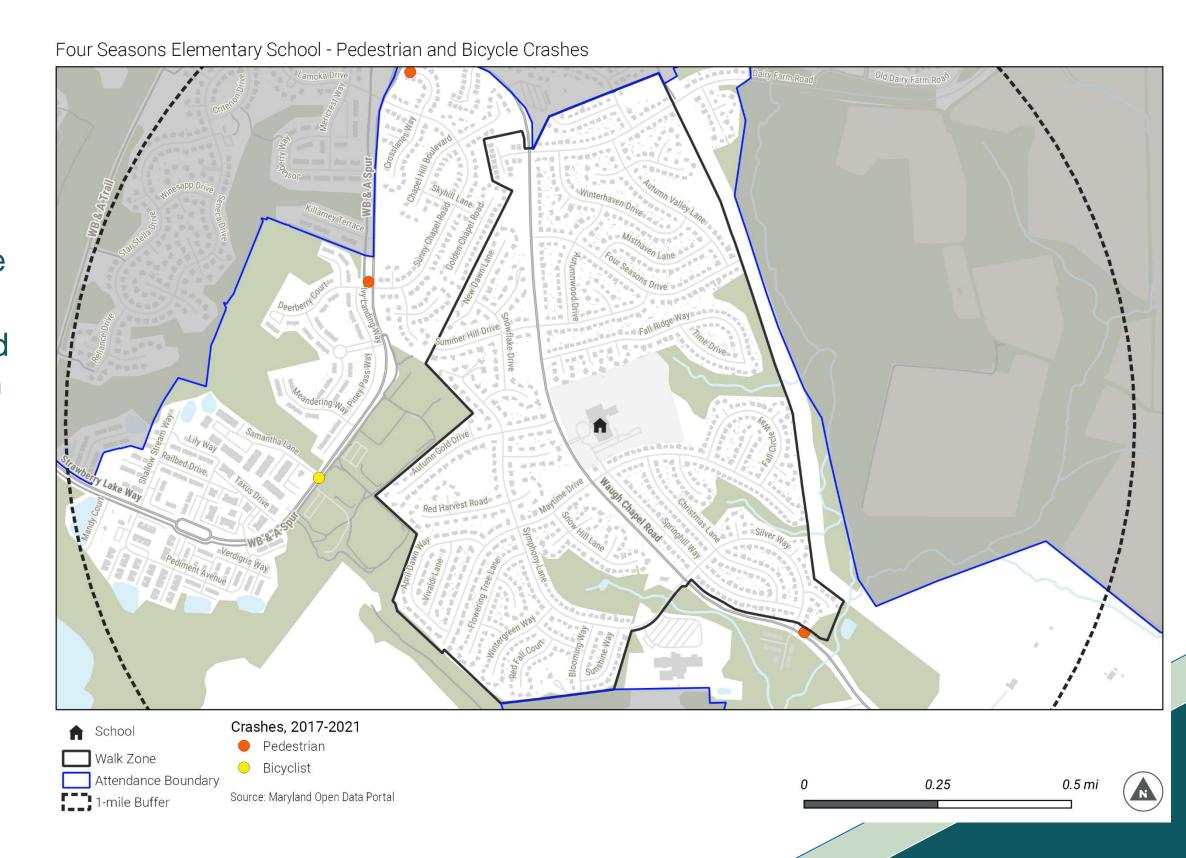
Crash Data (2017 – 2021)

Pedestrian and bicyclist crashes within the walk zone:

None within the walk zone, but one pedestrian crash just outside the southeast boundary

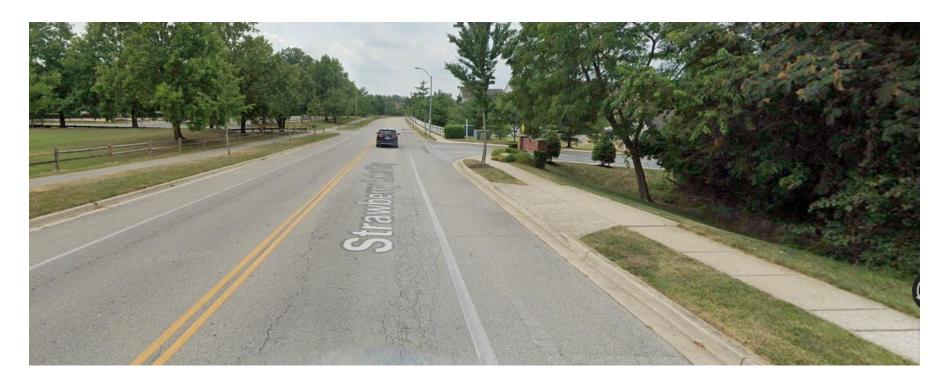
Residential areas west of GORC Park fall within what may be a realistic bicycling distance from the school using trails within the park, but Strawberry Lake Way lacks marked and controlled pedestrian crossing facilities. For long-term planning, the County could explore adding a rectangular rapid flashing beacon at a key crossing location for access to GORC park.

View of Strawberry Lake Way near GORC Park via Google Maps

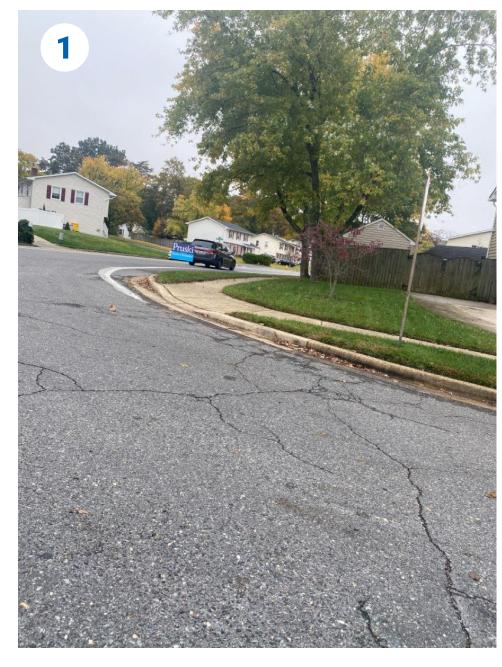
| Map ID | Location | Facility Type | Issue | Recommendation | Potential Cost | Timeframe* |
|---|--|---|---|---|---|---|
| 1 | Dairy Farm Rd & Snow Valley Ln | 1a. Crosswalk | Crossing is unmarked across Snow Valley Lane, No stop bar | Install new high-visibility crosswalk, Mark new stop bar | \$900 | Short |
| | | 1b. Curb Ramp | Ramps lack detectable warning surface, Curb ramp not aligned with crossing | Reconstruct or repair existing ramps | \$8,000 | Medium |
| | | 1c. Other Intersection or Crossing Issues | Concern about motor vehicle turning movements and speeds speeds (onto Snow Valley Ln) | Install curb extensions or curb radius reduction on Snow Valley Ln | \$10,000 | Long |

Crossing of Snow Valley Lane.

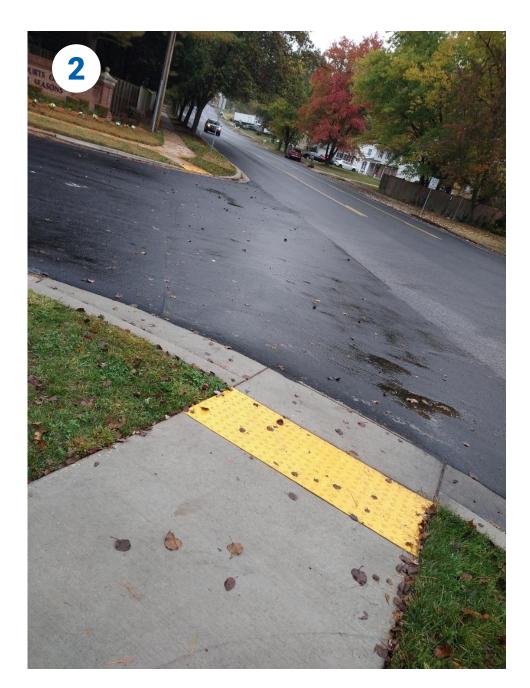
| Map ID | Location | Facility Type | Issue | Recommendation | Potential Cost | Timeframe* |
|---|--|---|---|---|---|---|
| 2 | Waugh Chapel Rd & Summer Hill Dr (Along key student walking route, Inside school zone) | 2a. Crosswalk | Crossings are unmarked across Summer Hill Dr (east and west crossings), No stop bar | Install new standard crosswalk, Mark new stop bar. | \$1,000 | Short |
| | | 2b. Other | Concern about motor vehicle turning speeds (cars turning off Waugh Chapel Rd) | Install curb extensions or curb radius reduction for Summer Hill Dr crossings | \$20,000 | Long |
| | | 2c. Curb ramp | West ramps not aligned with crossing | Reconstruct or repair existing ramps | \$8,000 | Medium |

Crossing of Summer Hill Drive.

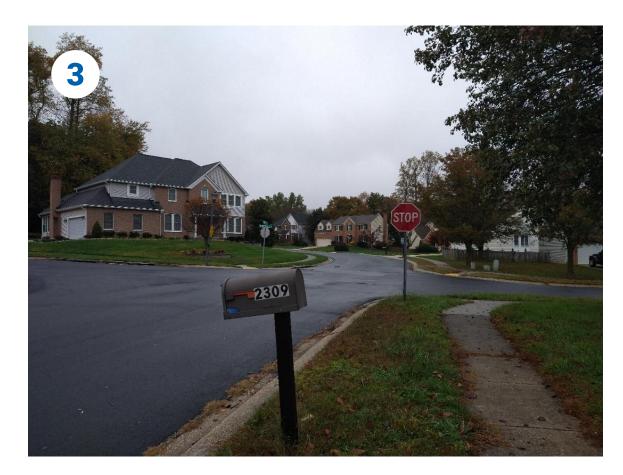
| Location | Facility Type | Issue | Recommendation | Potential Cost | Timeframe* |
|--|---|---|--|---|---|
| Summer Hill Dr & Snowflake Dr | 3a. Curb Ramp | Ramps lacks detectable warning surface, Ramps not aligned with crossing | Reconstruct or repair existing ramps | \$16,000 | Medium |
| | 3b. Crosswalk | Crossings are unmarked across Snowflake Dr (both legs), No stop bar | Install new standard crosswalk, Mark new stop bar | \$1,000 | Short |

Stop sign and crossing on Snowflake Drive.

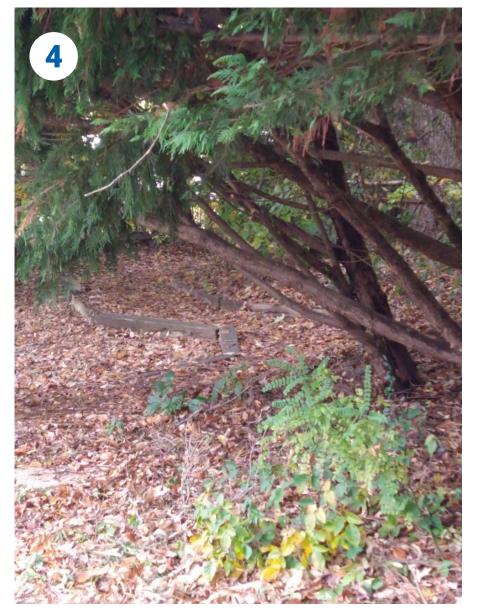
| Location | Facility Type | Issue | Recommendation | Potential Cost | Timeframe* |
|--|---|---|--|---|---|
| End of Summer Hill Dr | Sidewalk | Missing sidewalk/path connection | Explore potential for new path connection (length depends on geography and ROW). A sidewalk connection to the path between GORC Park Station House Ln may allow for expansion of the school walk zone. | N/A | Long |

Missing sidewalk connecting Summer Hill Drive to GORC Park.

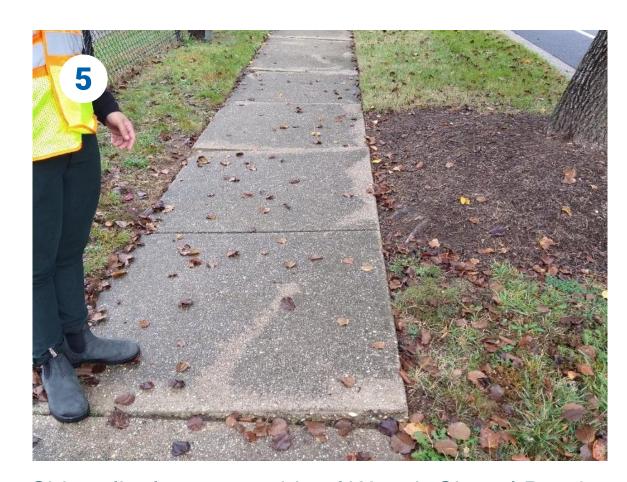
| Location | Facility Type | Issue | Recommendation | Potential Cost | Timeframe* |
|--|---|---|--|---|---|
| Waugh Chapel Rd (Fall Ridge Way to Summer Hill Dr) (Along key student walking route, Inside school zone) | Sidewalk | Sidewalk uplifted on west side of Waugh Chapel Rd | Reconstruct or repair sidewalk | \$13.440 | Long |

Sidewalk along west side of Waugh Chapel Road.

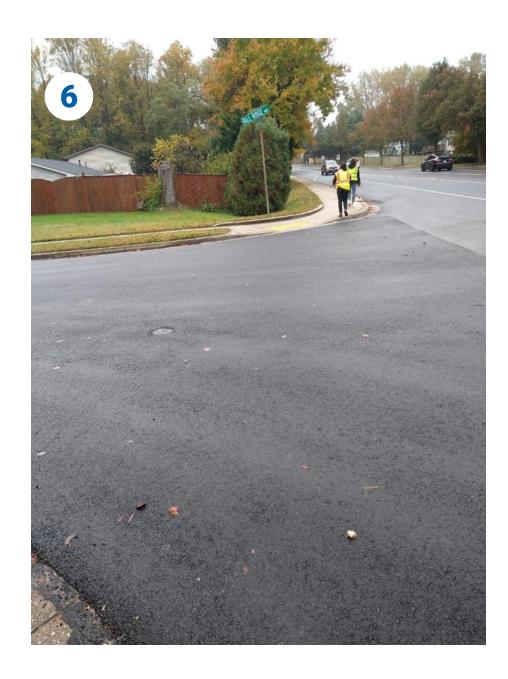
| Location | Facility Type | Issue | Recommendation | Potential Cost | Timeframe* |
|--|---|---|--|---|---|
| Waugh Chapel Rd & Fall Ridge Way (Along key student walking route, Inside school zone) | Crosswalk | Crossings are unmarked across Fall Ridge Way, No stop bar | Install new standard crosswalk, Mark new stop bar | \$500 | Short |

Crossing of Fall Ridge Way.

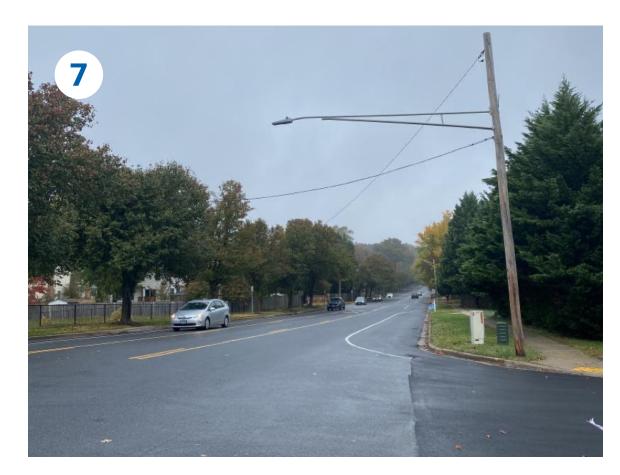
| Map ID | Location | Facility Type | Issue | Recommendation | Potential Cost | Timeframe* |
|---|---|---|---|--|---|---|
| | | 7a. Speed Management | Observed motor vehicle speeds appear to exceed speed limit | Conduct a speed study to consider speed management measures or other modifications | N/A | Long |
| | | and Pavement Markings | SCHOOL pavement marking missing School zone sign missing School zone speed limit sign missing | marking - Install new school zone signs (begin/end) | \$1,000 \$1,000 \$500 | Short |

View of Waugh Chapel Road within the school zone.

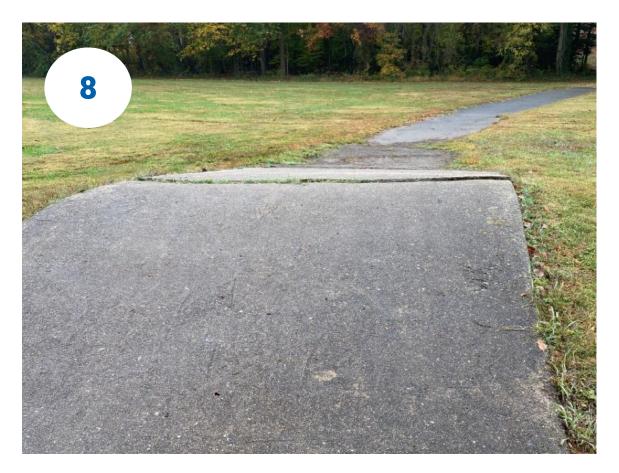
| Map ID | Location | Facility Type | Issue | Recommendation | Potential Cost | Timeframe* |
|---|---|---|---|--|---|---|
| | School path to Christmas Ct | Sidewalk | Sidewalk cracked and uplifted at various points along the path | Reconstruct or repair sidewalk | \$27,200 | Long |

Path between Christmas Court and the school.

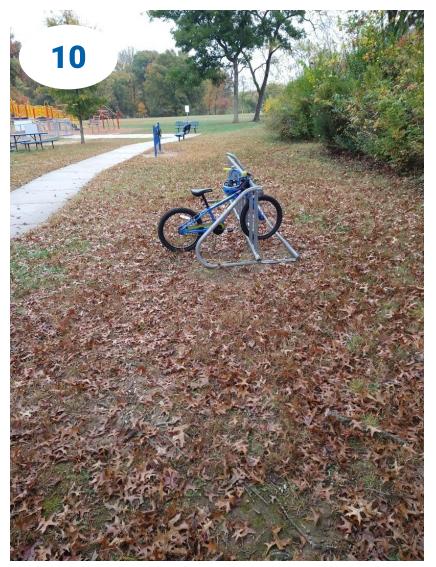
| Map ID | Location | Facility Type | Issue | Recommendation | Potential Cost | Timeframe* |
|---|---|---|---|--|---|---|
| 10 | Behind school | Bicycle rack | Existing rack does not allow locking of frame, New rack location needed | Replace existing rack with inverted U rack, place in more visible, accessible location | \$175/per (quantity TBD) | Short |

Bicycle rack behind the school.

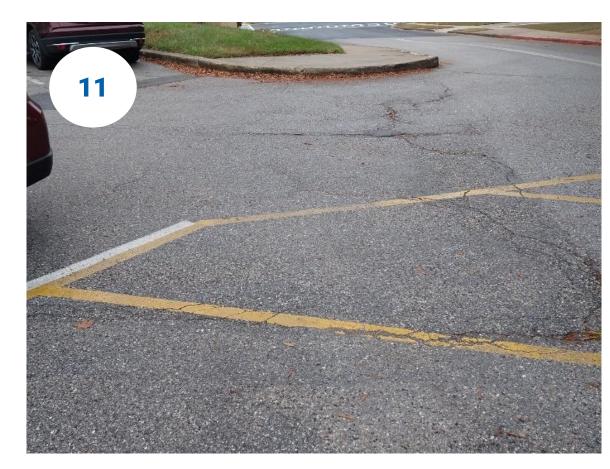
School parking lot with view of eastern sidewalk.

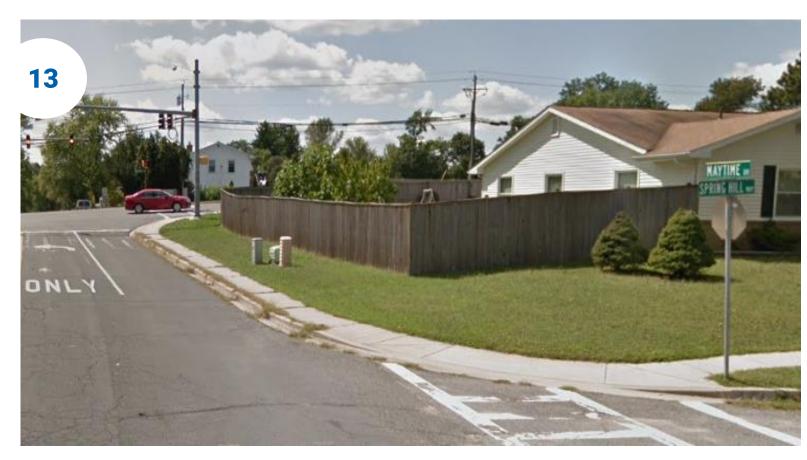
| | implementing any of the recommendations contained herein. | | | | | | | |
|---|---|---|--|--|---|---|--|--|
| | Maytime Dr (Waugh Chapel Rd to Springhill Way) (Along key student walking route, Inside school zone) | Sidewalk | Sidewalk narrow on north side of Maytime Dr and has no buffer from the road. | Reconstruct or repair sidewalk | \$7,200 | Long | | |

Sidewalk on the north side of Maytime Drive.

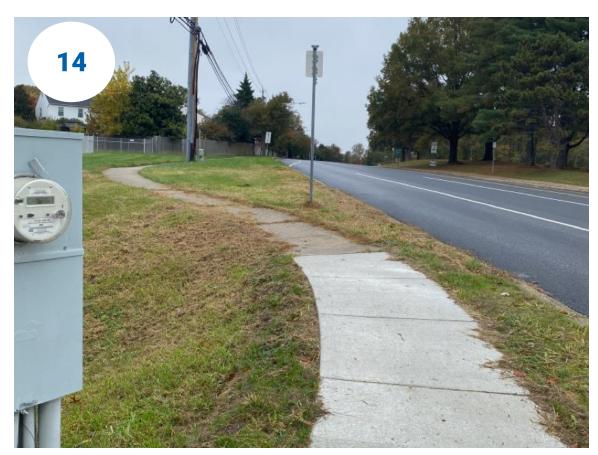
| | implementing any of the recommendations contained herein. | | | | | | | |
|---|---|---|--|--|---|---|--|--|
| | Waugh Chapel Rd (north of Maytime Dr) (Along key student walking route, Inside school zone) | Sidewalk | Sidewalk appears to exceed 2% maximum cross slope permitted by ADA Accessibility Guidelines | Assess cross slope in this general location and reconstruct or repair sidewalk as needed | N/A | Long | | |

Steep cross slope along the sidewalk on Waugh Chapel Road.

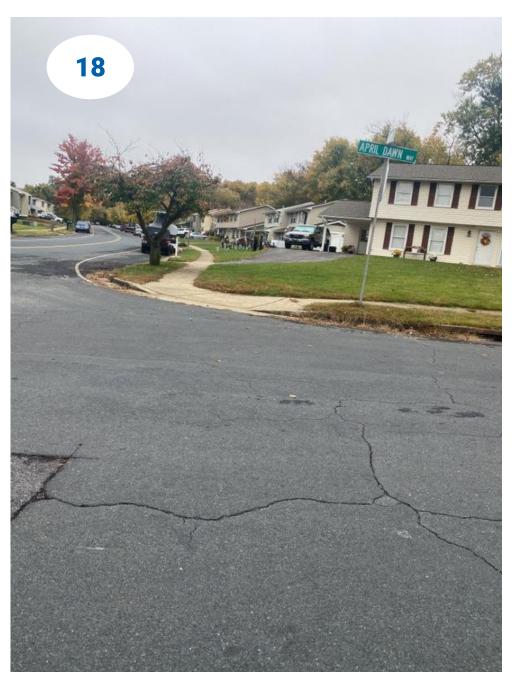
| Map ID | Location | Facility Type | Issue | Recommendation | Potential Cost | Timeframe* |
|---|---|---|---|---|---|---|
| 18 | April Dawn Way (northeast) & Maytime Dr | • | · | Reconstruct or repair existing ramps for crossing of April Dawn Way | \$8,000 | Medium |

Crossing of April Dawn Way (northeast intersection with Maytime Drive).

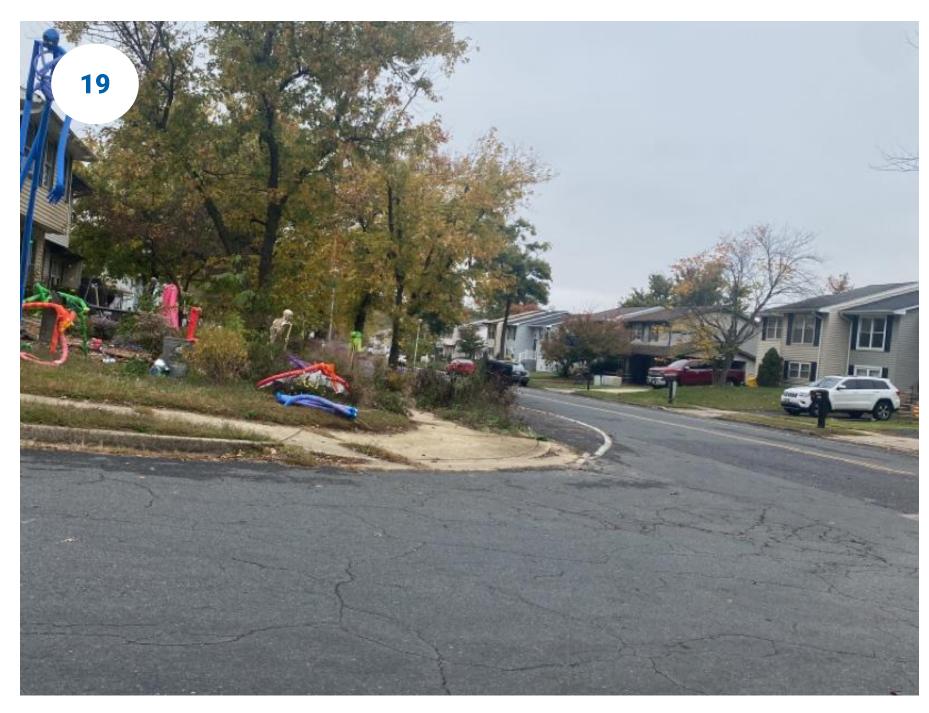
| Map ID | Location | Facility Type | Issue | Recommendation | Potential Cost | Timeframe* |
|---|---|---|---|---|---|---|
| 19 | April Dawn Way (west) & Maytime Dr | Curb Ramp | · · · · · · · · · · · · · · · · · · · | Reconstruct or repair existing ramps for crossing of April Dawn Way | \$8,000 | Medium |

Crossing of April Dawn Way (western intersection with Maytime Drive)
