Waugh Chapel Elementary School Safe Routes to School Accessibility Study: Existing Conditions and Recommendations

August 17, 2023

Anne Arundel Safe Routes to School Accessibility Study

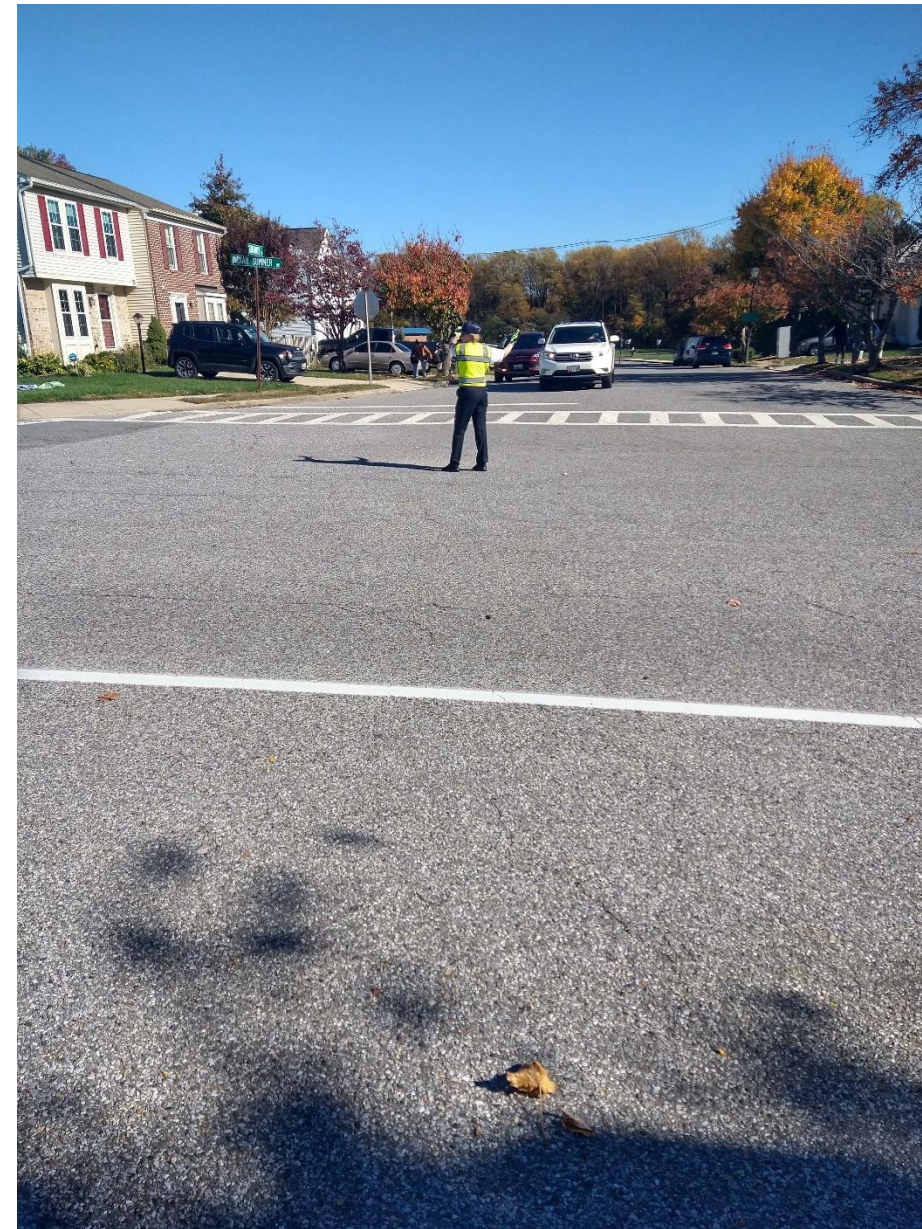
One crossing guard is stationed in the center of the intersection of Indian Summer Drive and Sunflower Drive.

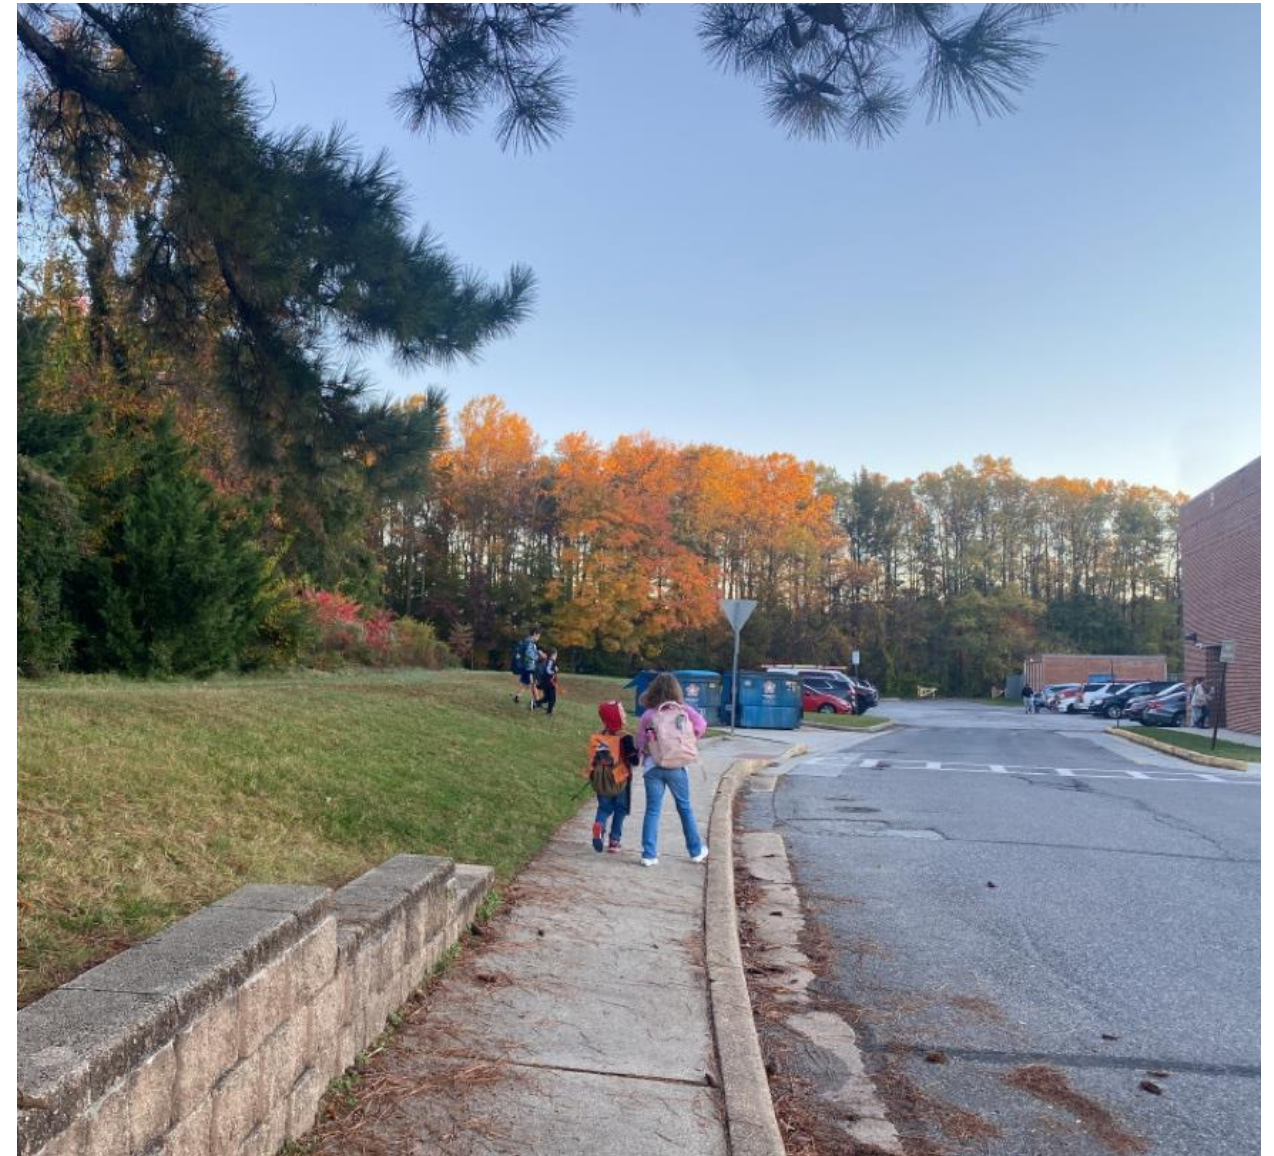
- Approximately 135 student walkers and three bicyclists were observed during arrival. Most walkers came from Indian Summer Drive, the northern formal path, and the Lea Court informal path.
- Most students who walked were in groups, not many were accompanied by adults.
- A few parents were seen dropping their student off in Lea Court, allowing them to walk along the informal trail.

Walkers are seen coming from the sidewalk and the informal paths.

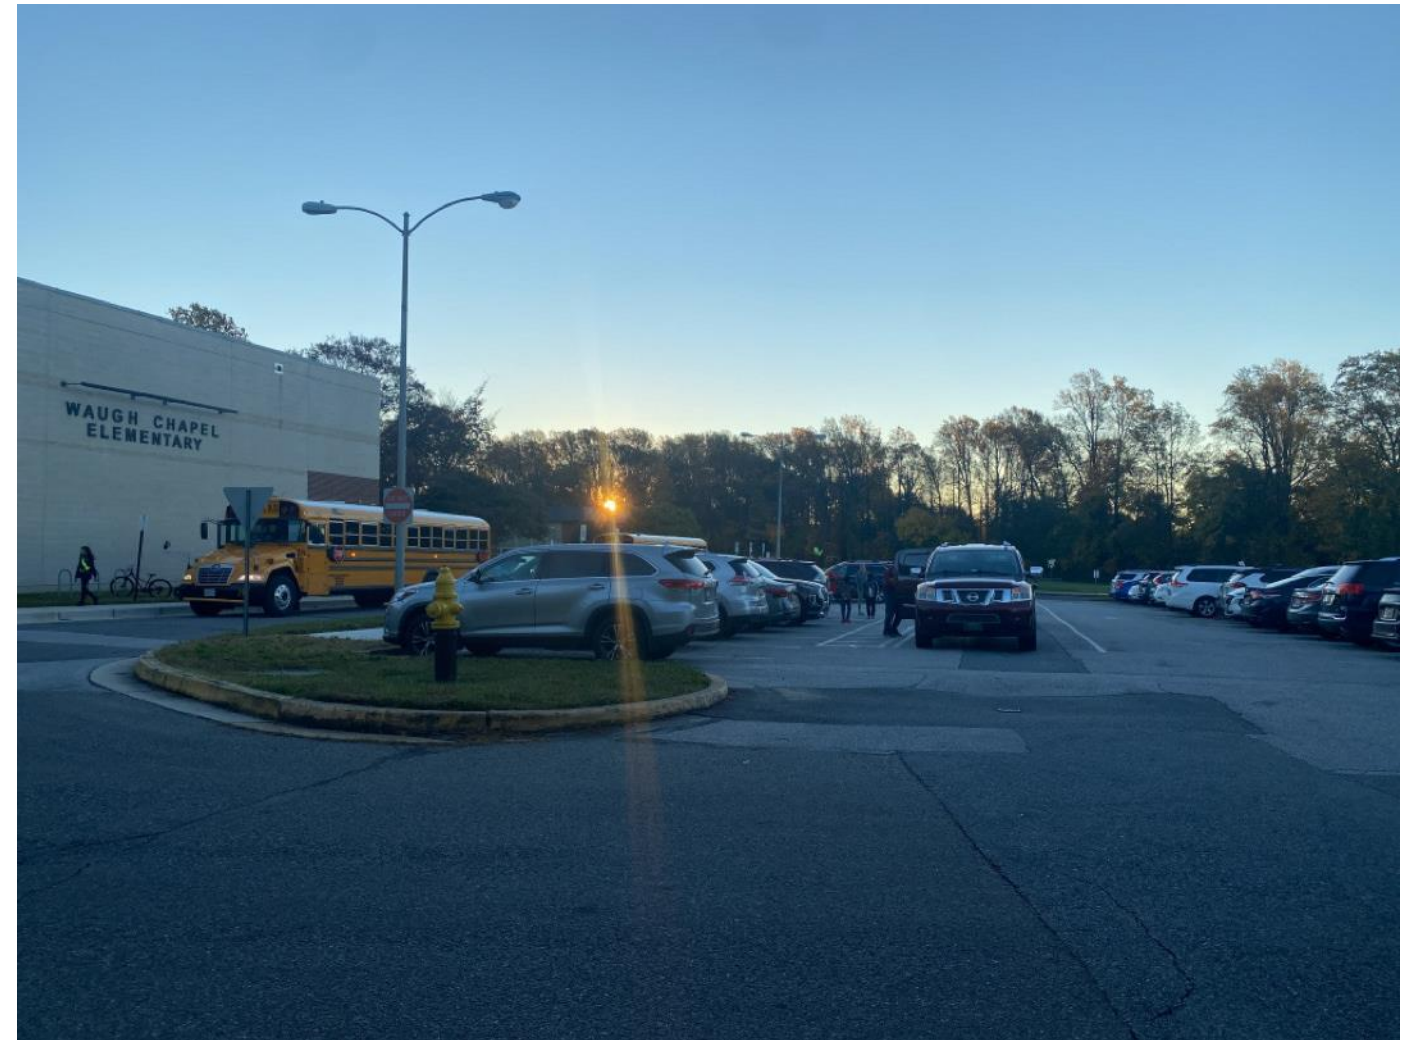
Teachers assisting with the car drop-off line; buses are unloading students.

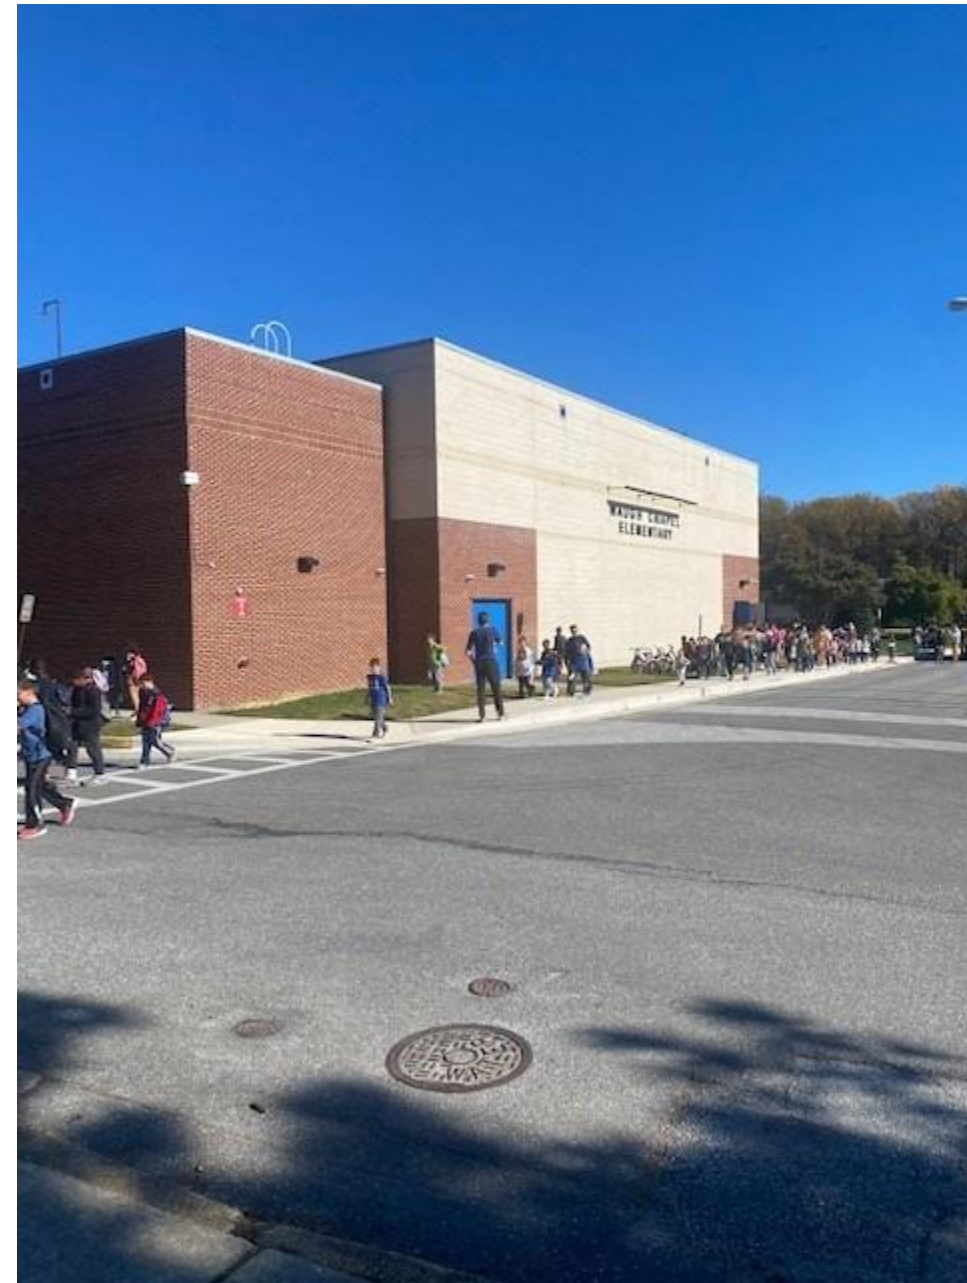
Walkers being dismissed for the day, heading towards Indian Summer Drive.

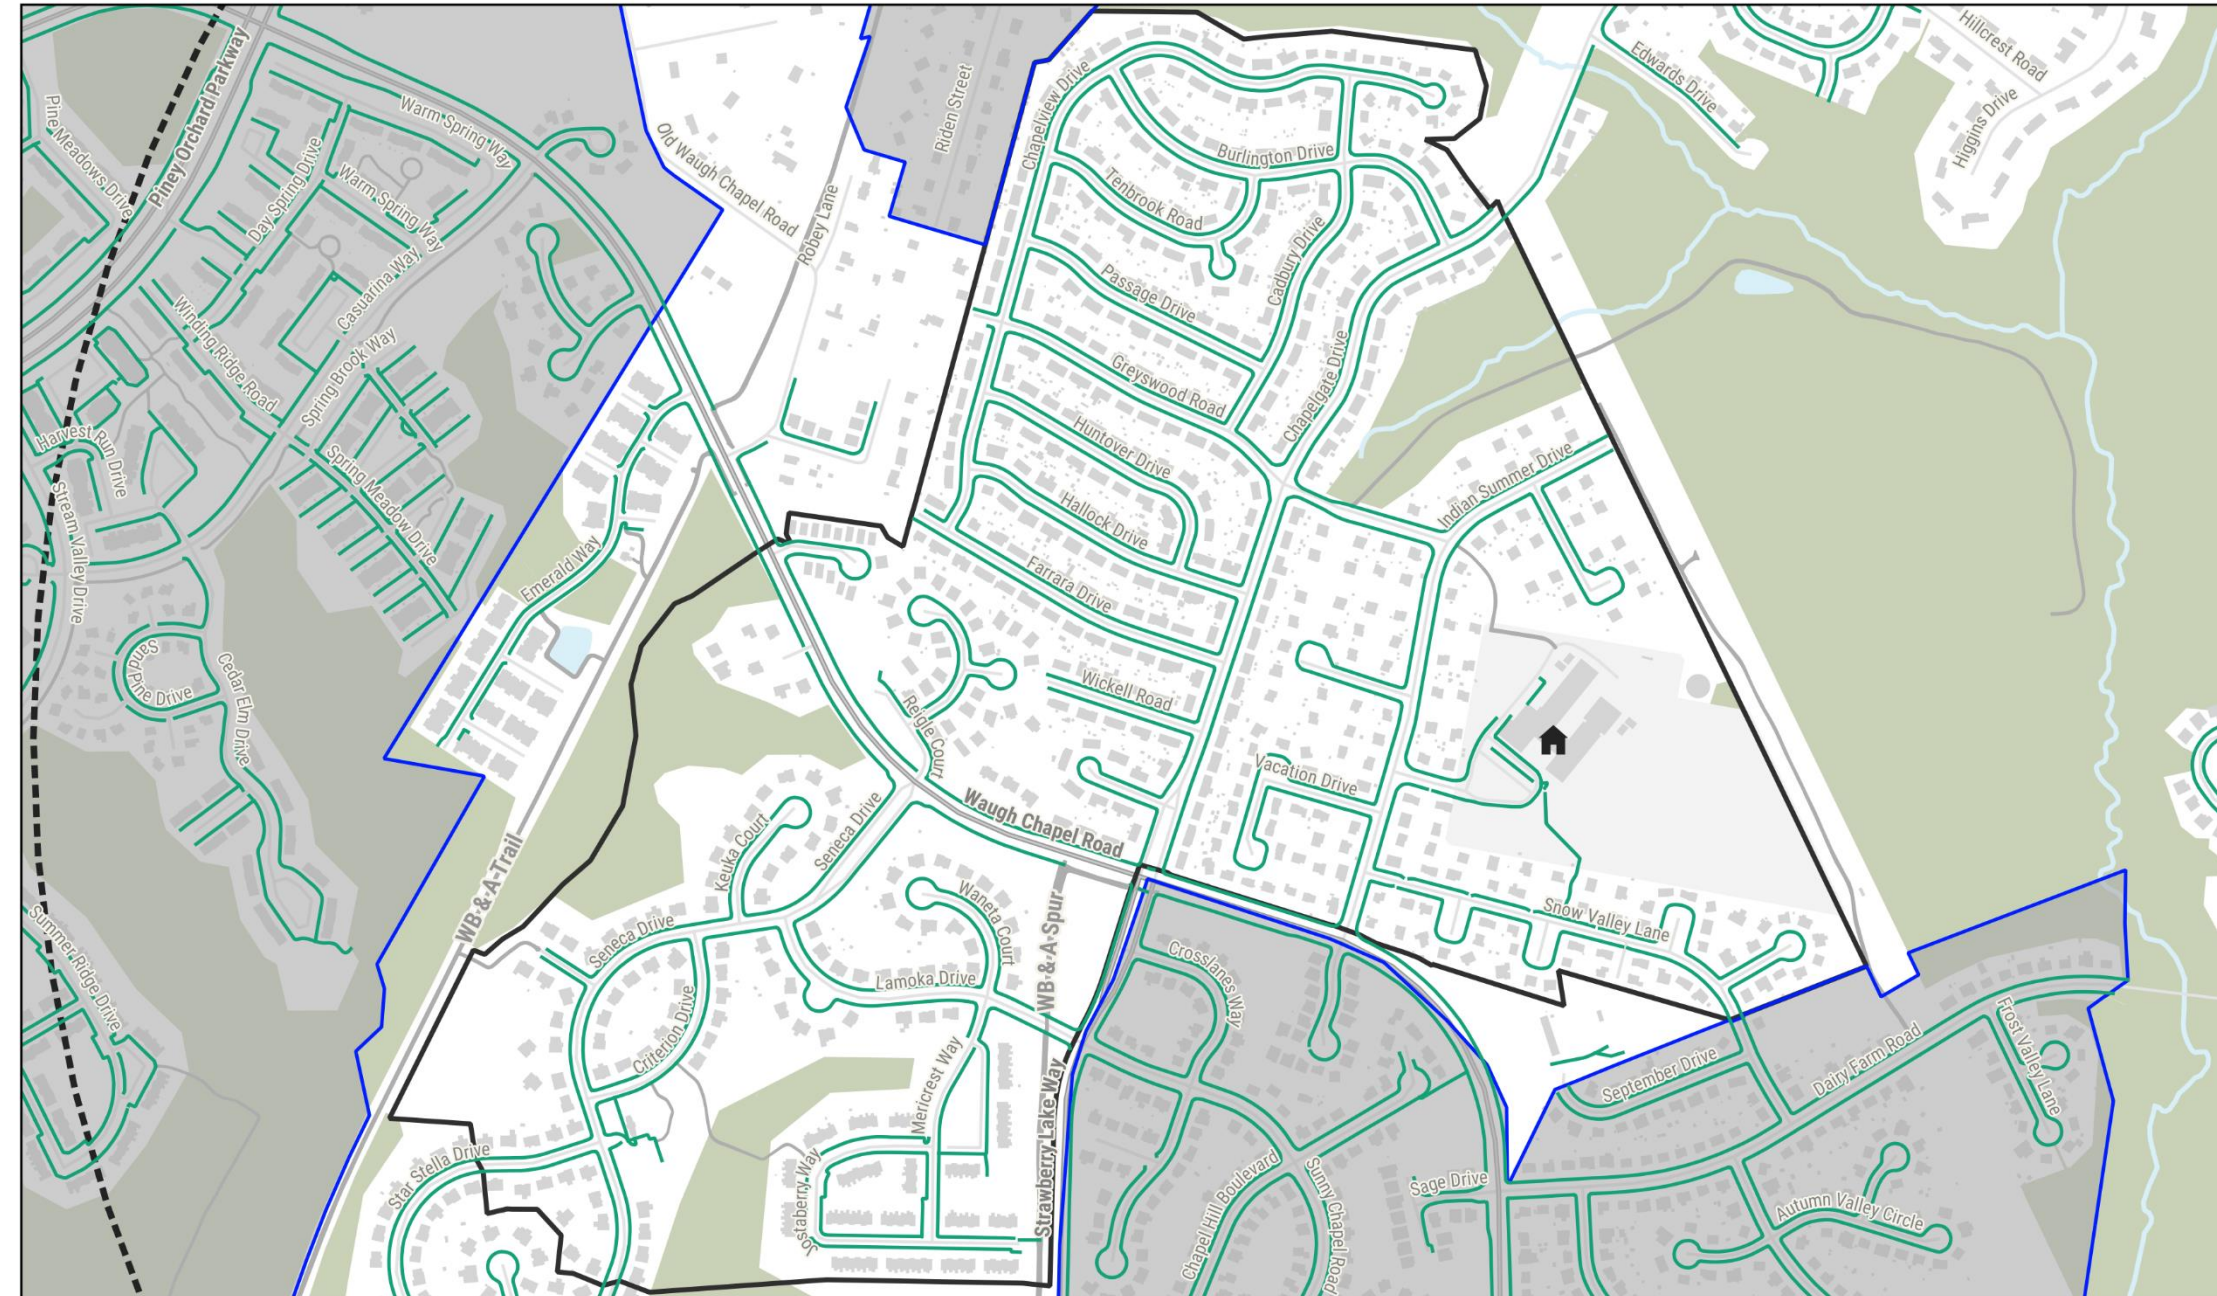
Waugh Chapel Elementary School - Existing Sidewalk Network

There are sidewalks present on all roads within the walk zone, with no observed gaps in the sidewalk network.

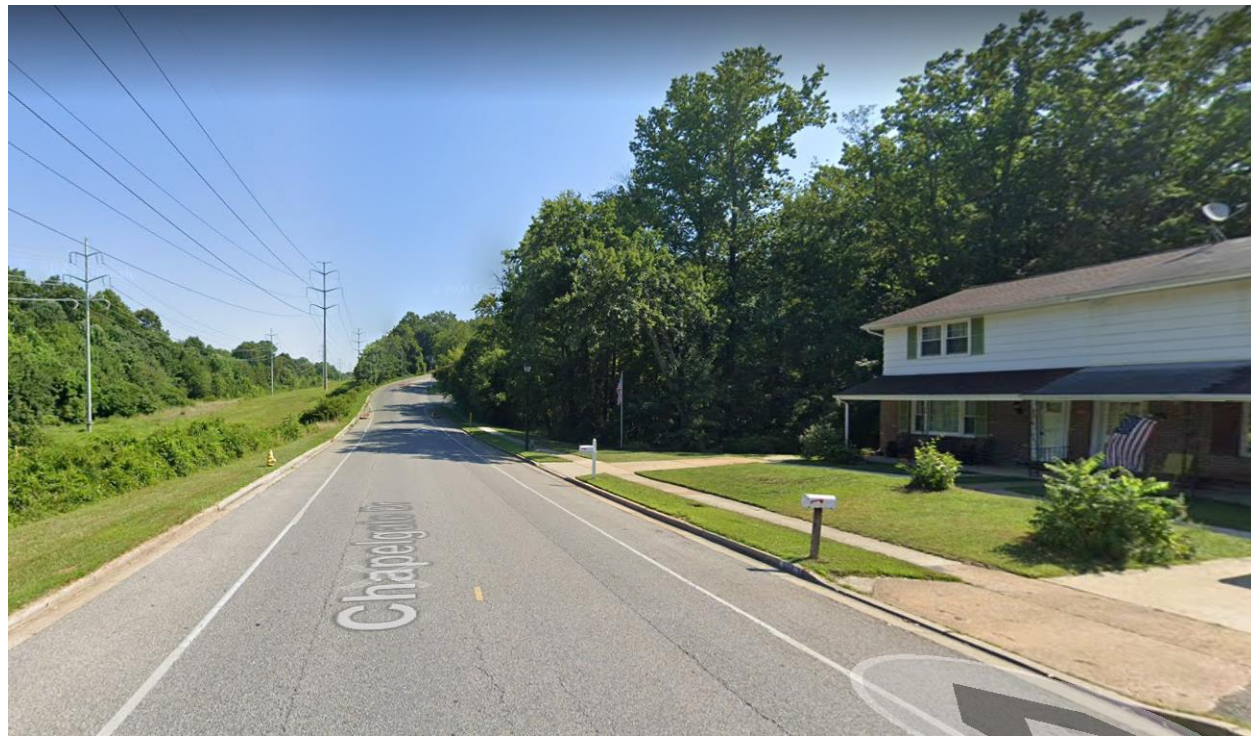
While Chapelgate Drive north of Burlington Drive contains a sidewalk on the east side, the walking distance to Waugh Chapel Elementary from houses along Edwards Drive are approaching one mile. This distance may be bikeable, but vehicles speeds and lack of separated bicycle facilities may present a barrier to active travel to school. For long-term planning, the County could explore separated bike lanes or a shared use path on Chapelgate Drive north of Burlington Drive. Additionally, there is a shared use path recommended for Waugh Chapel Road in Walk and Roll Anne Arundel. Construction of this shared use path could increase bicycle connectivity to the school for students living off Waugh Chapel Road.

View of Chapelgate Drive north of Burlington Drive
via Google Maps

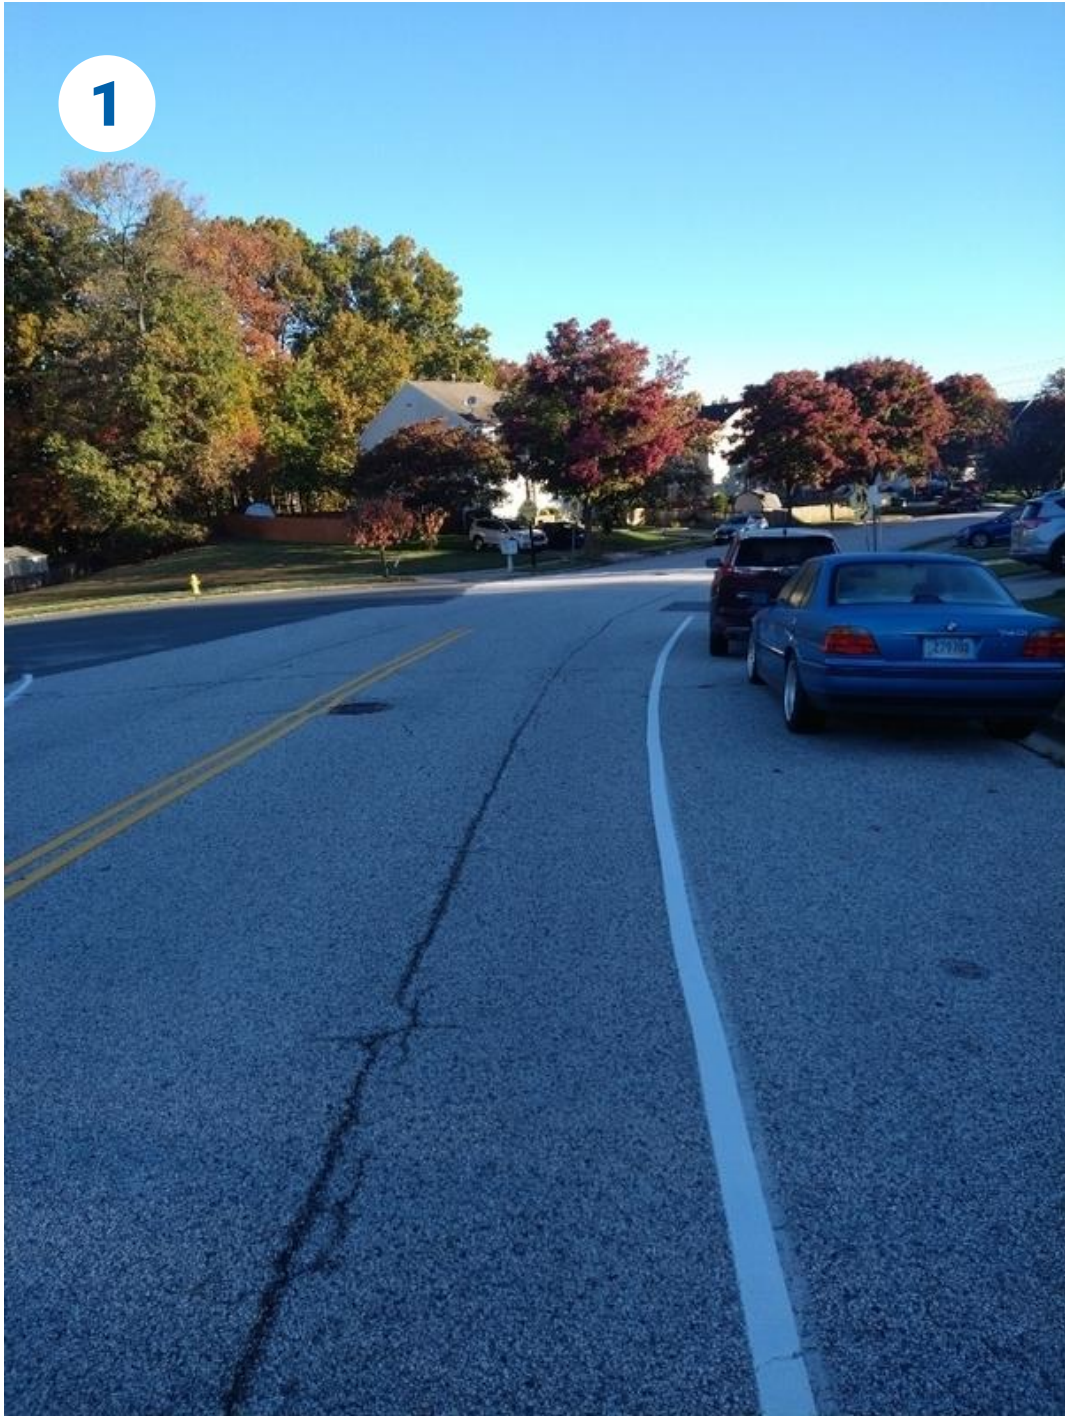
Indian Summer Drive, looking North. Greyswood Rd to the left.

Map ID	Location	Facility Type	Issue	Recommendation	Potential Cost	Timeframe*
1	Indian Summer Dr & Greyswood Rd (Along key student walking route, Inside the school zone)	1a. Curb ramp	All curb ramps lack detectable warning surface.	Reconstruct or repair existing ramps.	\$12,000	Medium
		1b. Crosswalk	Crossing of Greyswood Rd is unmarked, No stop bar	Mark new stop bar and install new standard crosswalk on Greyswood Rd.	\$500	Short
			Existing crosswalk across Indian Summer Dr is narrow.	Remark existing crosswalk to 10ft wide with high-visibility markings.	\$800	
		1c. Other intersection or crossing issues	Concern about motor vehicle turning speeds (turning onto Greyswood Rd).	Install curb extensions or curb radius reduction.	\$8,000	Long
	School crossing signs exist but are bent and/or hidden and not aligned with crossing.			Relocate/reinstall school crossing signs.	\$500	Short
2	Trail from school property to Knob Ct (Along key student walking route)	Sidewalk	90-degree corner raised above surrounding ground; exposed edge presents a tripping hazard.	Fill in curve or raise surrounding ground.	\$23,470	Long

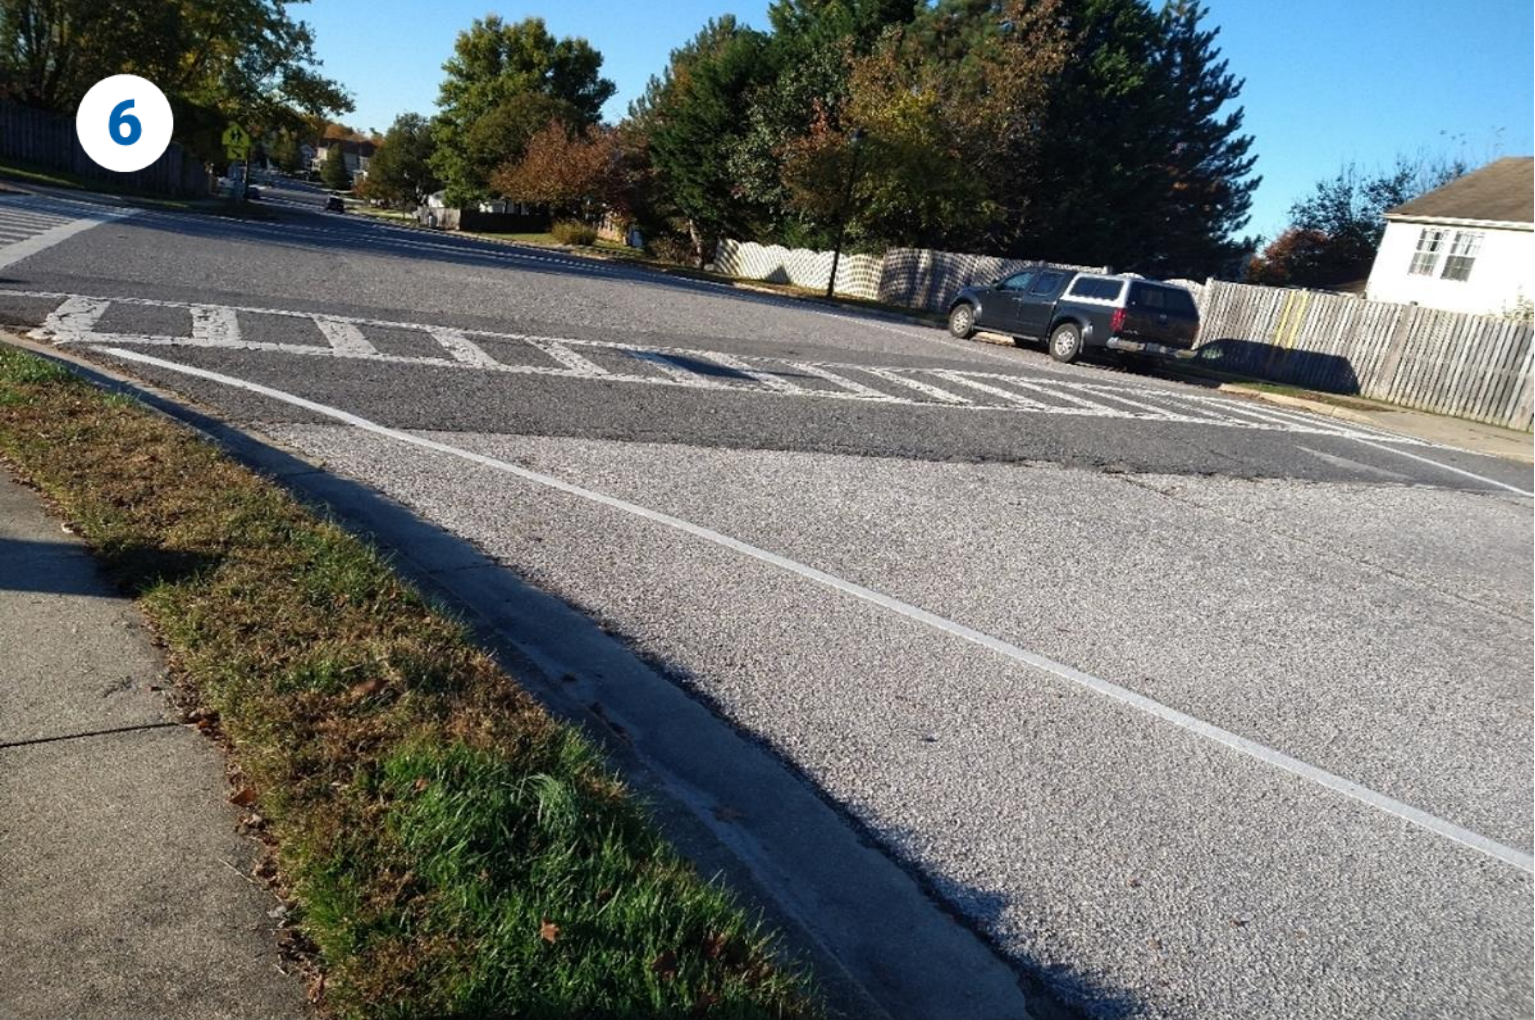
The raised crosswalk at the intersection of Indian Summer Drive and Sunflower Drive.

Map ID	Location	Facility Type	Issue	Recommendation	Potential Cost	Timeframe*
6	Indian Summer Dr & Sunflower Dr (Along key student walking and bicycling route, Inside school zone, Existing crossing guard location)	6a. Other intersection or crossing issues	Concern about motor vehicle volumes and turning speeds. Currently no stop control on Indian Summer Dr. Sunflower Dr is stop controlled.	Consider evaluating for STOP control with stop bars on north and south legs of Indian Summer Dr.	N/A	Long
			Parked cars obstruct sight lines.	Install curb extensions at all crossings.	\$20,000	Long
			Crossing lacks appropriate signage.	Install school crossing signs with downward pointing arrows.	\$500	Short
		6b. Crosswalk	South crossing of Indian Summer Dr is unmarked	Install new high-visibility crosswalk Consider installing raised crosswalk similar to north leg.	\$800 for crosswalk, \$10,000 for raised crosswalk	Short Medium

Existing crosswalks across Indian Summer Drive (north) and Sunflower Dr appear narrow.	Remark existing crosswalk to 10ft wide with high-visibility markings; ensure the curb ramps are within the extension of the crosswalk markings.	\$1,600	Short

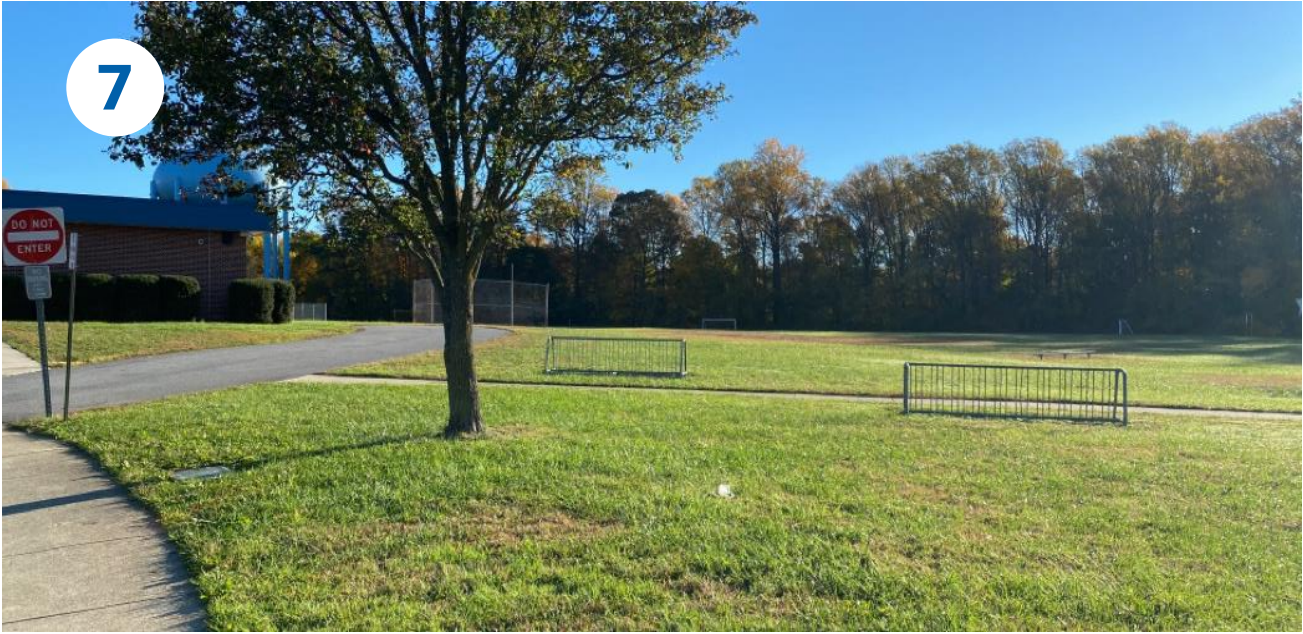
Bike racks on the east side of campus.

Map ID	Location	Facility Type	Issue	Recommendation	Potential Cost	Timeframe*
7	South school path, near east apex of driveway loop (On school campus)	Bicycle Rack	Existing rack does not allow locking of frame.	Replace existing rack with inverted U rack. Consider moving rack closer to school entrance.	\$175/per (quantity TBD)	Short
8	Snow Valley Ln & Indian Summer Dr (Along key student walking route, Inside the school zone)	8a. Crosswalk	Crossing of Snow Valley Ln in unmarked, No stop bar.	Mark new stop bar and install new standard crosswalk across Snow Valley Ln.	\$500	Short
		8b. Curb ramp	Northeast and southeast ramps lack detectable warning surface.	Reconstruct or repair existing ramps.	\$8,000	Medium
9	Waugh Chapel Rd & Chapelgate Dr / Strawberry Lake Way (Along key student walking route)	9a. Crosswalk	Crosswalk markings across Waugh Chapel Rd not high visibility.	Remark existing crosswalk with high-visibility markings	\$800	Short

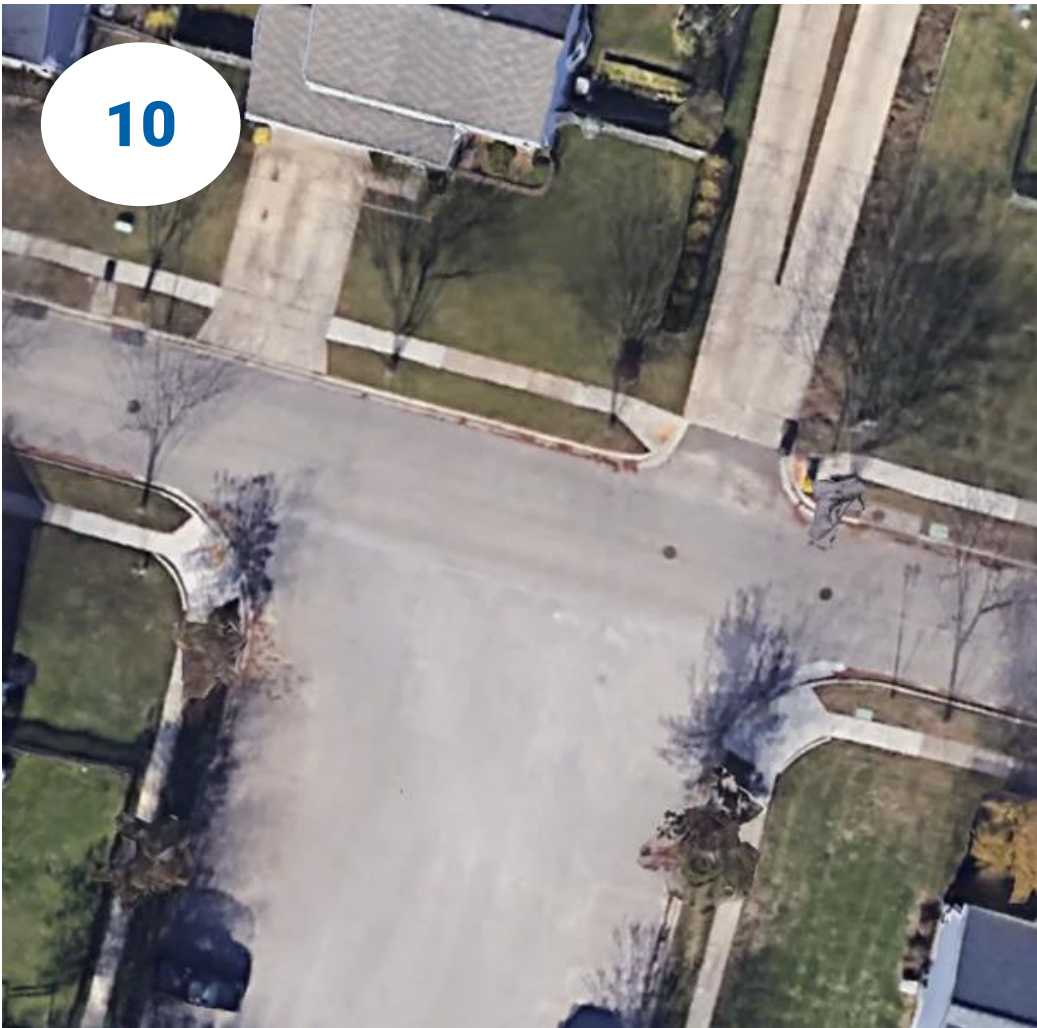
Aerial view of the crossing of Snow Valley Lane and Summer Court.

Map ID	Location	Facility Type	Issue	Recommendation	Potential Cost	Timeframe*
10	Snow Valley Ln & Summer Ct	10a. Other intersection or crossing issues	Southern crossing of Summer Ct is long. Concern about motor vehicle turning speeds	Install curb extensions or curb radius reduction.	\$10,000	Long
			Parked cars obstruct sight lines.	Restrict parking in advance of crosswalk.	\$500	Short
		10b. Crosswalk	Crossing of Summer Ct is unmarked, No stop bar.	Install new standard crosswalk. Mark new stop bar.	\$500	Short
11	Waugh Chapel Rd (Strawberry Lake Way to Chapel Hill Blvd path) (Along key student walking route)	11a. School Zone Signs and Pavement Markings	Existing school zone sign deficient, SCHOOL pavement marking missing, School advance warning sign missing, School zone speed limit sign missing.	Expand school zone and enhance signage per MdMUTCD part 7.		Short

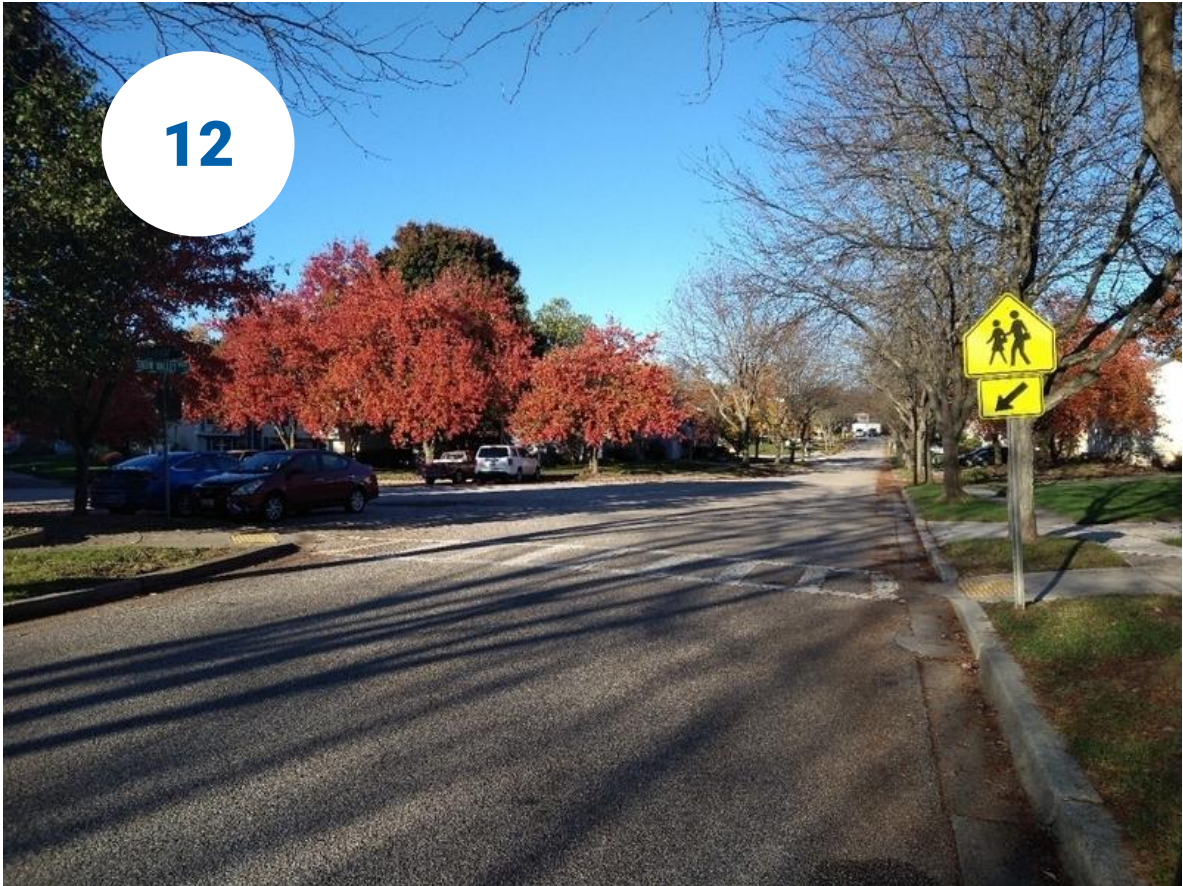
The crossing at Snow Valley Lane and Raindrop Court.

Map ID	Location	Facility Type	Issue	Recommendation	Potential Cost	Timeframe*
12	Snow Valley Ln & Raindrop Ct (Along key student walking route)	12a. Crosswalk	Crossing of Raindrop Ct is unmarked, No stop bar	Install new standard crosswalk, Mark new stop bar	\$500	Short
		12b. Other intersection or crossing issues	Crossing of Raindrop Ct is long. Parked cars obstruct sight lines.	Install curb extensions	\$10,000	Long
			East crossing of Snow Valley Ln lacks appropriate crossing signage	Install school crossing signs with downward pointing arrows on both sides of the crosswalk for both east and westbound traffic.	\$500	Short
13	Waugh Chapel Rd & Indian Summer Dr (Along key student walking route)	Other intersection or crossing issues	Currently no stop controls or pedestrian crossing facilities exist at any leg of this intersection.	Consider evaluating for traffic signal. If installed:	N/A	Long
			<i>Neighborhood immediately to the south is zoned for Four Seasons Elementary but if attendance boundaries change this would be a critical school crossing.</i>	- Install curb extensions or curb radius reduction and ramps with detectable warning surface (all corners)	\$20,000	Long

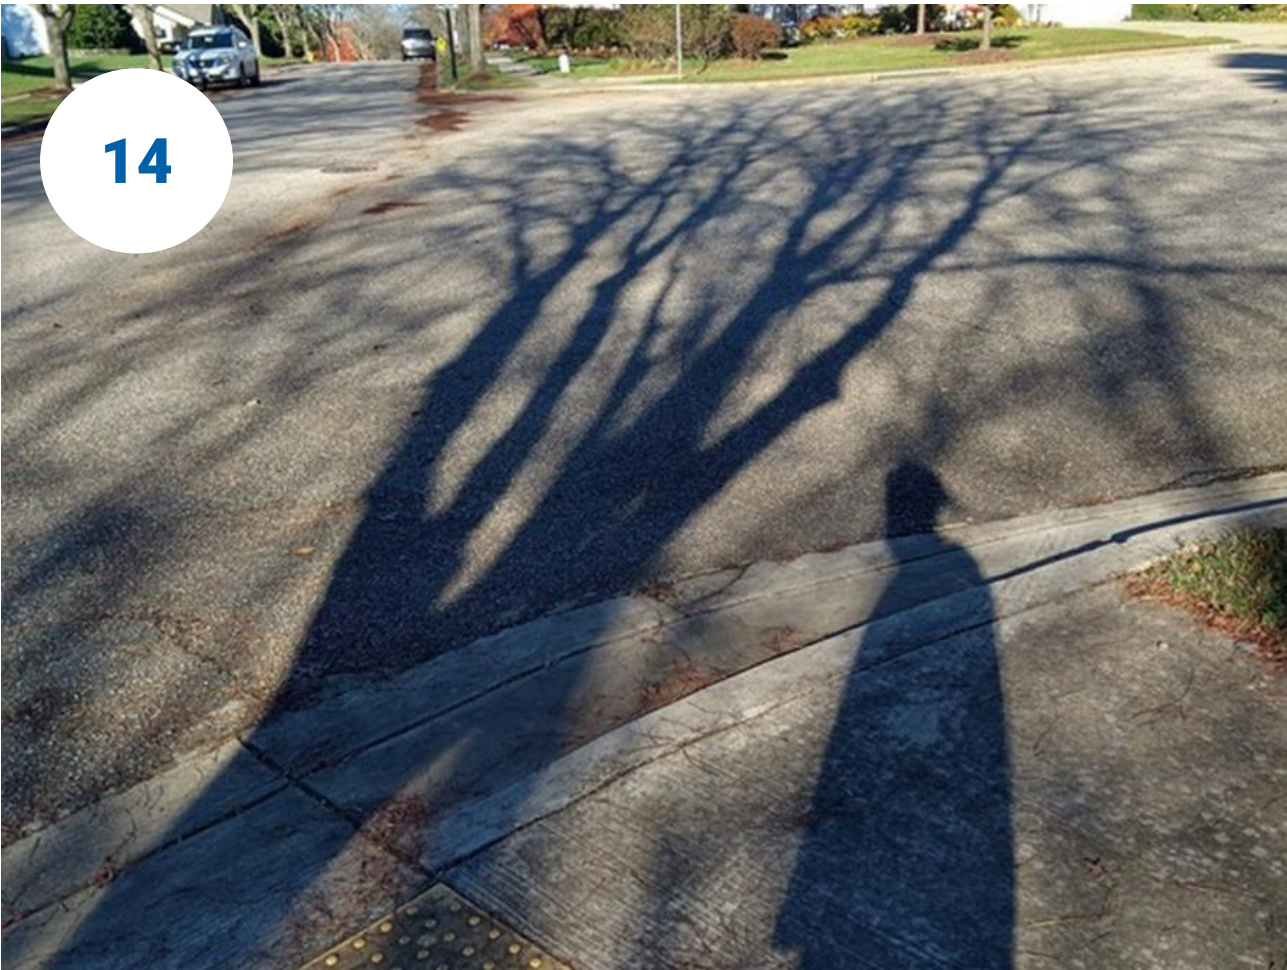
The crossing at Snow Valley Lane and Autumn Court.

Map ID	Location	Facility Type	Issue	Recommendation	Potential Cost	Timeframe*
14	Snow Valley Ln & Autumn Ct	14a. Other intersection or crossing issues	Crossing of Autumn Ct is long. Concern about motor vehicle speeds turning into Autumn Ct.	Install curb extensions.	\$10,000	Long
			Concern about motor vehicle yielding. Currently there is no stop control.	Consider evaluating for STOP control.	N/A	Medium
		14b. Crosswalk	Crossing of Autumn Ct is unmarked, No stop bar.	Install new standard crosswalk, Mark new stop bar.	\$500	Short
15	Snow Valley Ln & Snowfall Ct	Crosswalk	Crossing of Snowfall Ct is unmarked	Install new standard crosswalk	\$400	Short

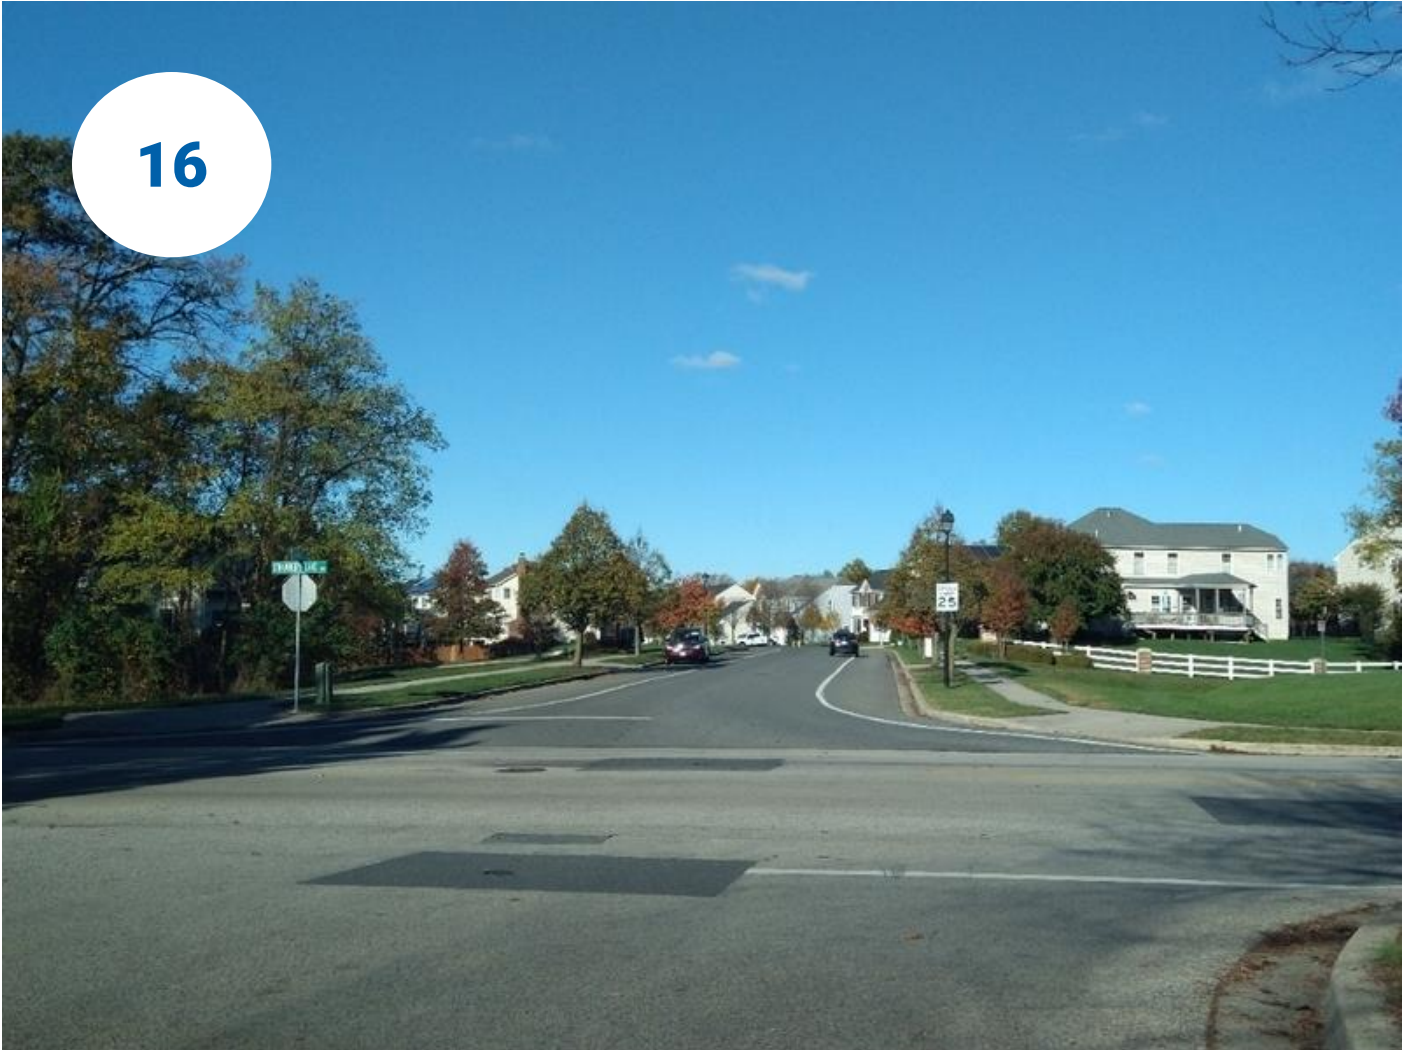
The intersection of Strawberry Lake Way and Lamoka Drive/Sunny Chapel Road

Map ID	Location	Facility Type	Issue	Recommendation	Potential Cost	Timeframe*
16	Strawberry Lake Way & Lamoka Dr (Along key student walking route)	16a. Crosswalk	Crossing of Lamoka Dr is unmarked.	Install new standard crosswalk	\$400	Short
			Stop bar located too close to crossing	Remark existing stop bar a minimum of 4 feet in advance of nearest crosswalk line	\$100	
		16b. Curb ramp	Ramps lack detectable warning surface, Ramps not aligned with crossing	Reconstruct or repair existing ramps	\$8,000	
		16c. Other intersection or crossing issues	Concern about motor vehicle turning movements and speeds	Install curb extensions	\$10,000	Long
