Linthicum Elementary School Safe Routes to School Accessibility Study: Existing Conditions and Recommendations

August 17, 2023

Anne Arundel Safe Routes to School Accessibility Study

Linthicum Elementary Accessibility Study

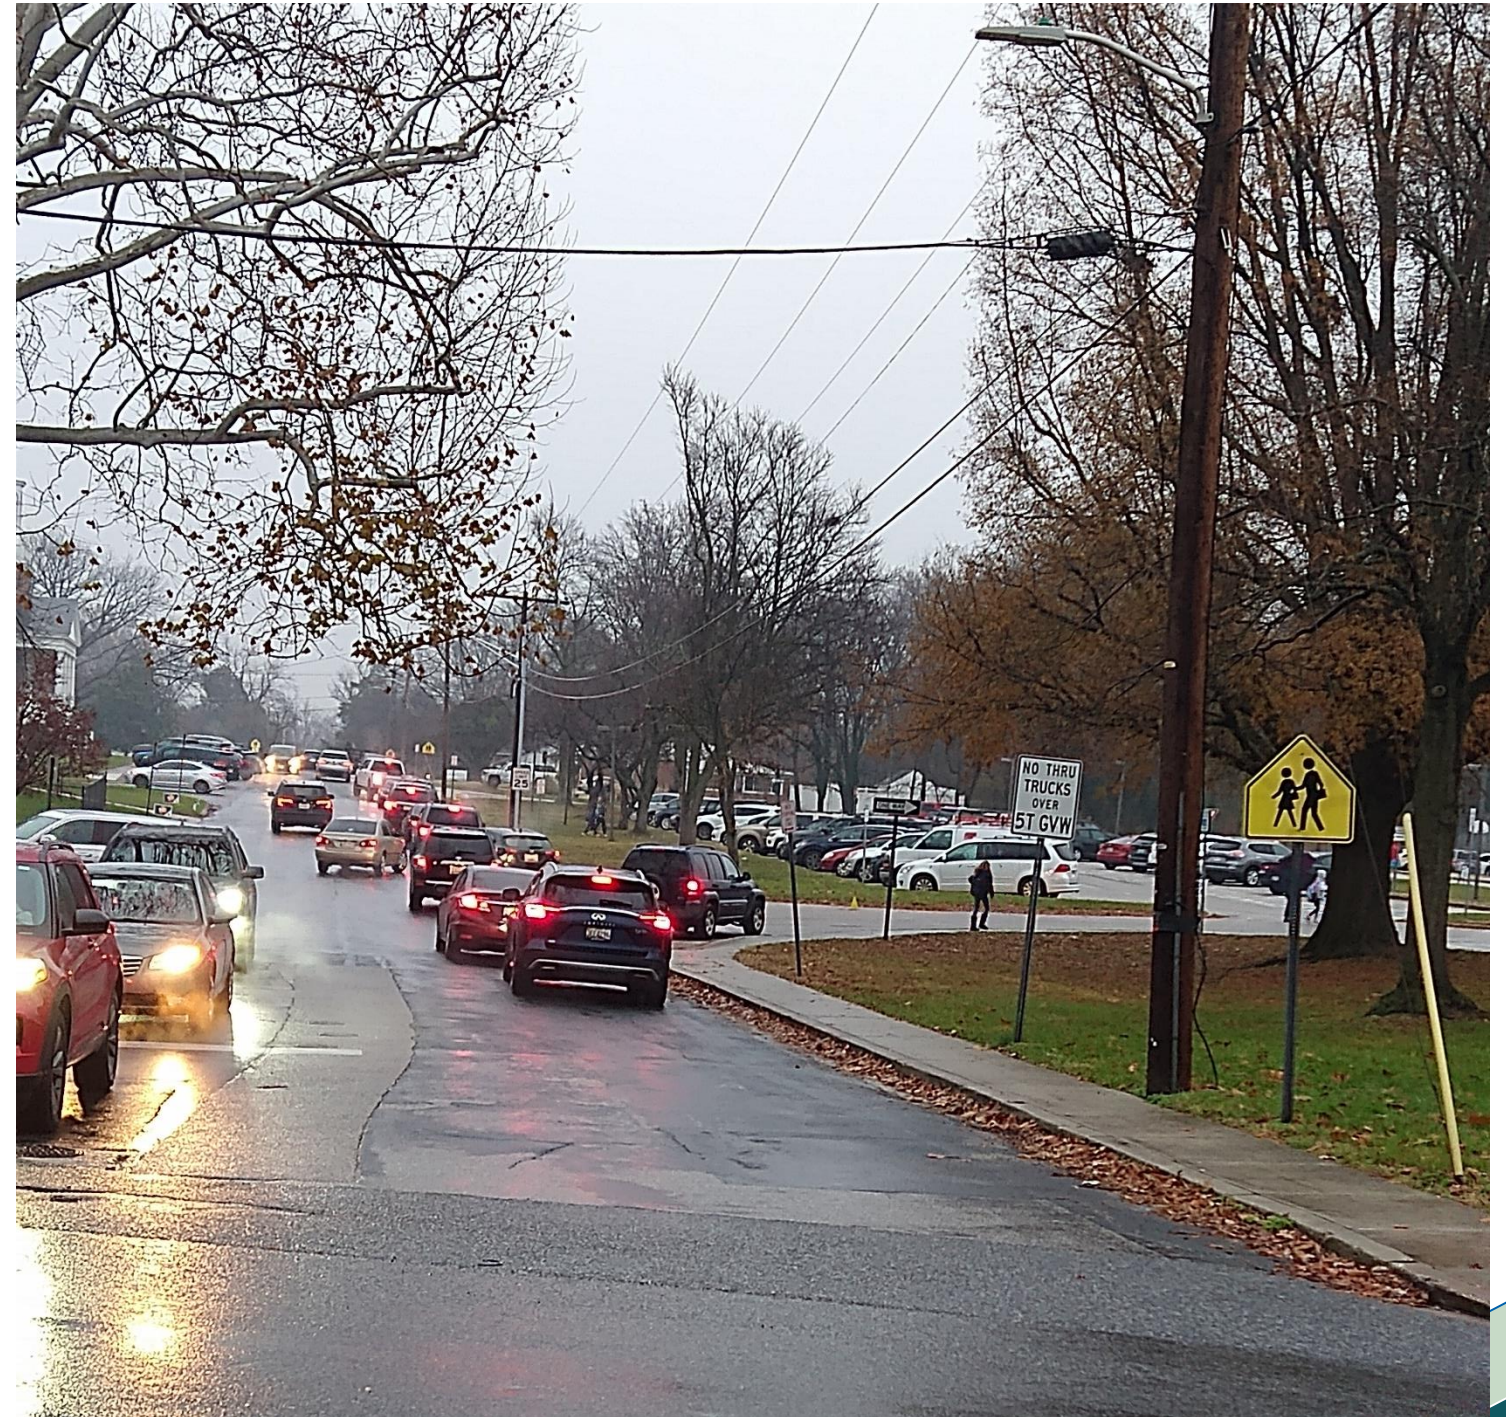
- Per AACPS data, two crossing guard locations are assigned to Linthicum Elementary School; one crossing guard was observed at the intersection of School Lane and South Camp Meade Road.
- The crossing guard managed traffic to assist drivers entering and exiting School Lane.

School Lane during school arrival.

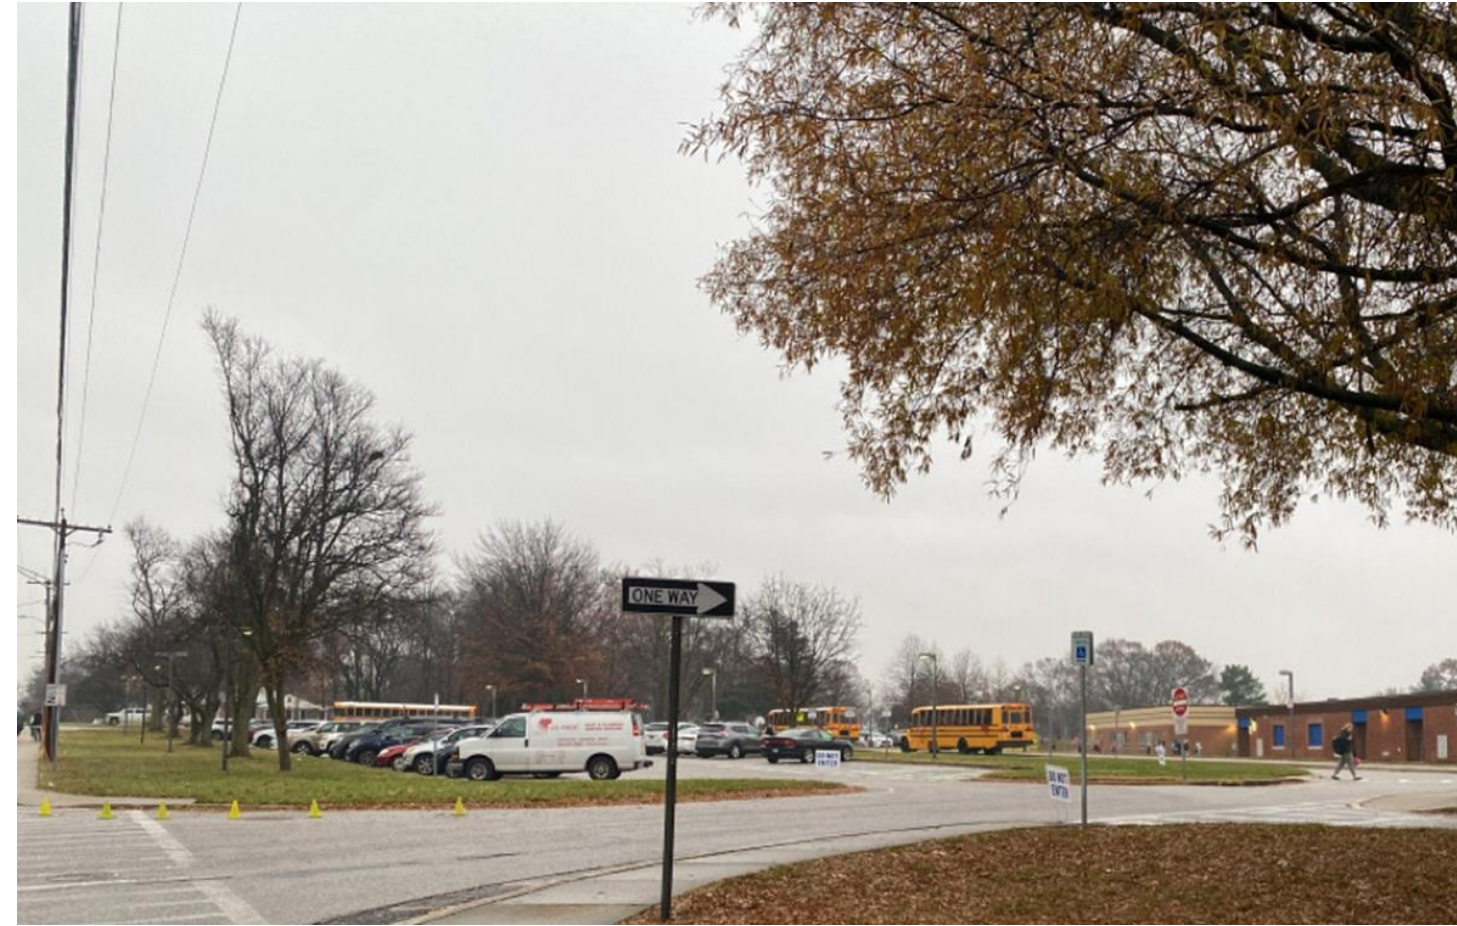
Buses waiting to drop off students during arrival.

- Approximately four buses were observed at arrival.

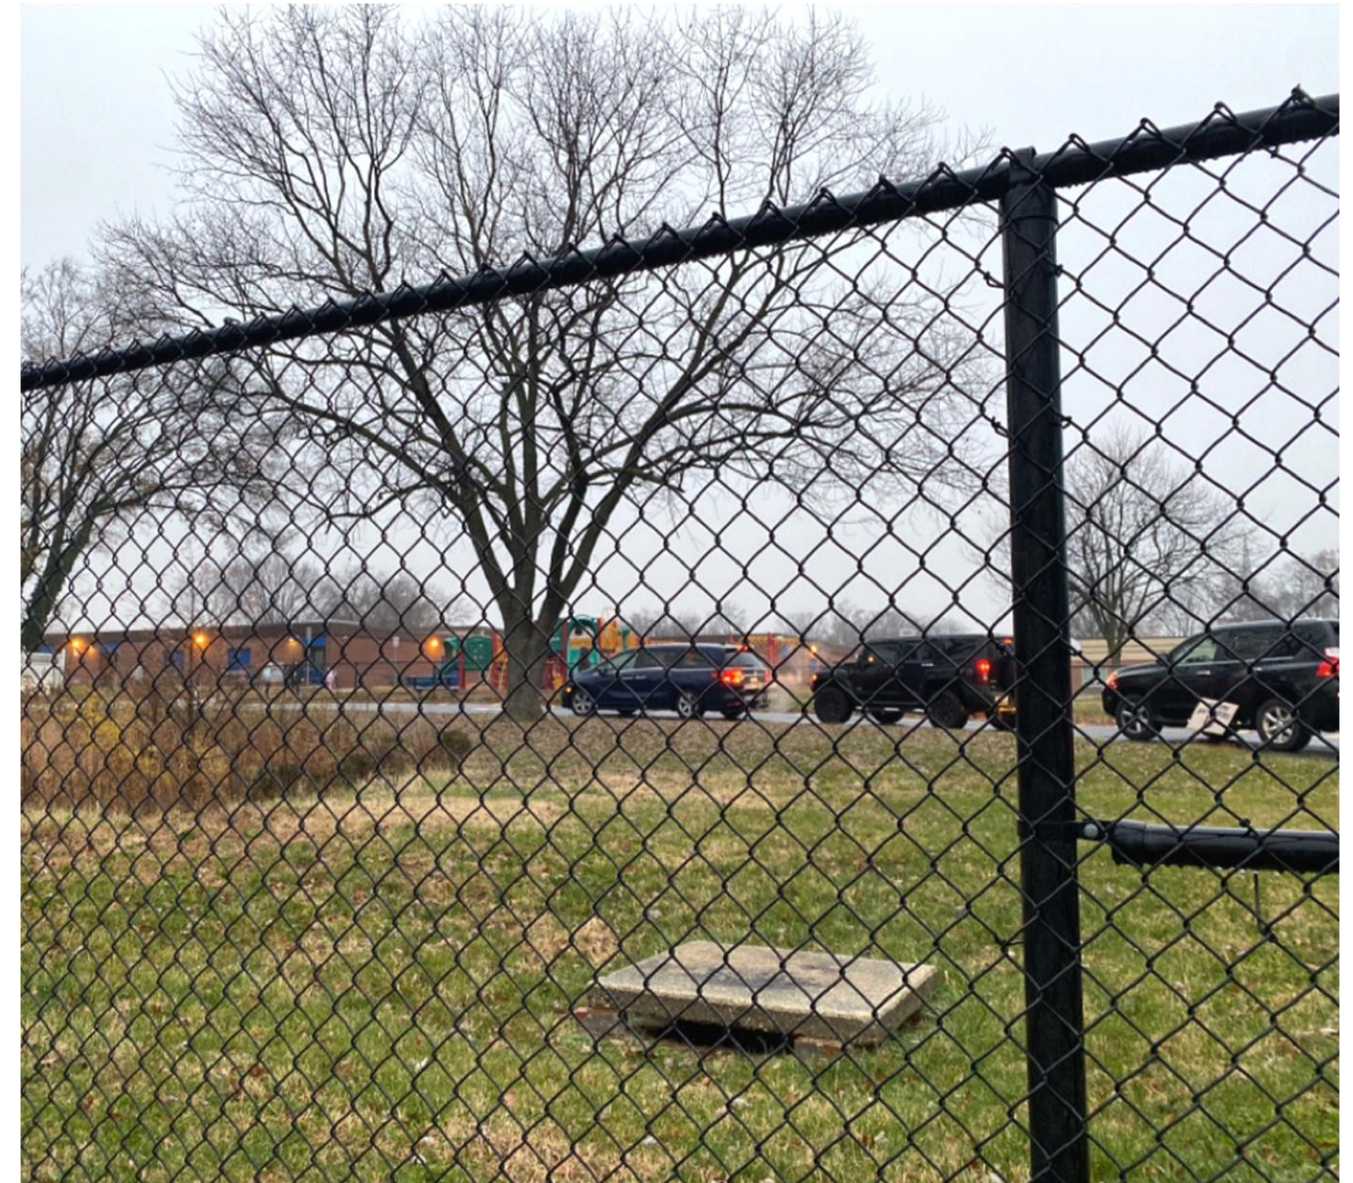
- Drivers were observed transporting students from houses across Benton Avenue.
- Many drivers were observed entering Benton Avenue from South Camp Meade Road, driving past the drop-off driveway, and making a U-turn on Benton Avenue at Golden Oak Drive to return to the driveway.
- Many parents dropped off students on School Lane or parked along the street and walked their kids to the door; double-parking, parking in crosswalks, U-turns, and several near-collisions were observed.

Parent drop-off loop at school arrival.

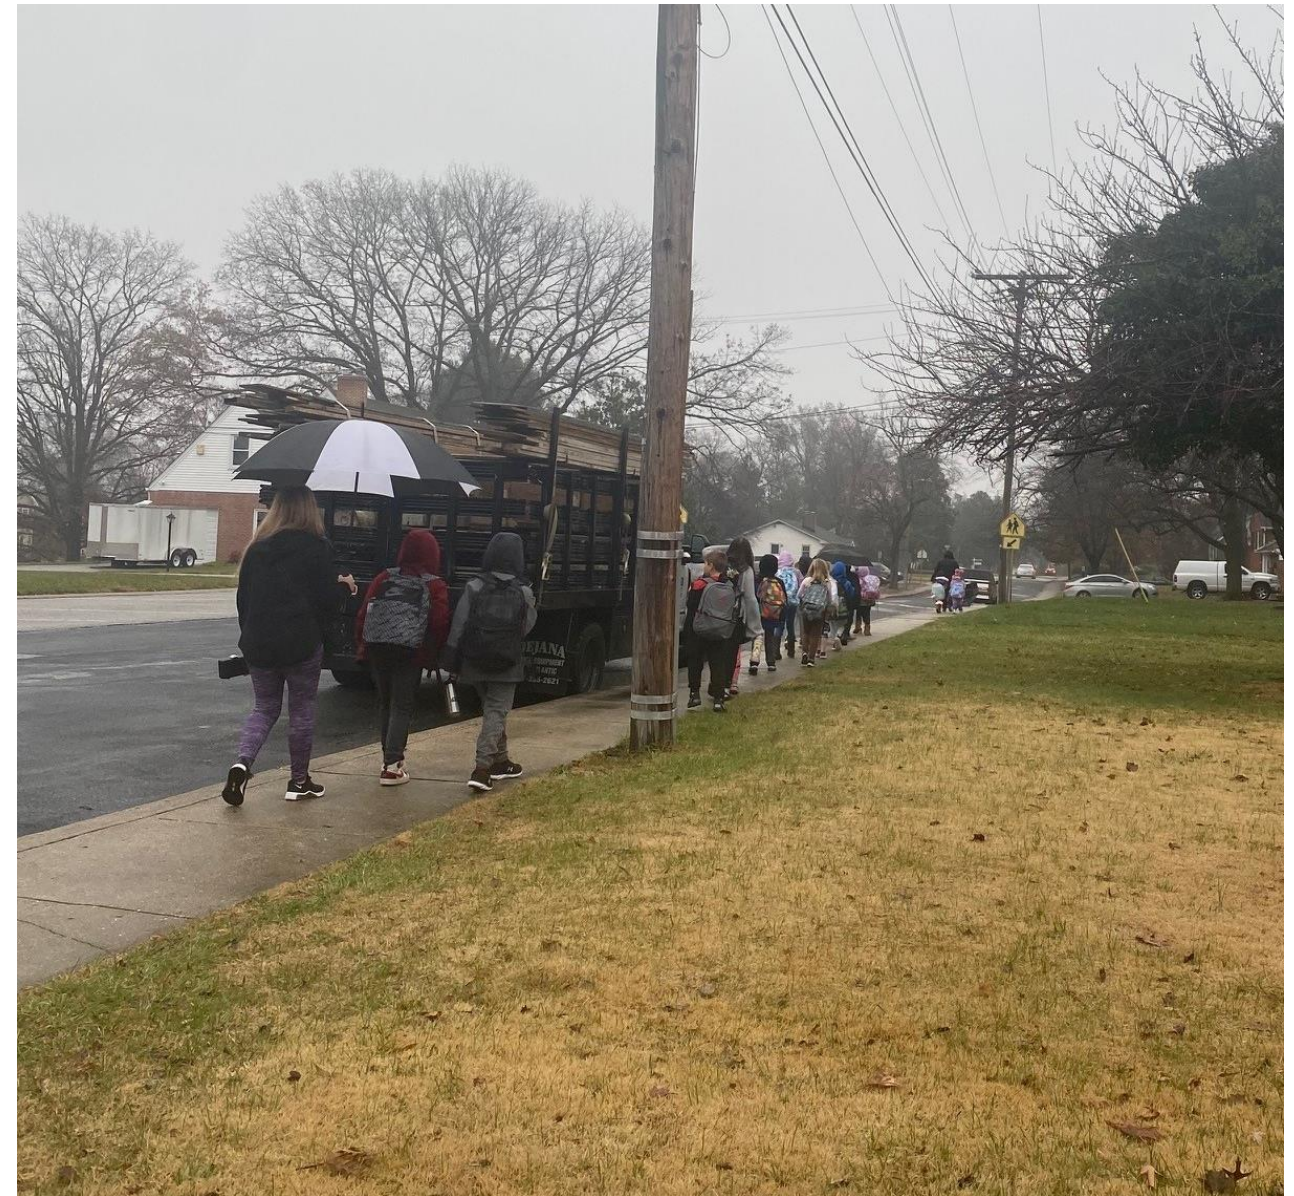
- Approximately 30 students, including a group of about 20 students and 2 parents were observed walking east on School Lane toward Sycamore Street.
- Approximately 5 students with one parent were observed crossing South Camp Meade Road at School Lane and heading south.
- Most students getting dismissed as walkers appeared to be park-and-walk students.

Walkers on School Lane at dismissal.

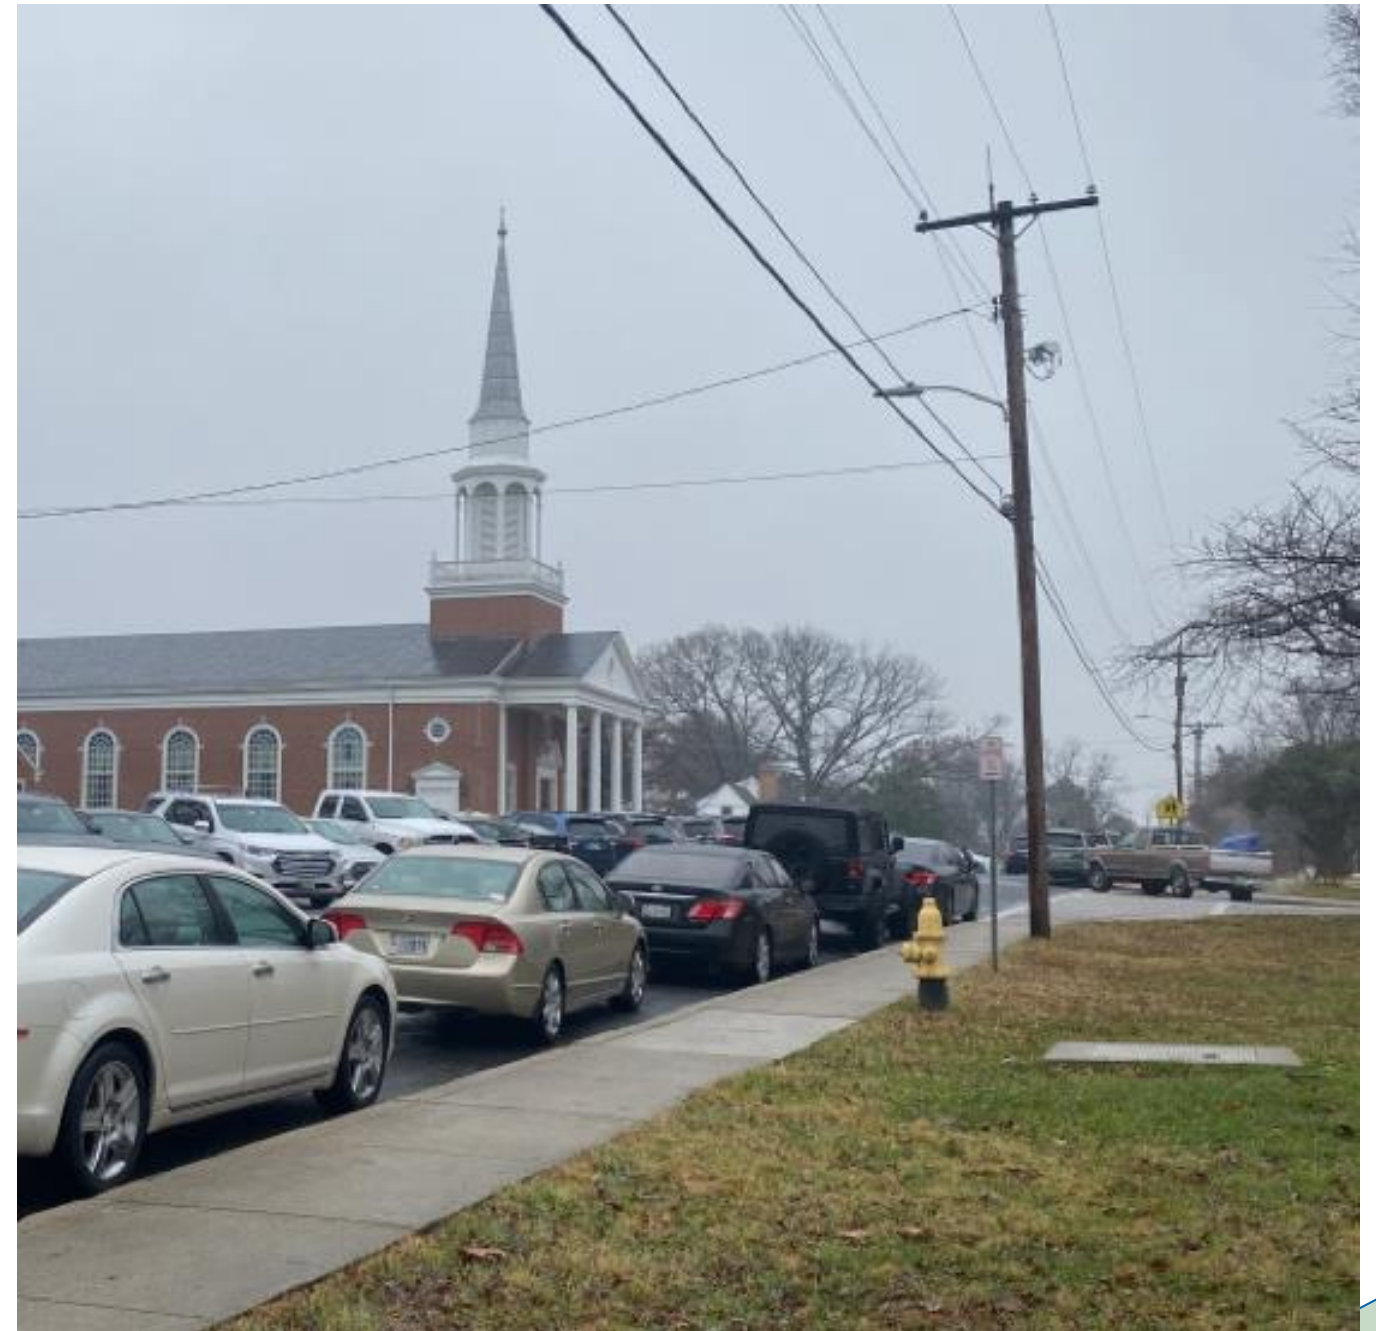
- Approximately 70 cars were parked along School Lane at dismissal, including in the parking area of the church across the street.
- Numerous vehicular conflicts were observed on School Lane, including drivers pulling out of parking spaces cutting off other drivers, drivers double-parking, and parking in areas posted no-parking and in intersections and crosswalks.
- Multiple cars observed blocking crosswalks at both ends of the school driveway on School Lane.

School Lane at dismissal

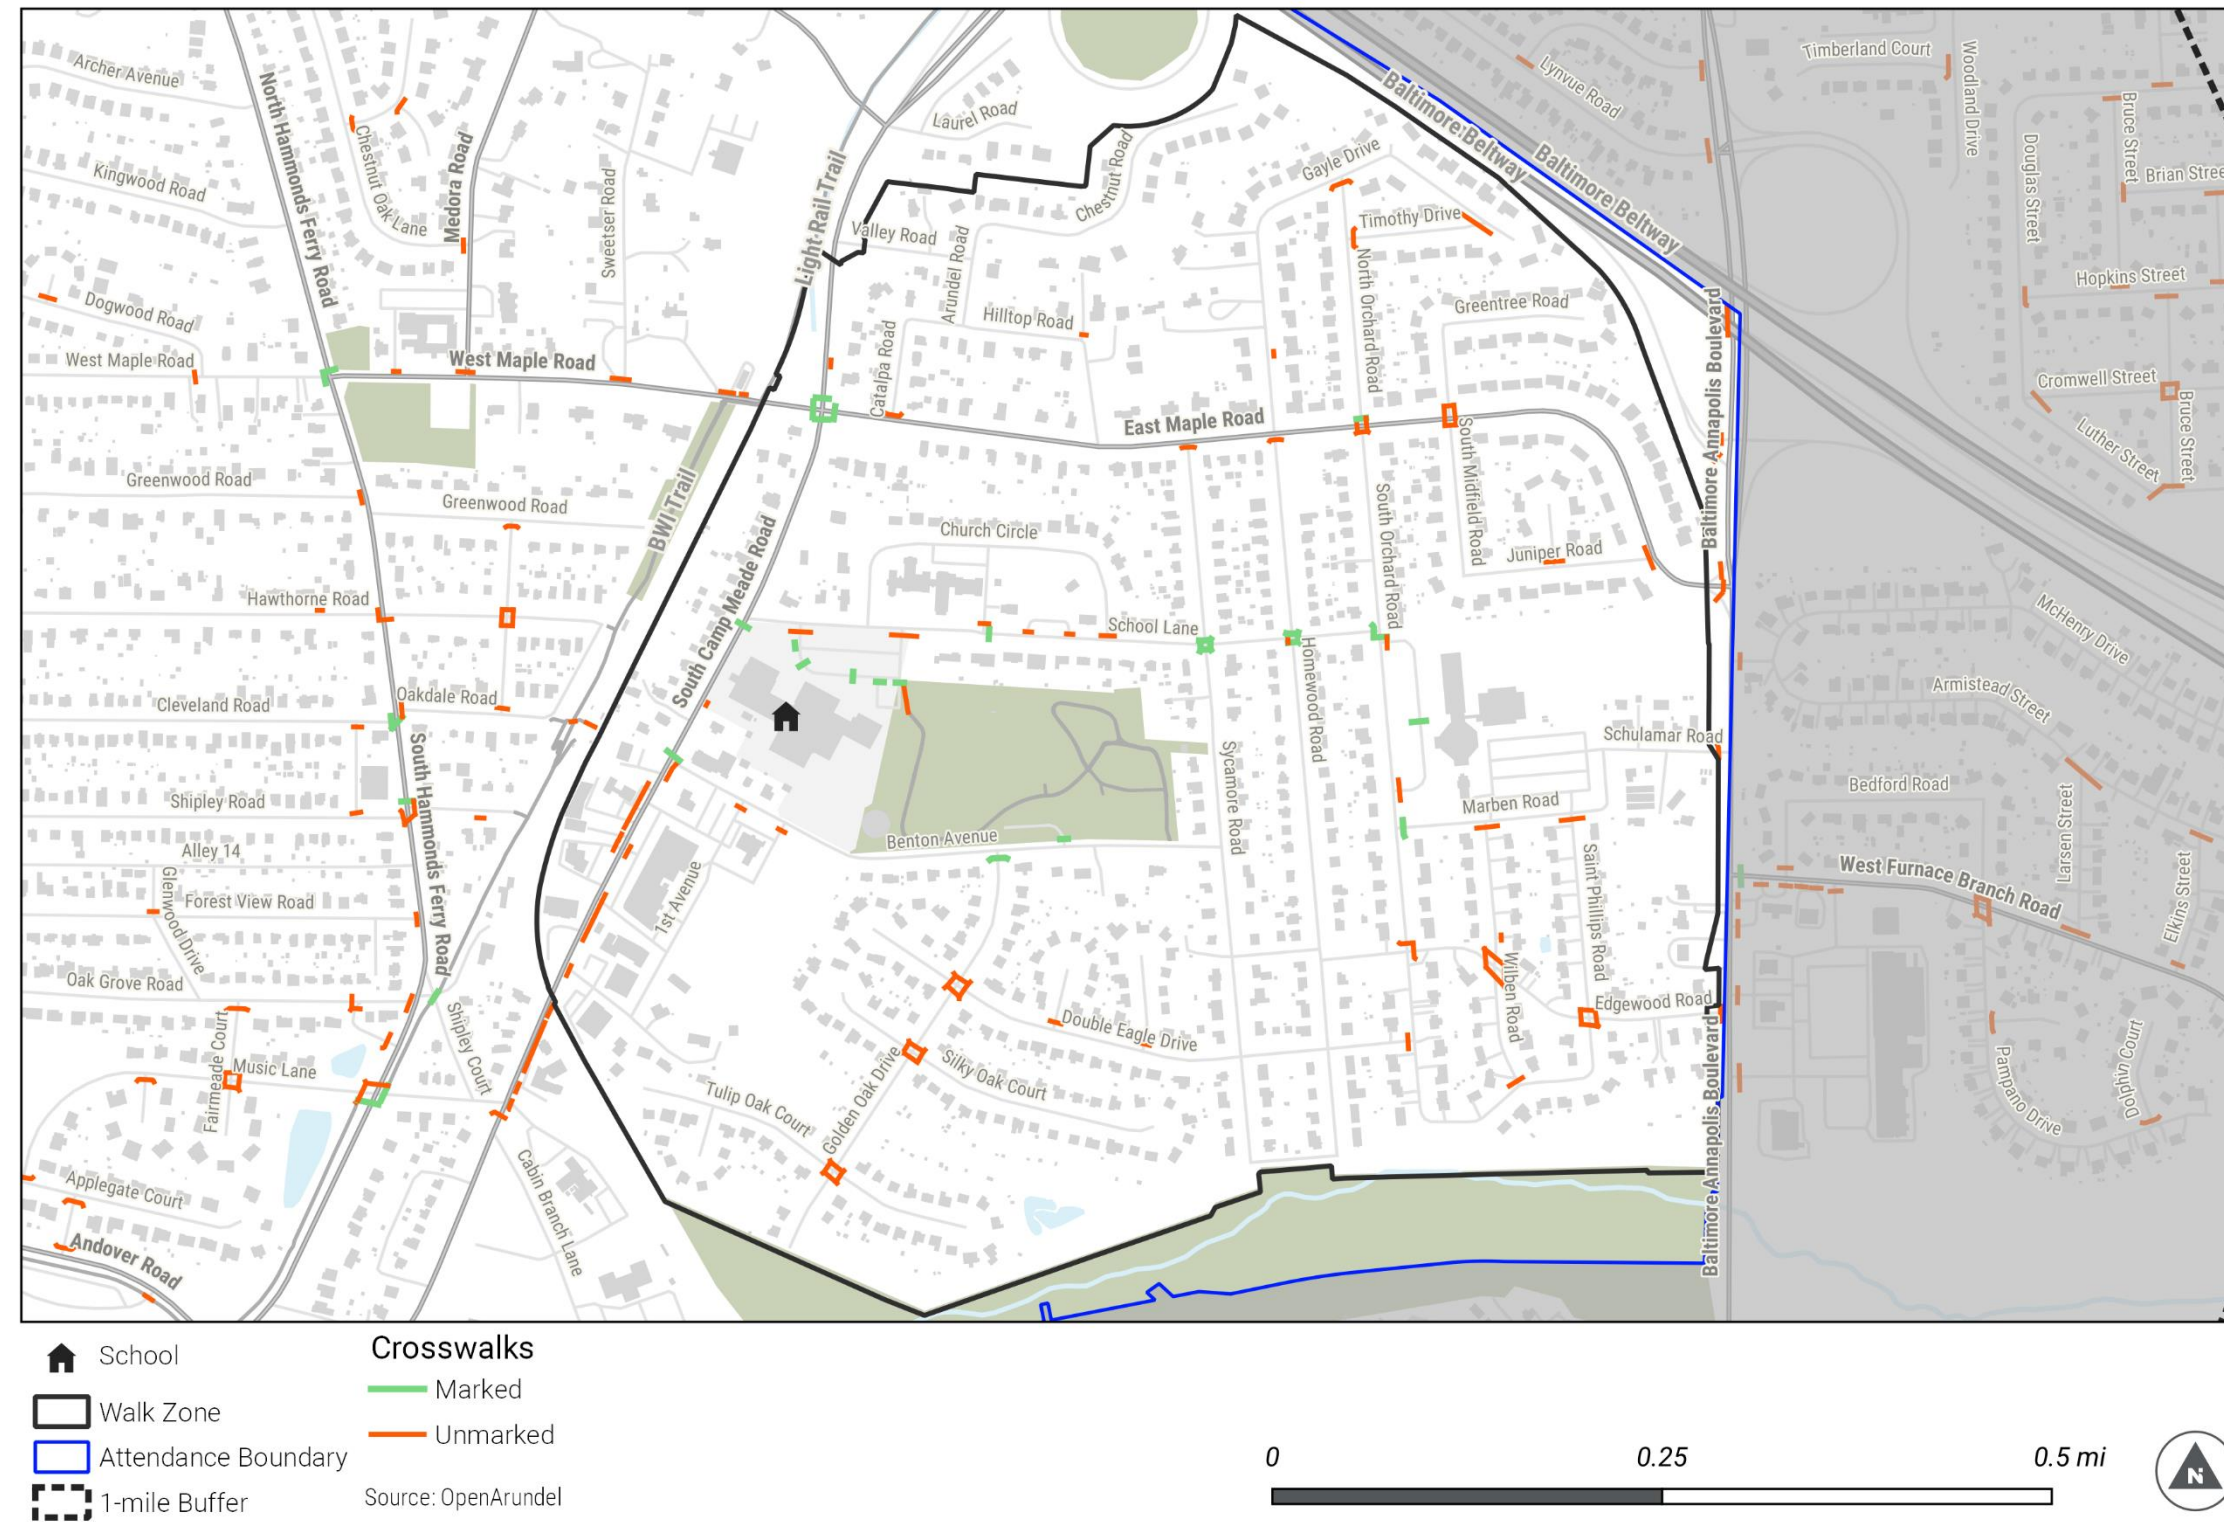
Linthicum Elementary School - Existing Crosswalks

Many crossings at intersections within the walk zone are unmarked.

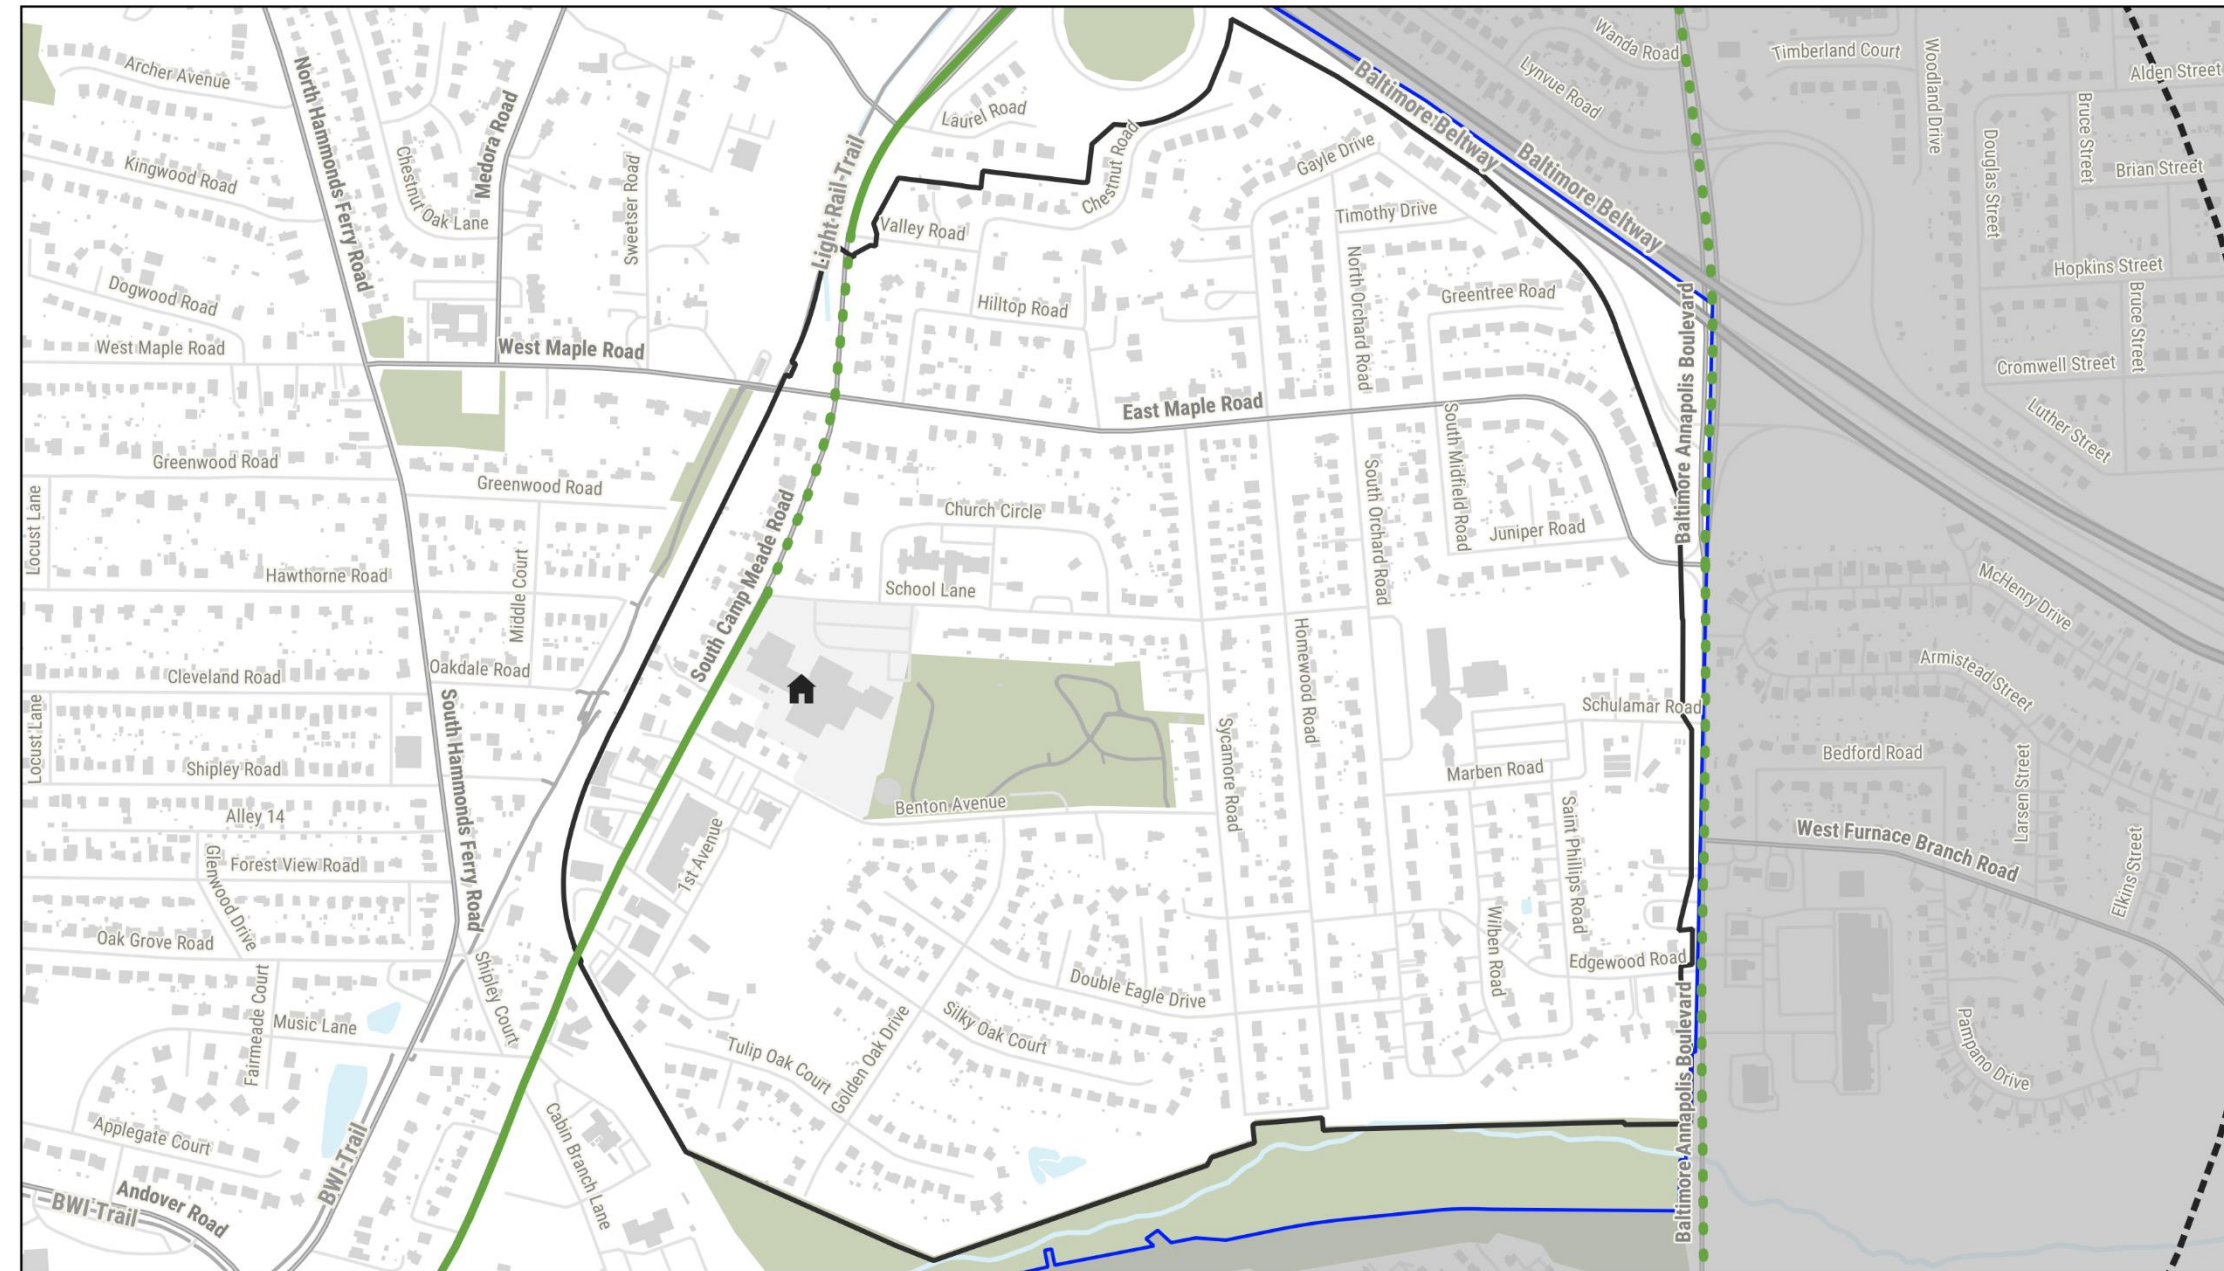
Linthicum Elementary School - Existing On-Road Bicycle Facilities

Parts of South Camp Meade Road south of School Lane and north of Valley Road have painted bike lanes on one or both sides.

No other on-road bike facilities were observed within the school walk zone.

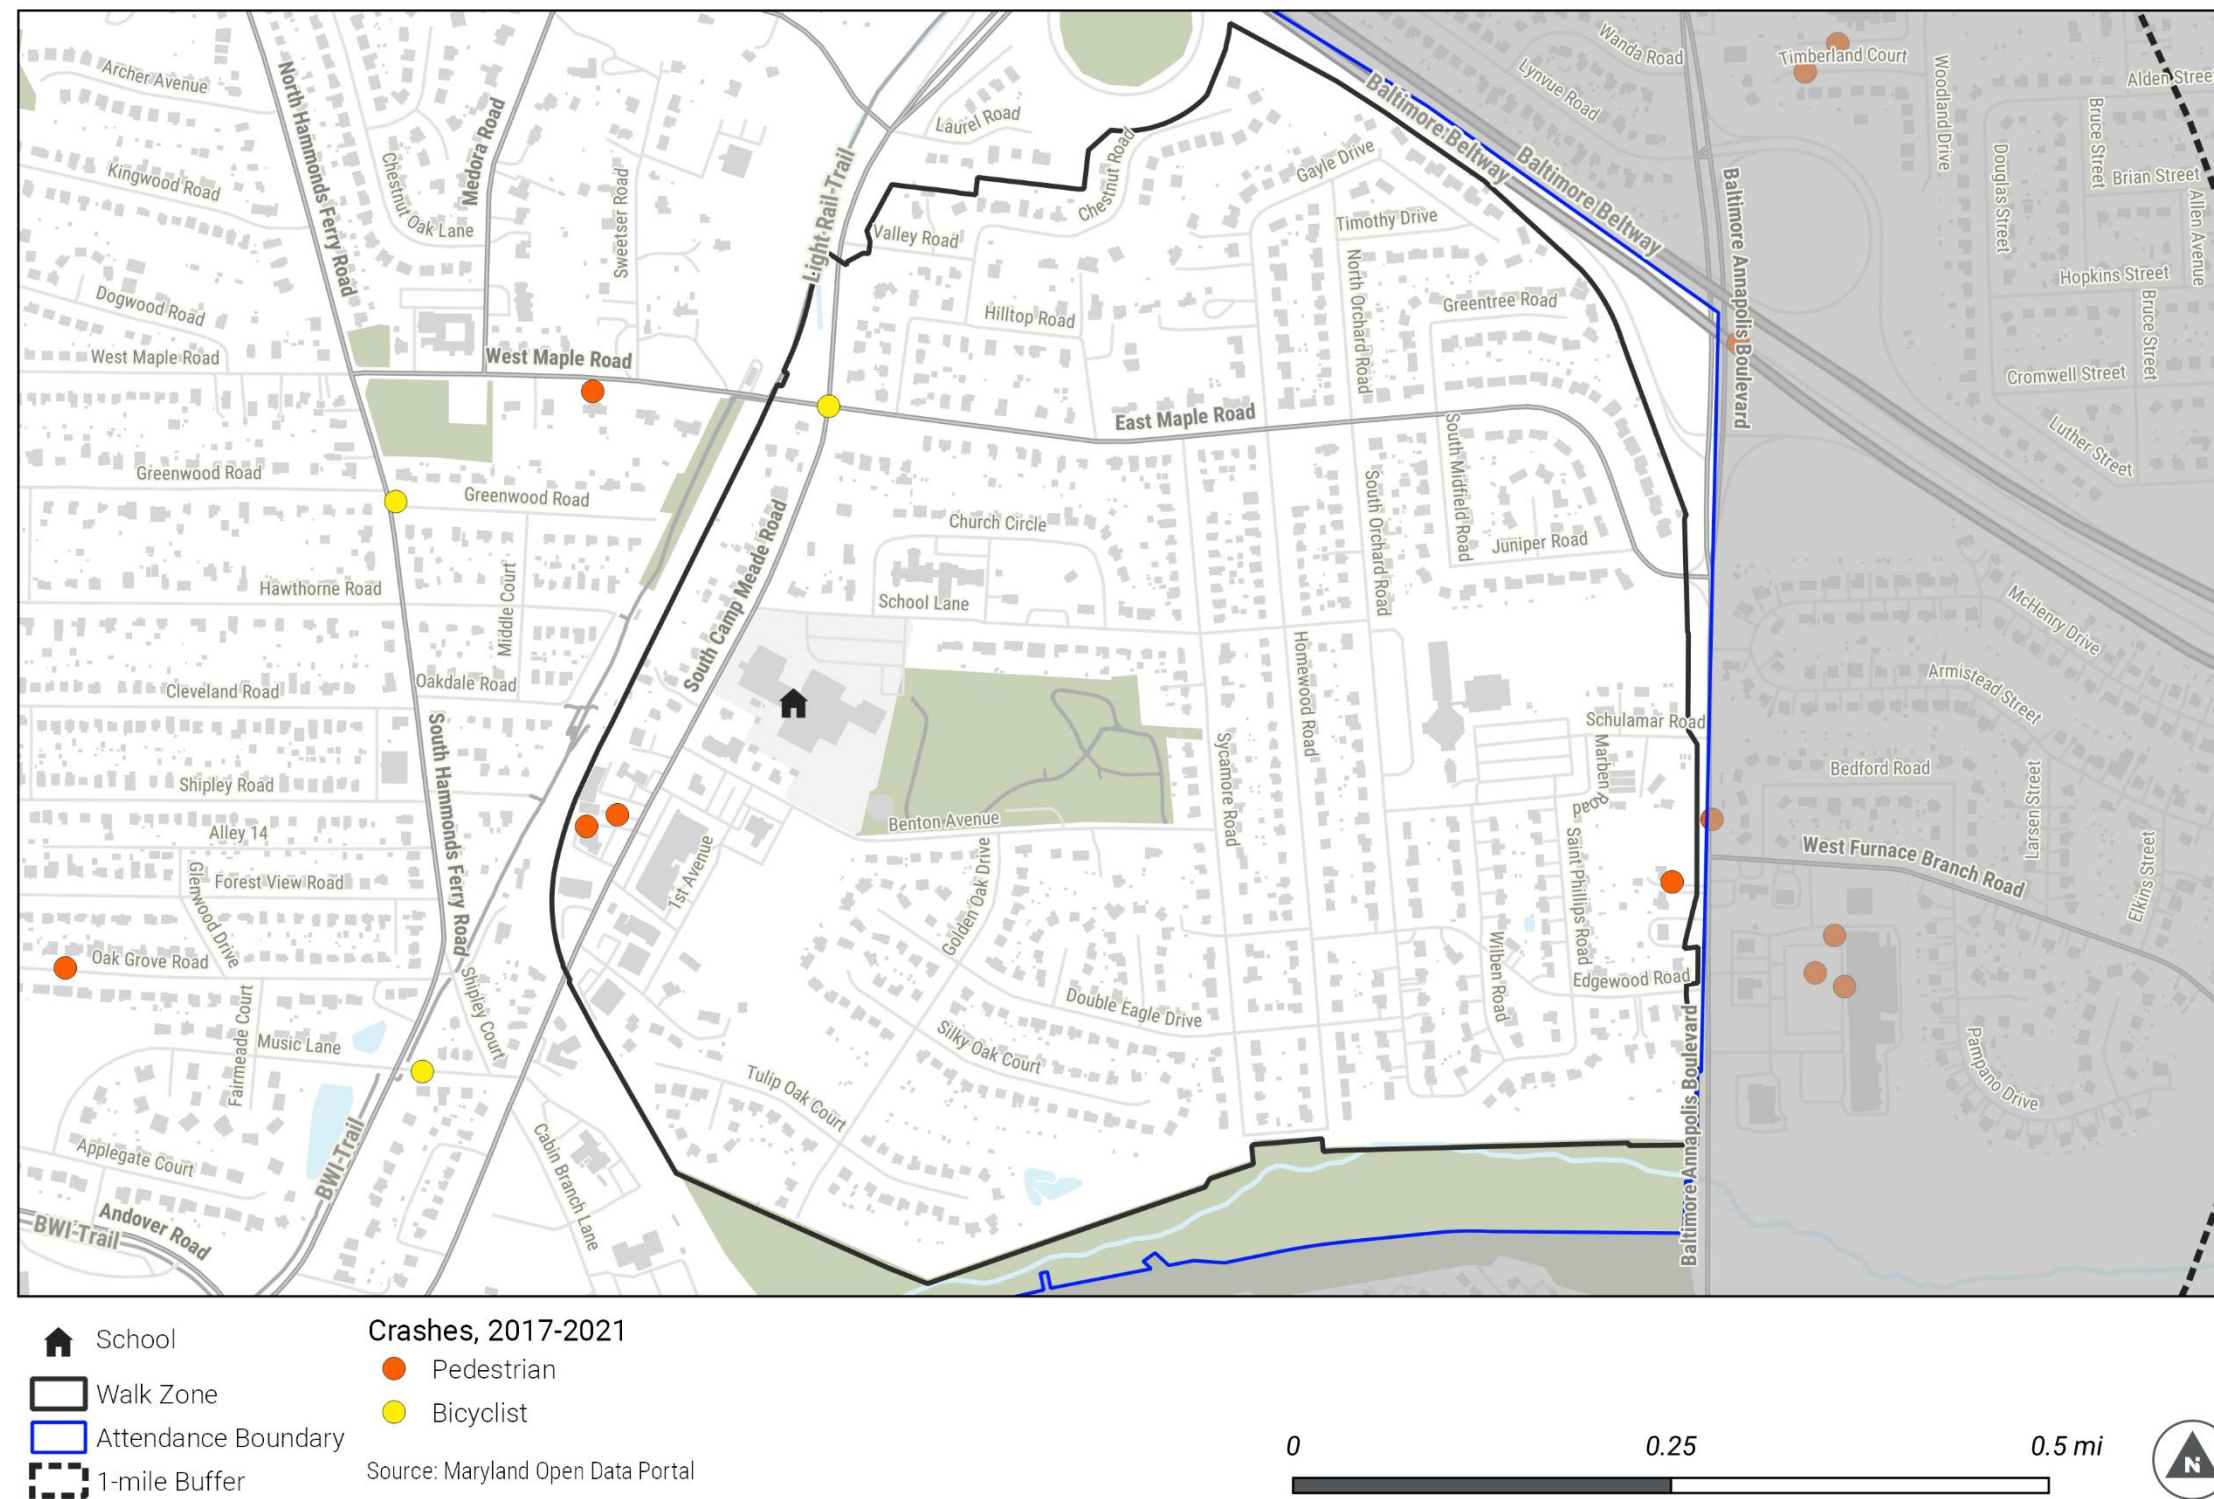
Linthicum Elementary School - Pedestrian and Bicycle Crashes

- 3 pedestrian-involved and 1 bicyclist-involved crashes occurred in the walk zone.

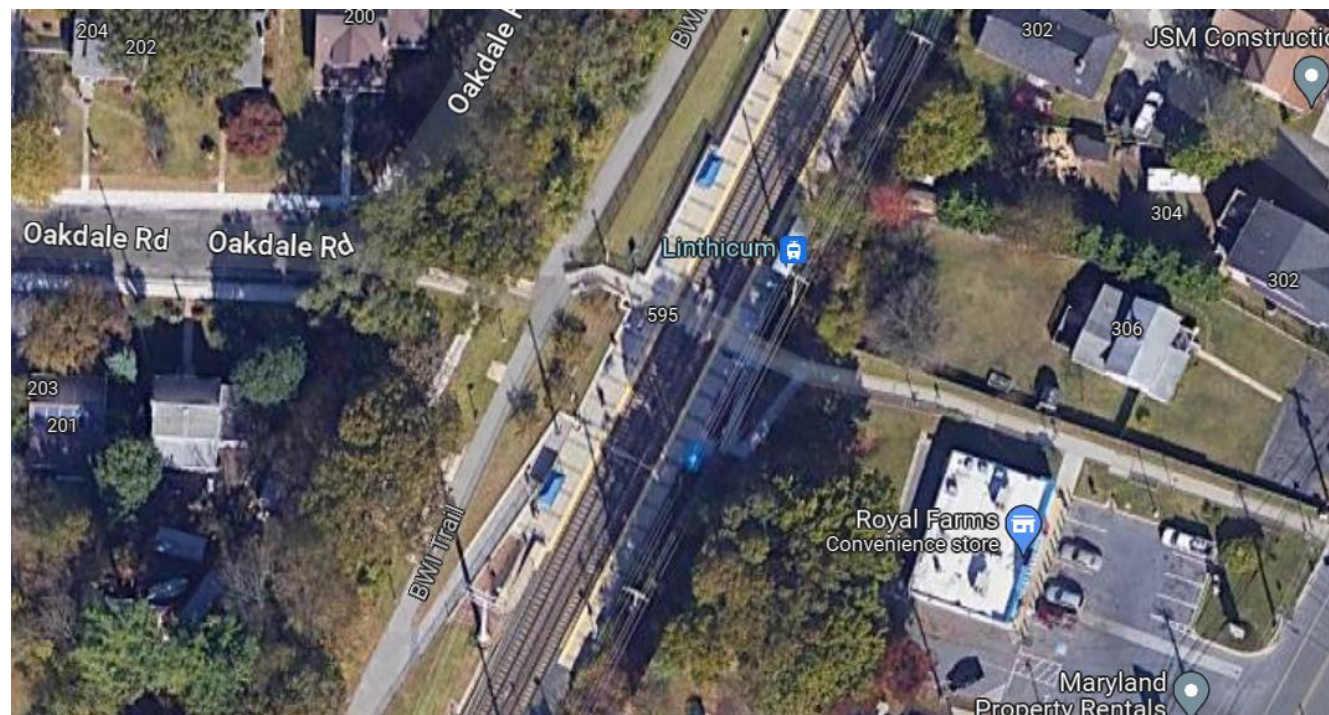
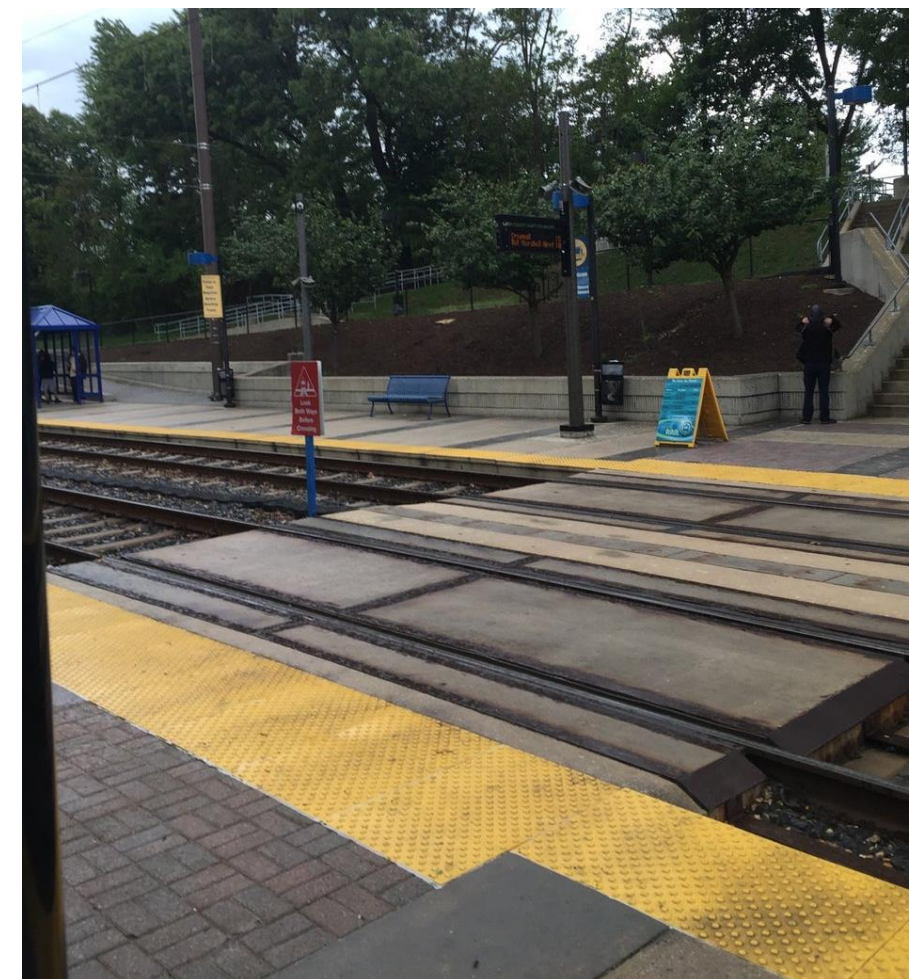
A light-rail line runs parallel to South Camp Meade Road, creating a significant barrier to expanding the walk zone to the west. Although a connection/pedestrian crossing exists at Linthicum Station near Benton Avenue, it requires an unsupervised, non-stop controlled crossing of the tracks. For long-term planning, the County could explore building a pedestrian bridge over the tracks to connect Benton Avenue and Oakdale road and provide a safe connection for Linthicum students and residents of both neighborhoods.

Aerial view of Linthicum Station using Google Maps

View of pedestrian crossing of rail tracks
Source: foursquare.com
