Manor View Elementary School Safe Routes to School Accessibility Study: Existing Conditions and Recommendations

August 17, 2023

Anne Arundel Safe Routes to School Accessibility Study

Manor View Elementary Accessibility Study

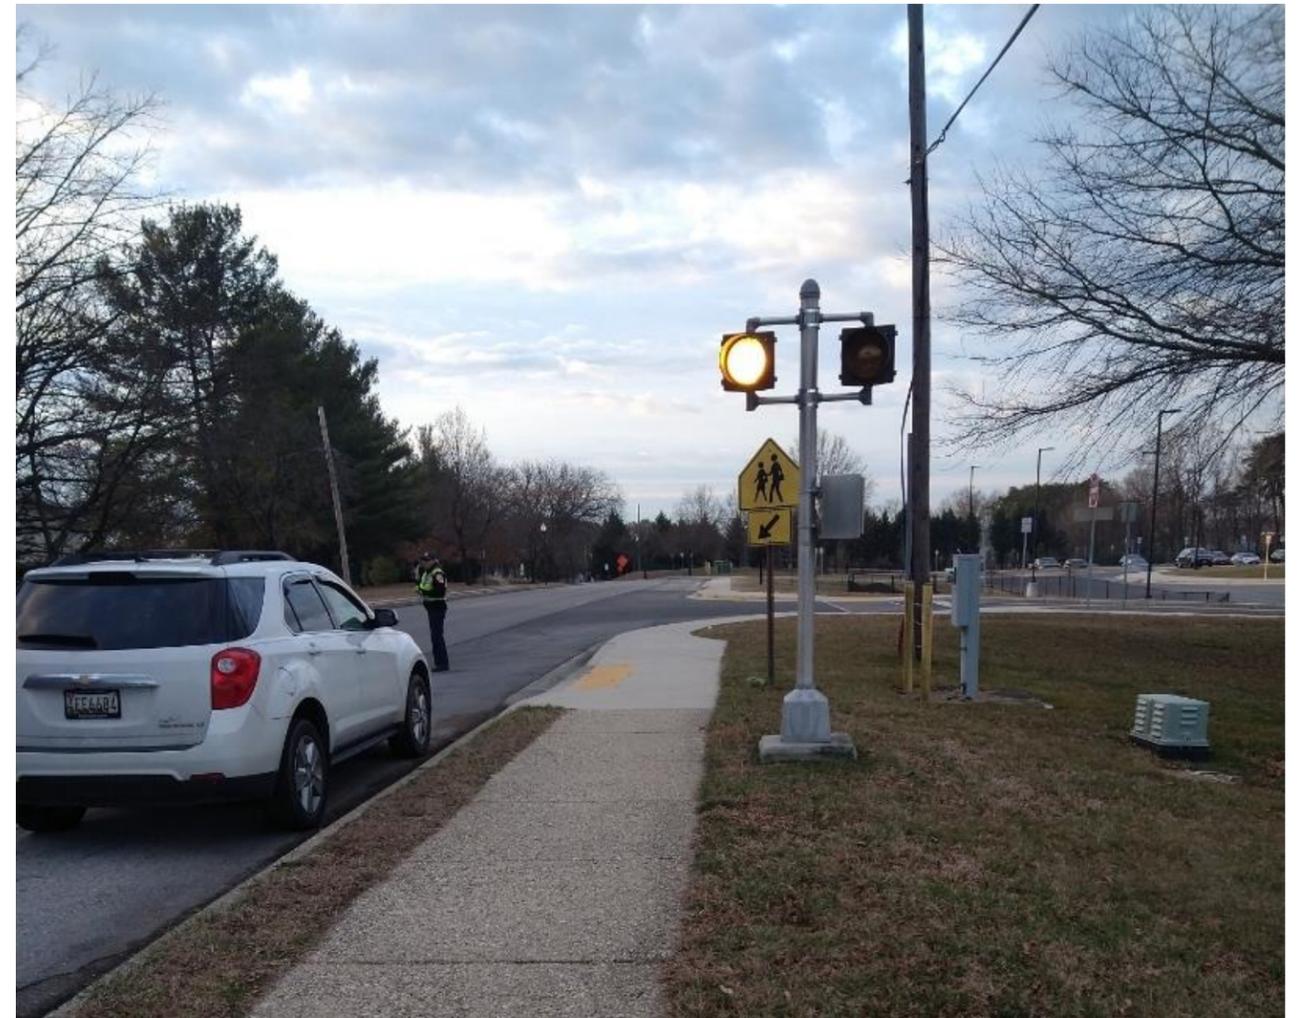
- Provided data did not include crossing guards assigned to Manor View Elementary School; one crossing guard was observed on MacArthur Road at the drop-off loop exit.

The MacArthur Road crossing guard stationed at the crosswalk near the school driveway

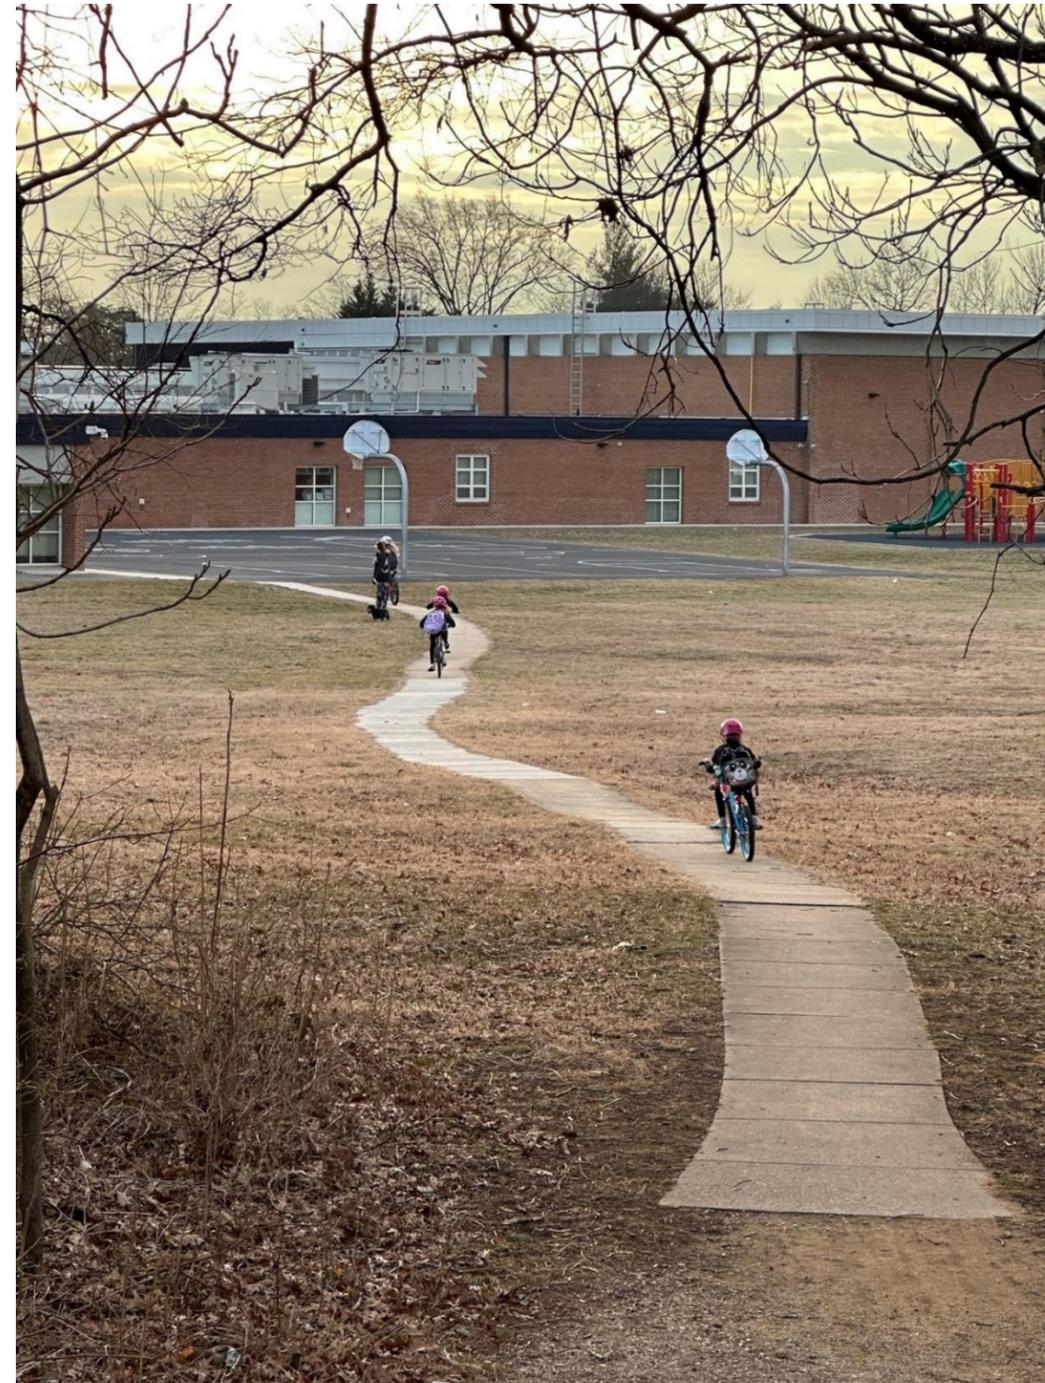
Many walkers and bike riders used this path to the school from Phelps Avenue.

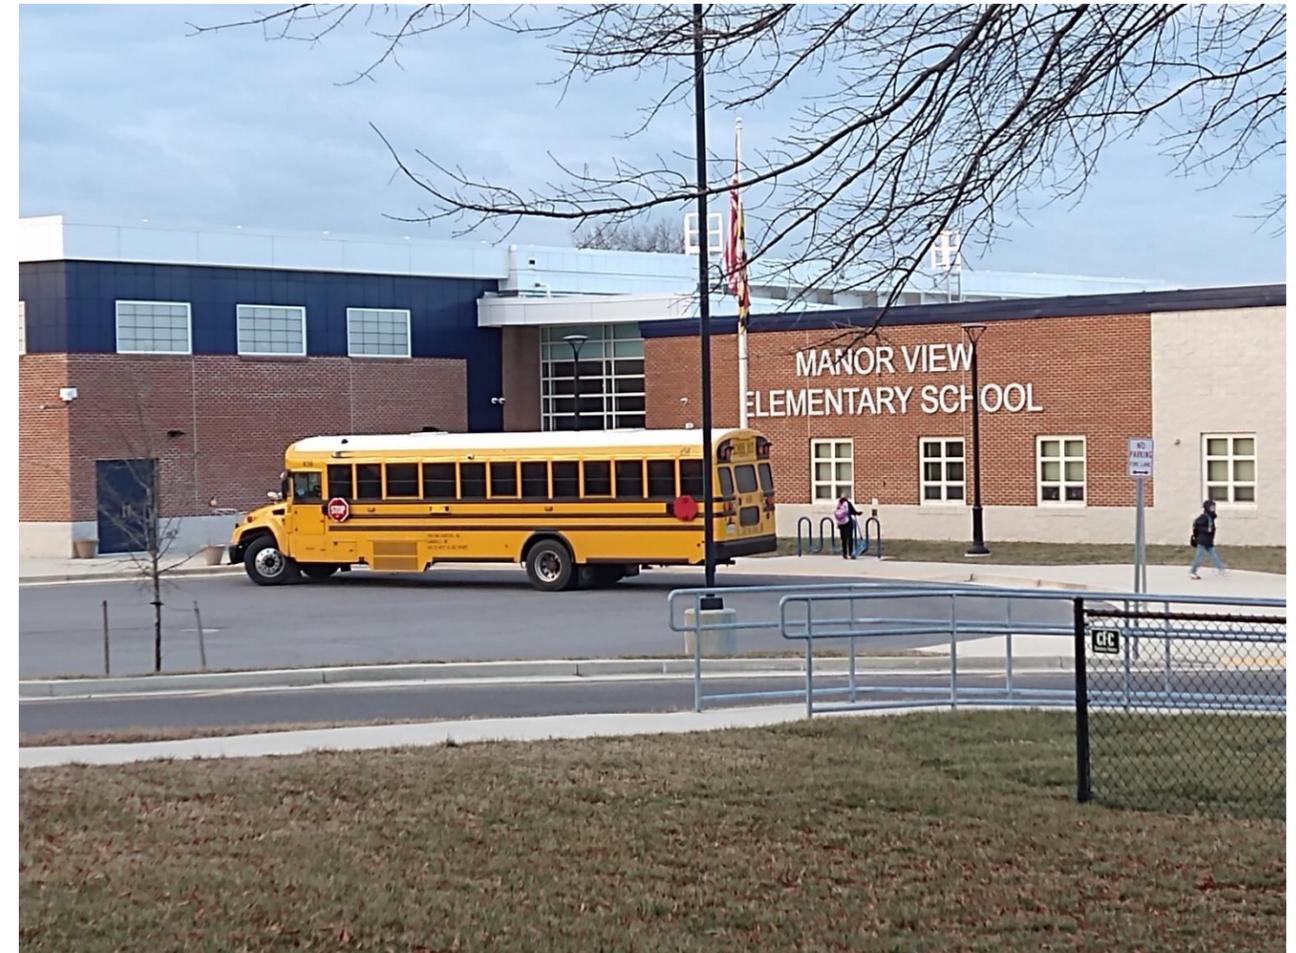
The bus in front of the main entrance of the school, as a student (far right) heads to the northeast entry.

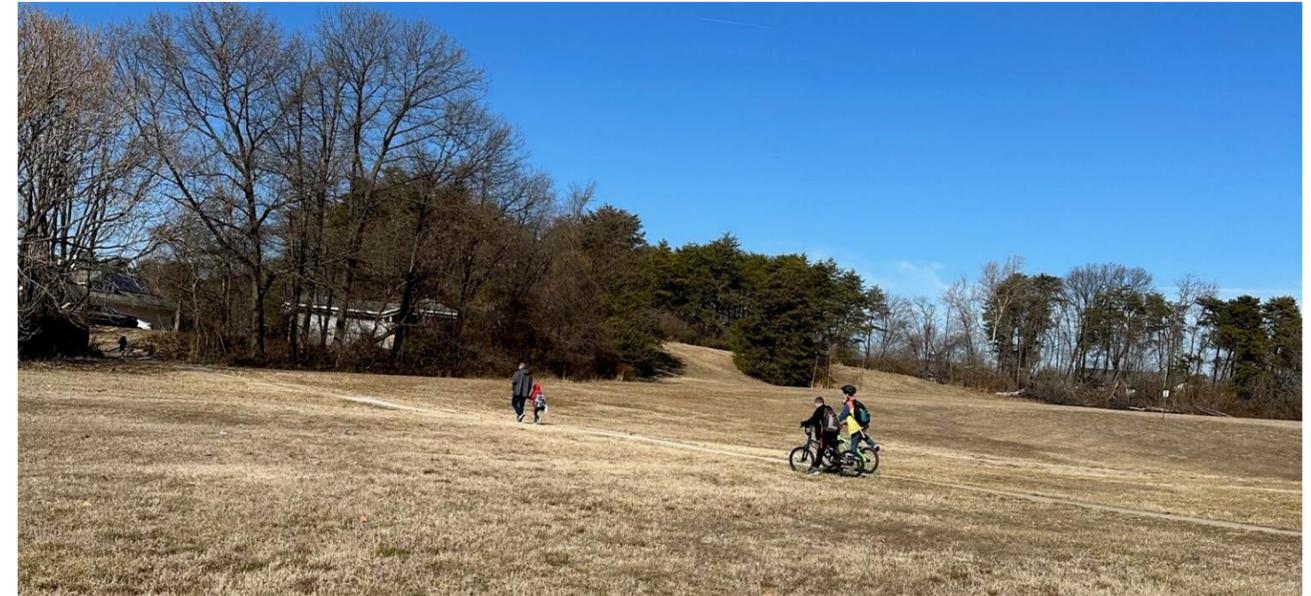
- Many students walking north did not use the sidewalk but walked across the grass field toward the apartment complex.
- Many walkers and bicyclists left with friends or by themselves.

Students walk and bike toward Phelps Avenue after dismissal.

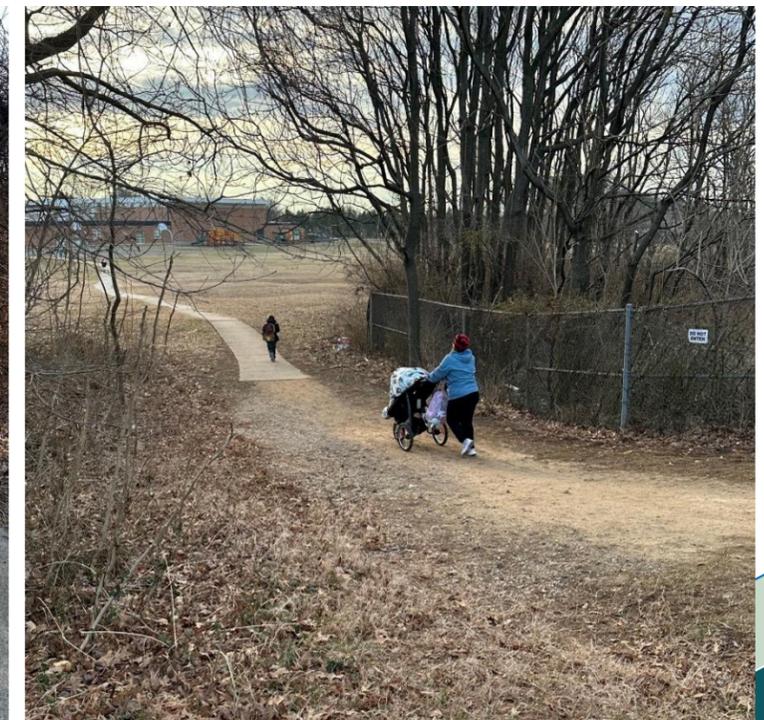
The path from Second Corps Boulevard (left);
The path from Phelps Avenue (right).

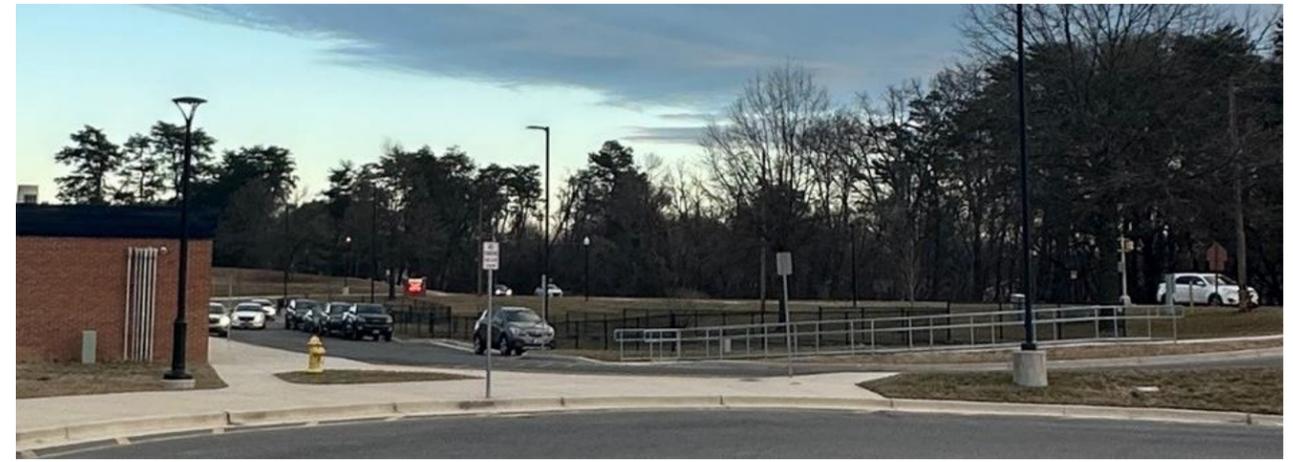
- Relatively few cars were lined up prior to dismissal.
- Vehicles maneuvered between parking on the left and pick-up activity on the right, but minimal conflicts were observed.

Parked cars and parents in the pick-up loop before dismissal

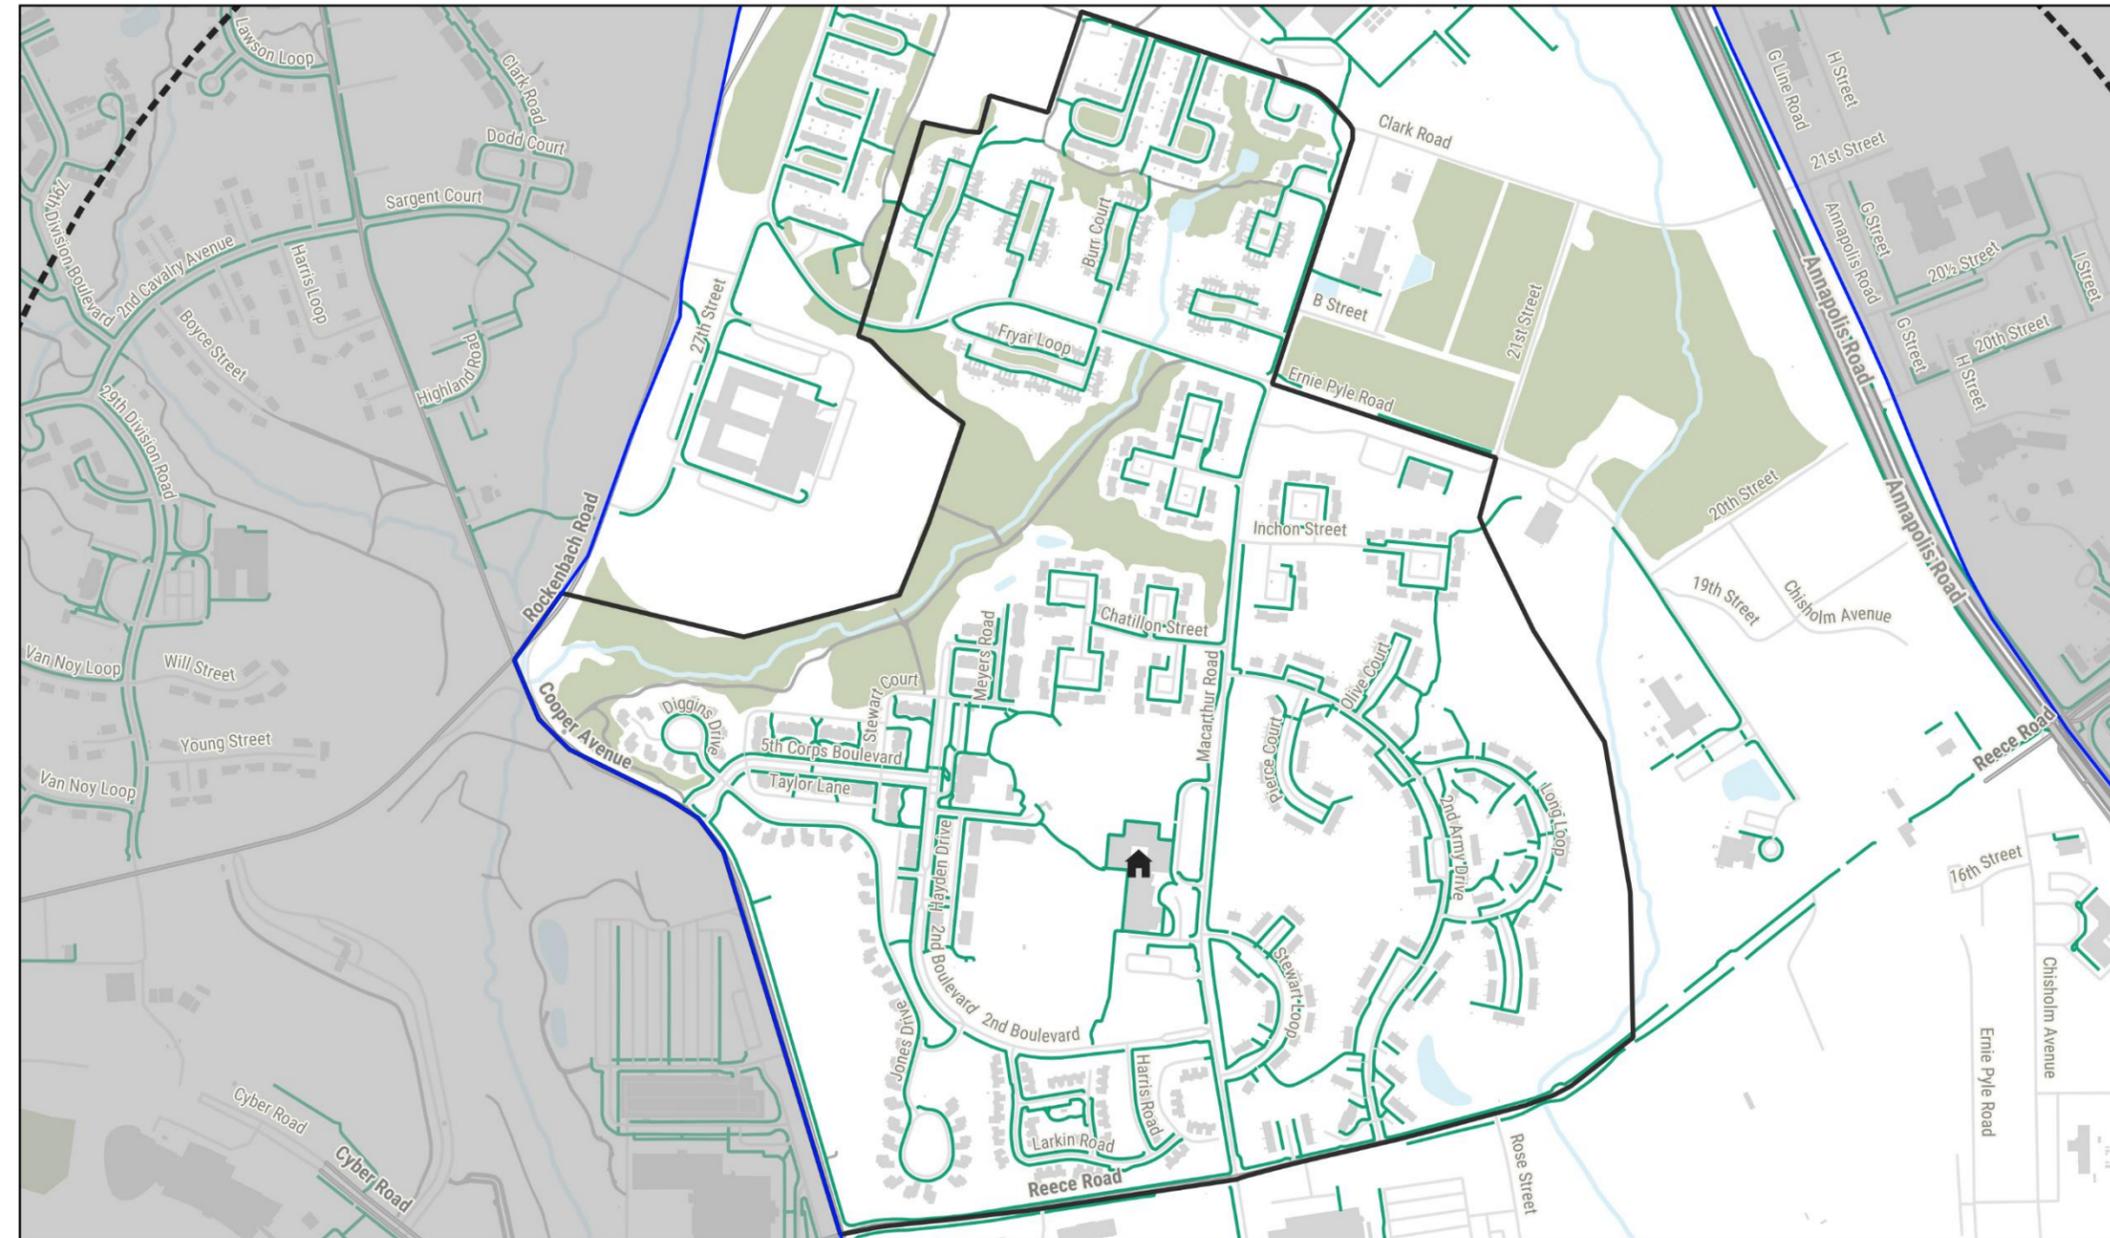
Manor View Elementary School - Existing Sidewalk Network

There are sidewalks present on nearly all roads within the walk zone, but several sidewalks are only on one side of the road.

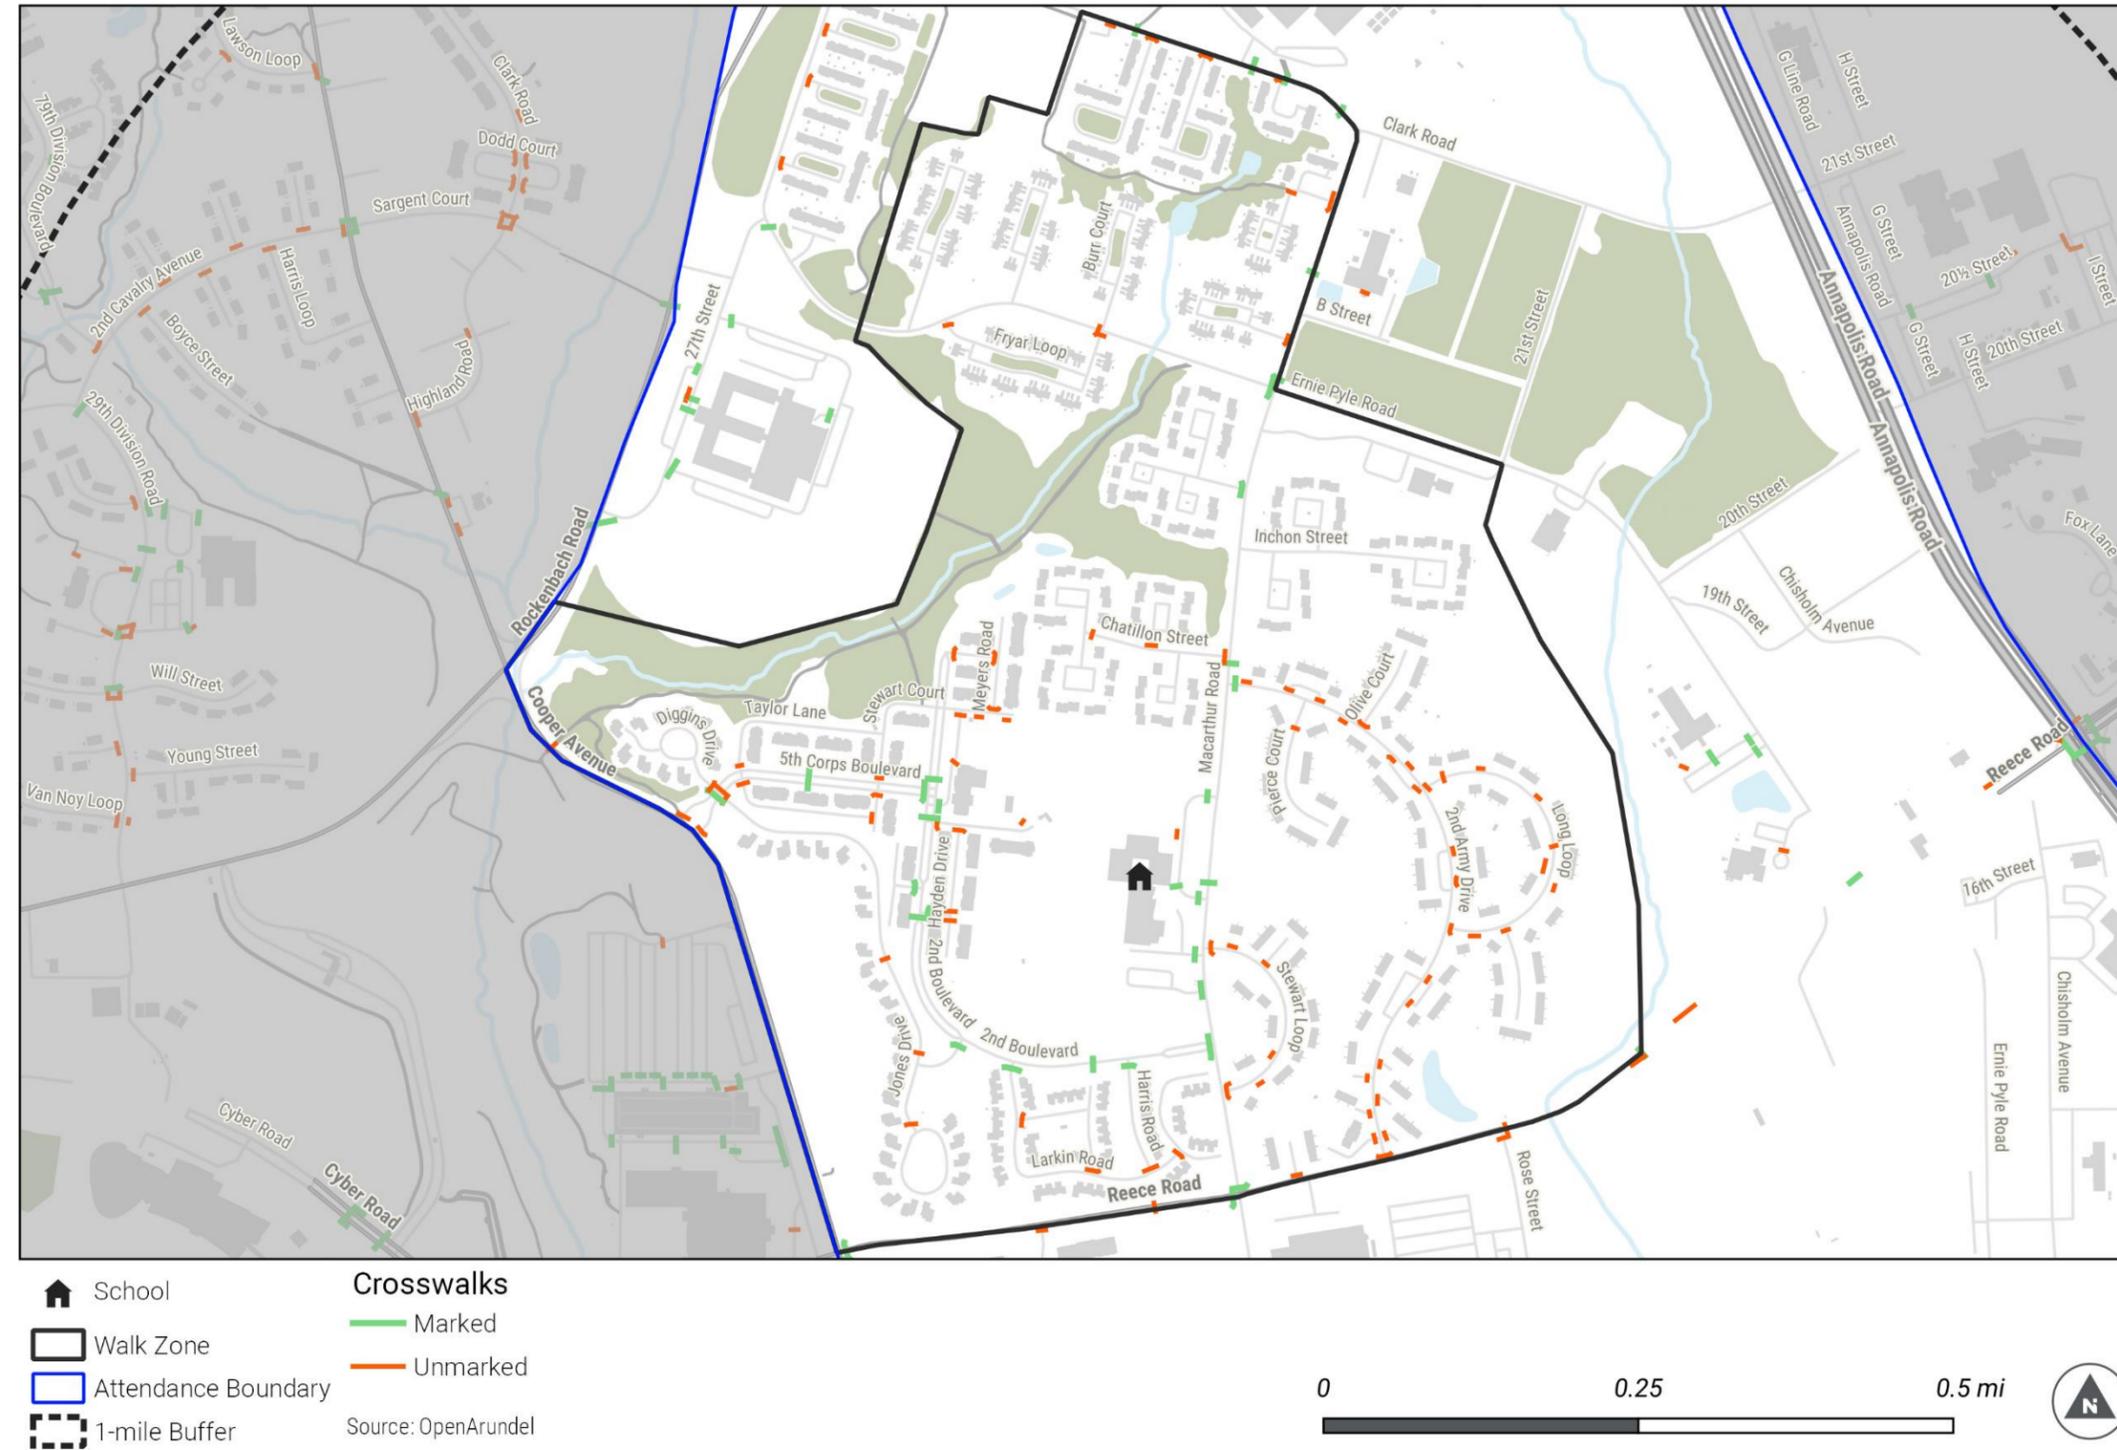
Manor View Elementary School - Existing Crosswalks

The crossings at many intersections in the walk zone are unmarked.

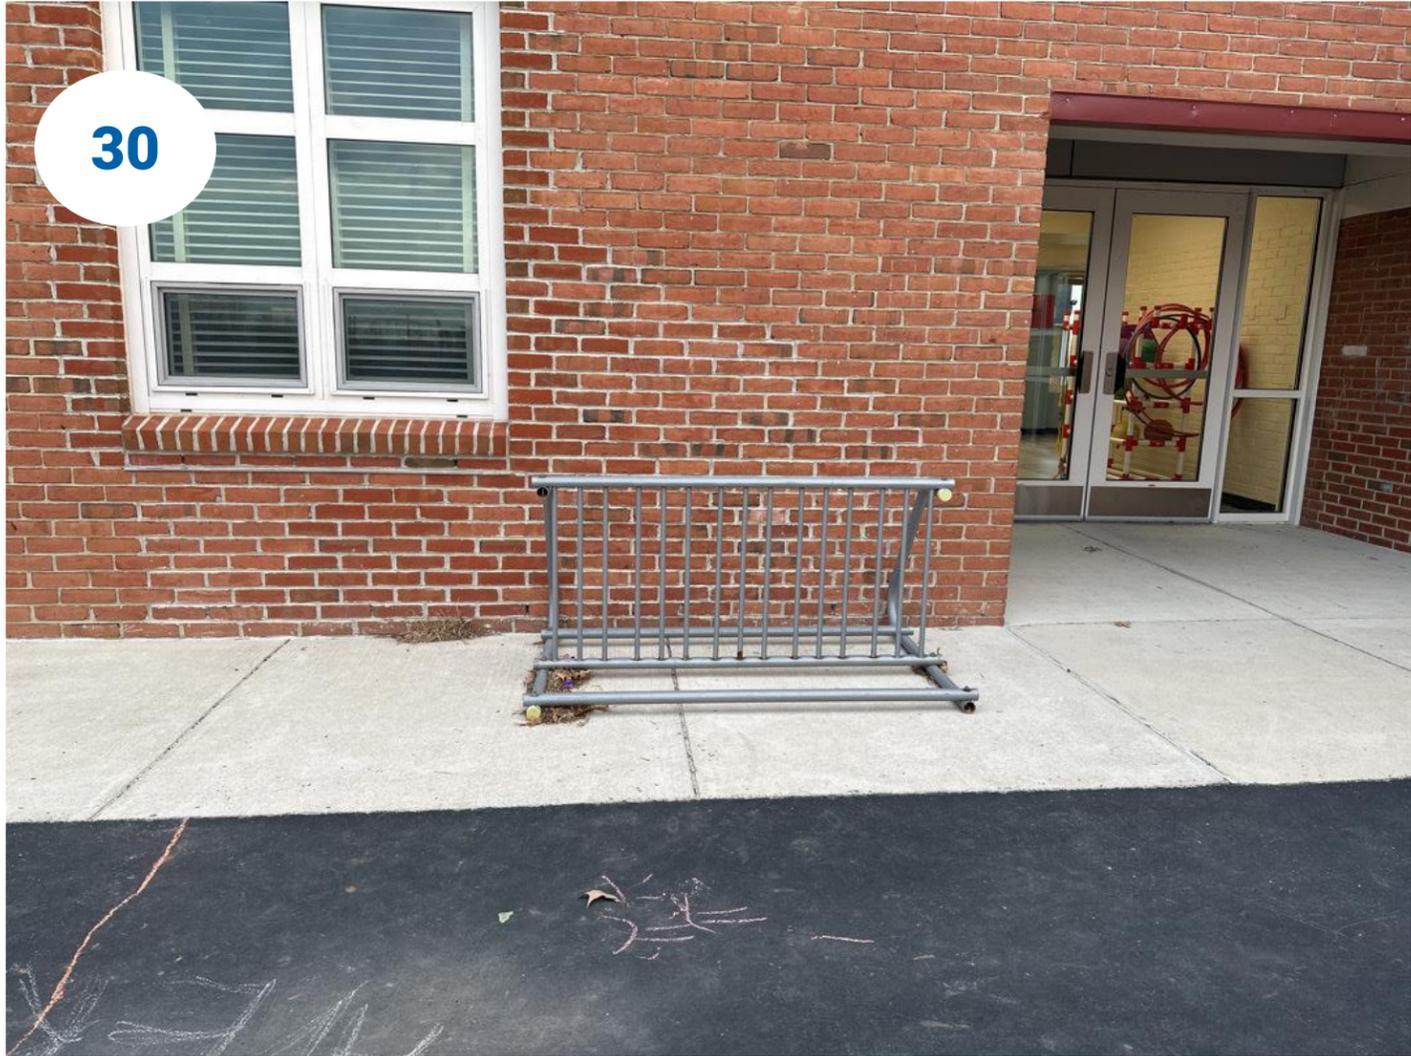
Blacktop Entrance to School

30	Blacktop entrance of school (On school campus)	Bicycle rack	Existing rack does not allow locking of frame	Replace existing rack with inverted U rack	\$175/per (quantity TBD)	Short

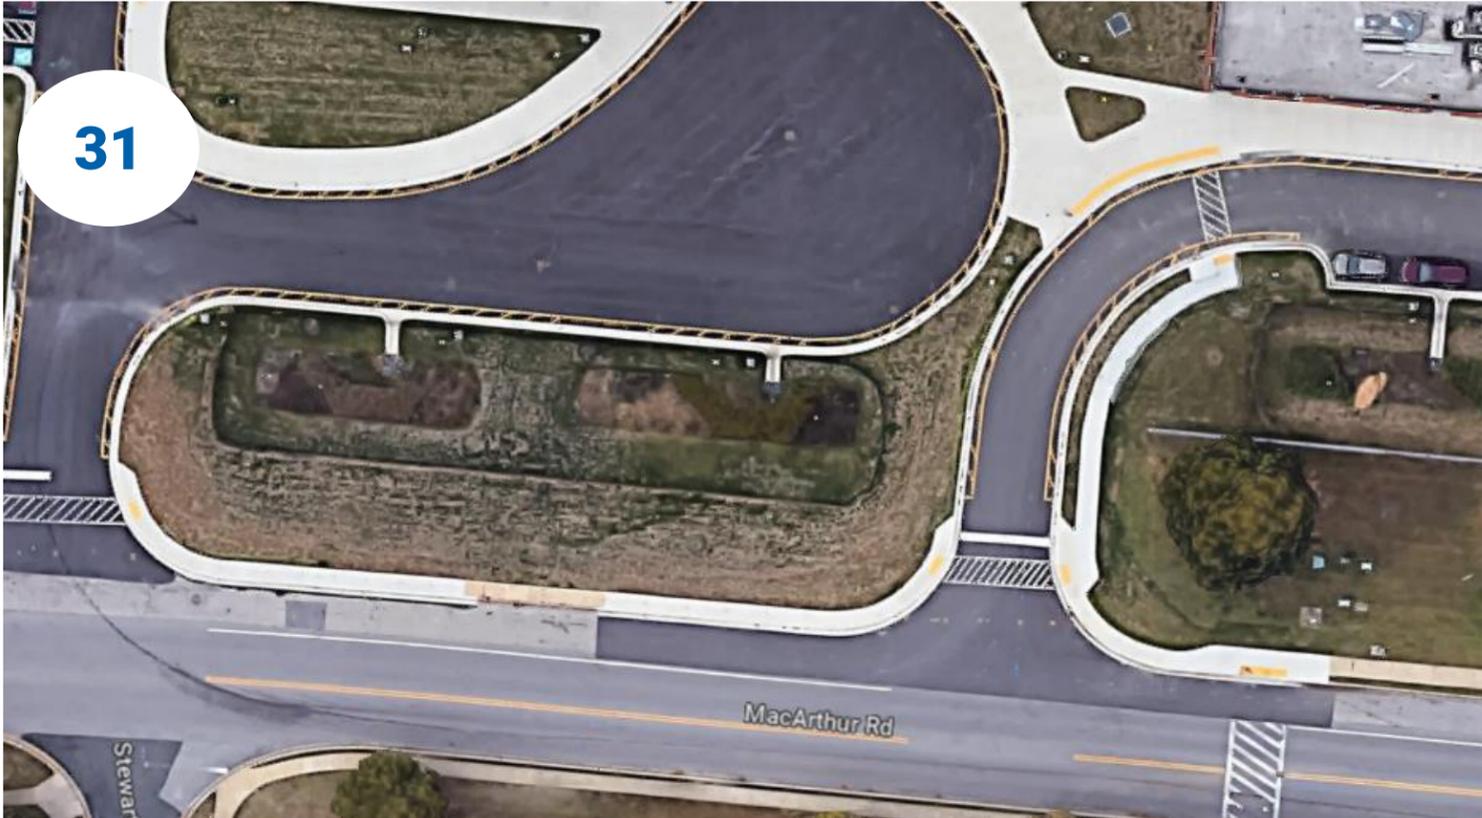
School Driveway (Middle)

Map ID	Location	Facility Type	Issue	Recommendation	Potential Cost	Timeframe*
31	School Driveway (middle)	Sidewalk	Missing sidewalk on south side	Install new sidewalk**	\$2,720	Long
32	Stewart Loop (north) & MacArthur Rd (Along key student walking route, Inside school zone)	32a. Crosswalk	North crossing of MacArthur Rd is unmarked	Install new high-visibility crosswalk	\$800	Short
		32b. Other intersection or crossing issues	Concern about motor vehicle yielding on MacArthur Rd	Install RRFB	\$15,000	Long
		32c. Curb ramp	North ramps missing	Install new ramps	\$8,000	Medium
33	Bus loop & MacArthur Rd (Along key student walking route, Inside school zone, On school campus)	Crosswalk	Crosswalk markings faded	Remark existing crosswalk with existing, high-visibility marking style	\$800	Short
