Crofton Meadows Elementary School Safe Routes to School Accessibility Study: Existing Conditions and Recommendations

August 17, 2023

Anne Arundel Safe Routes to School Accessibility Study

Crofton Meadows Elementary Accessibility Study

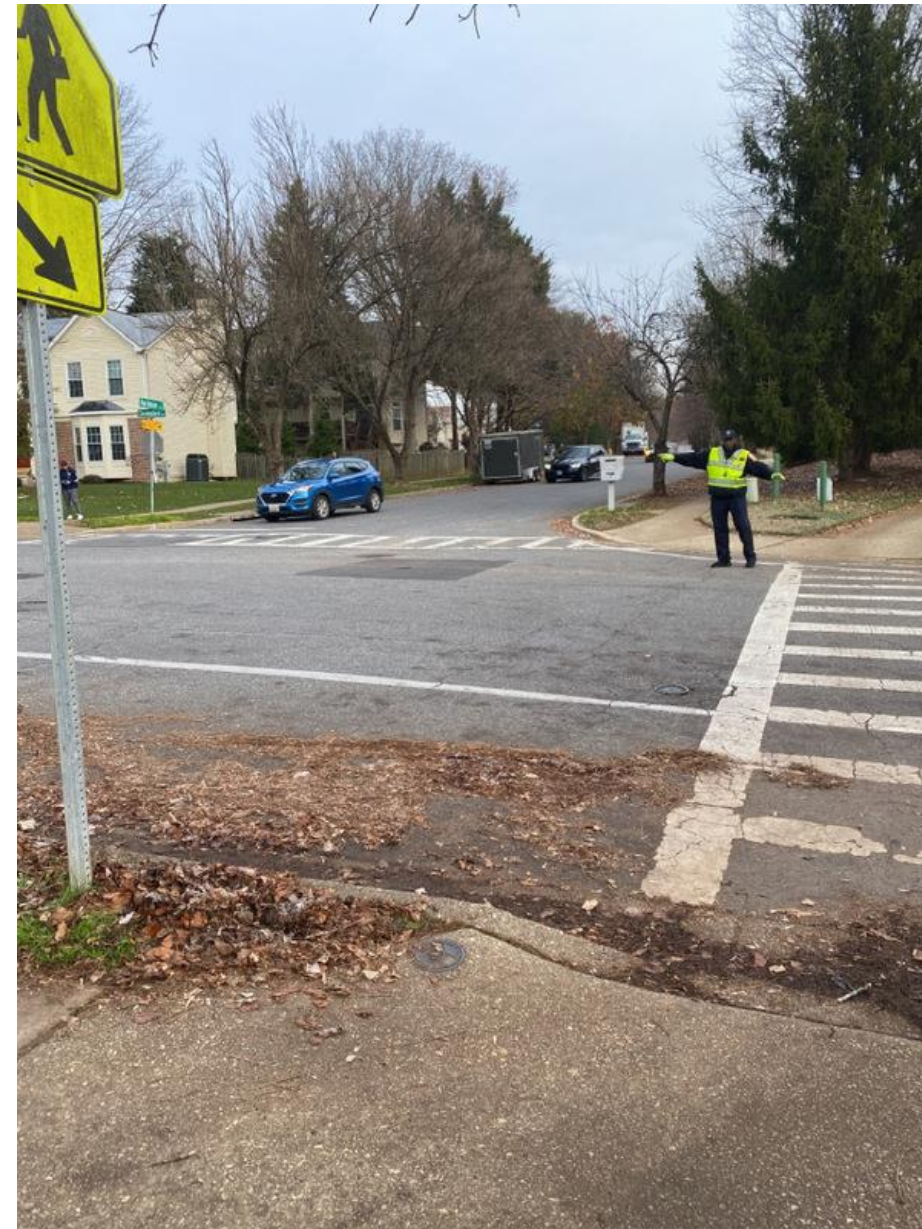
One of the crossing guards is stationed at the intersection of Chelmsford Drive and Hornbeam Drive

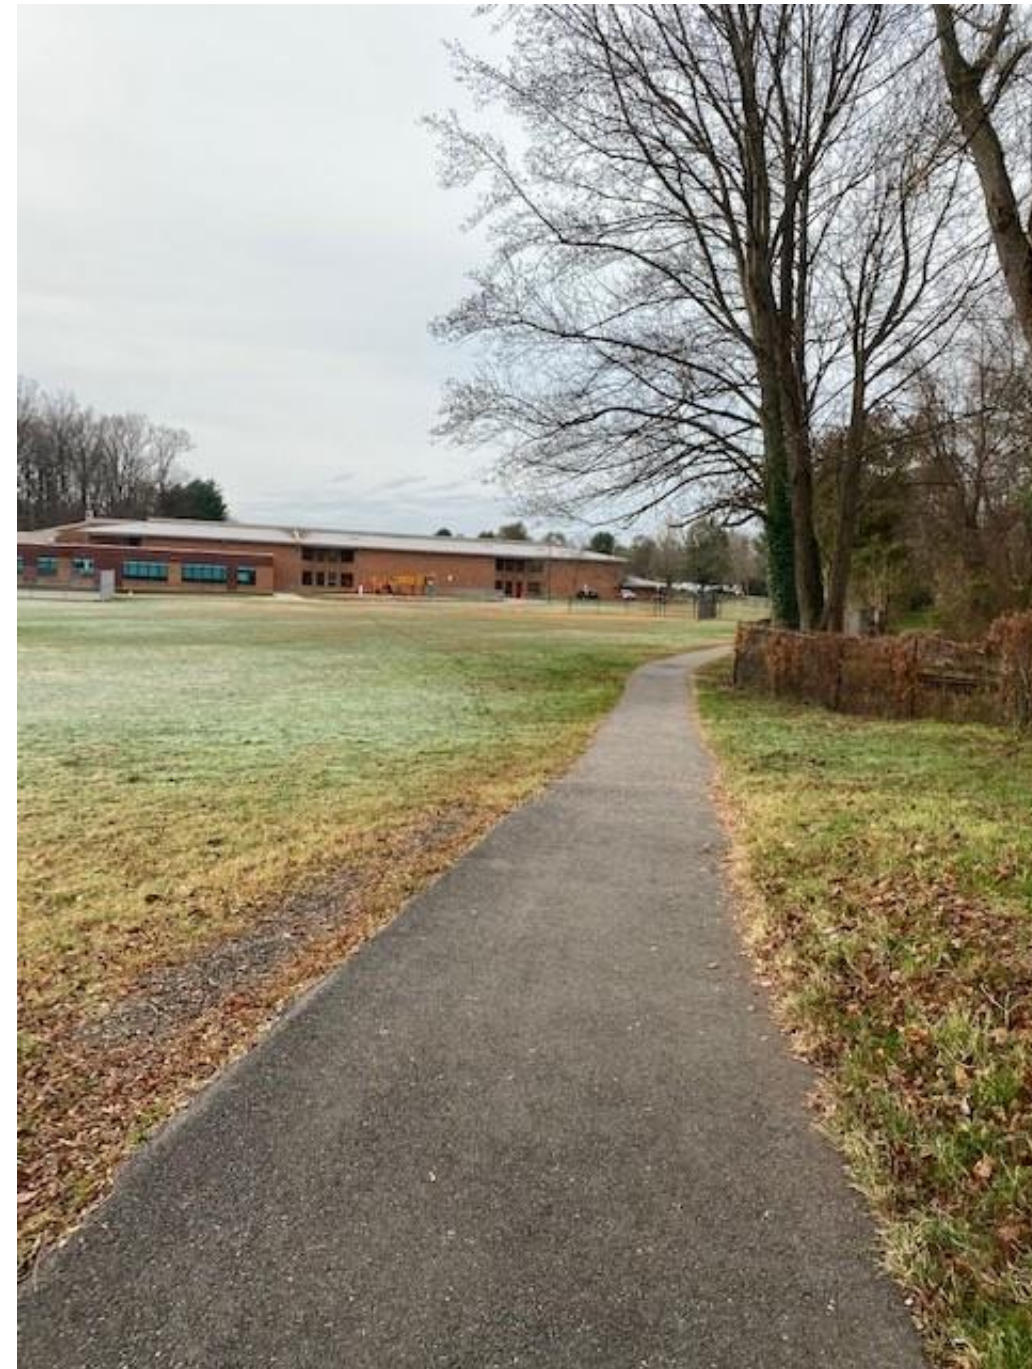
Many walkers at arrival were seen using this path to the school.

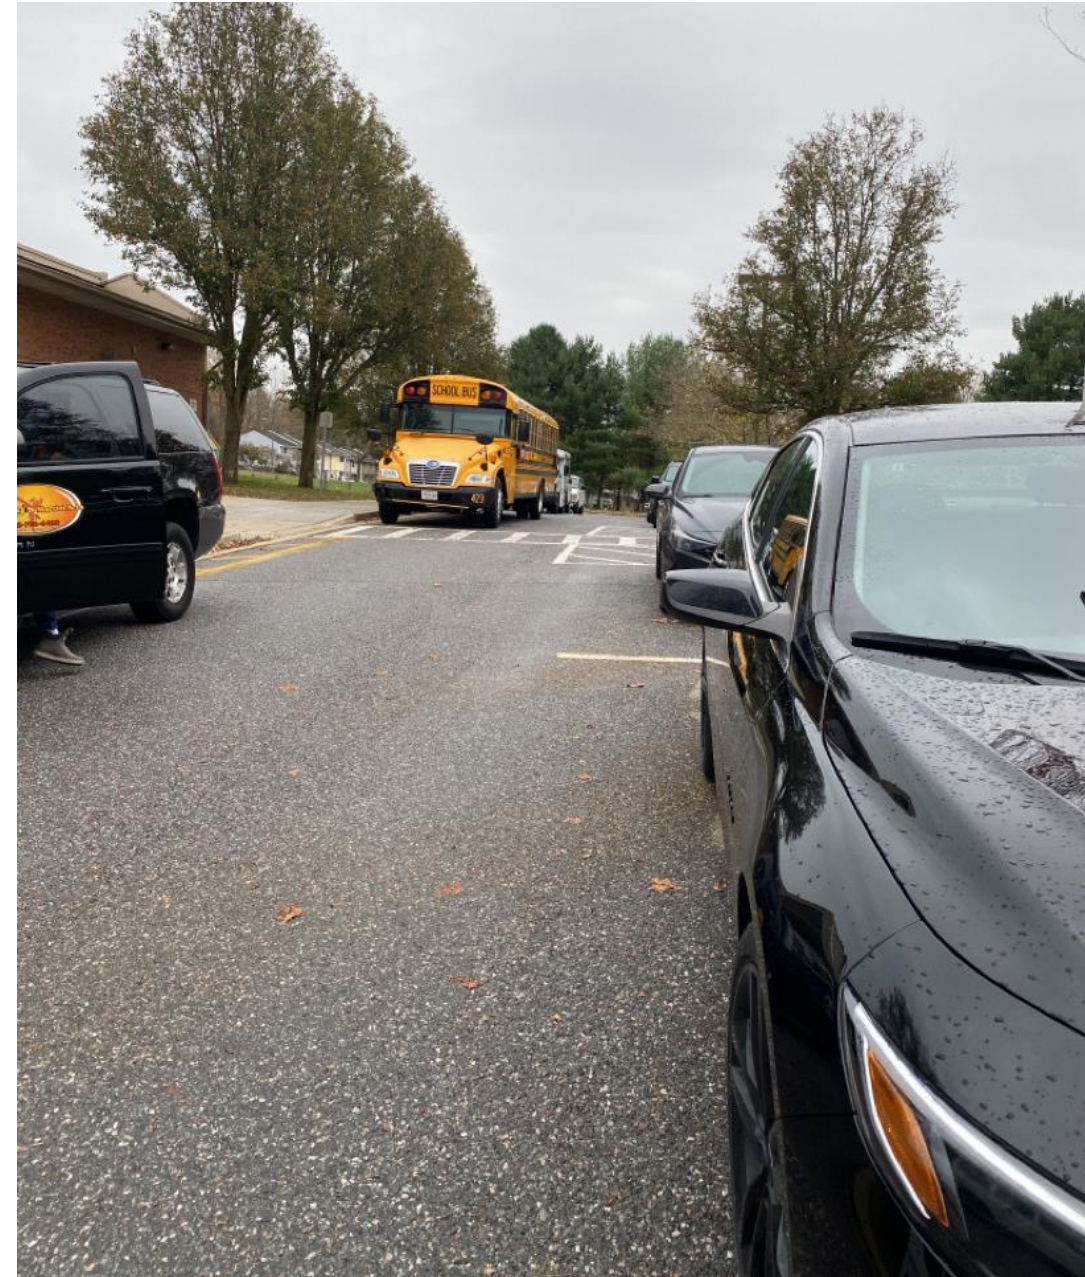
Bus drop off at the main entrance of the school (note cars are parked in marked parking spaces).

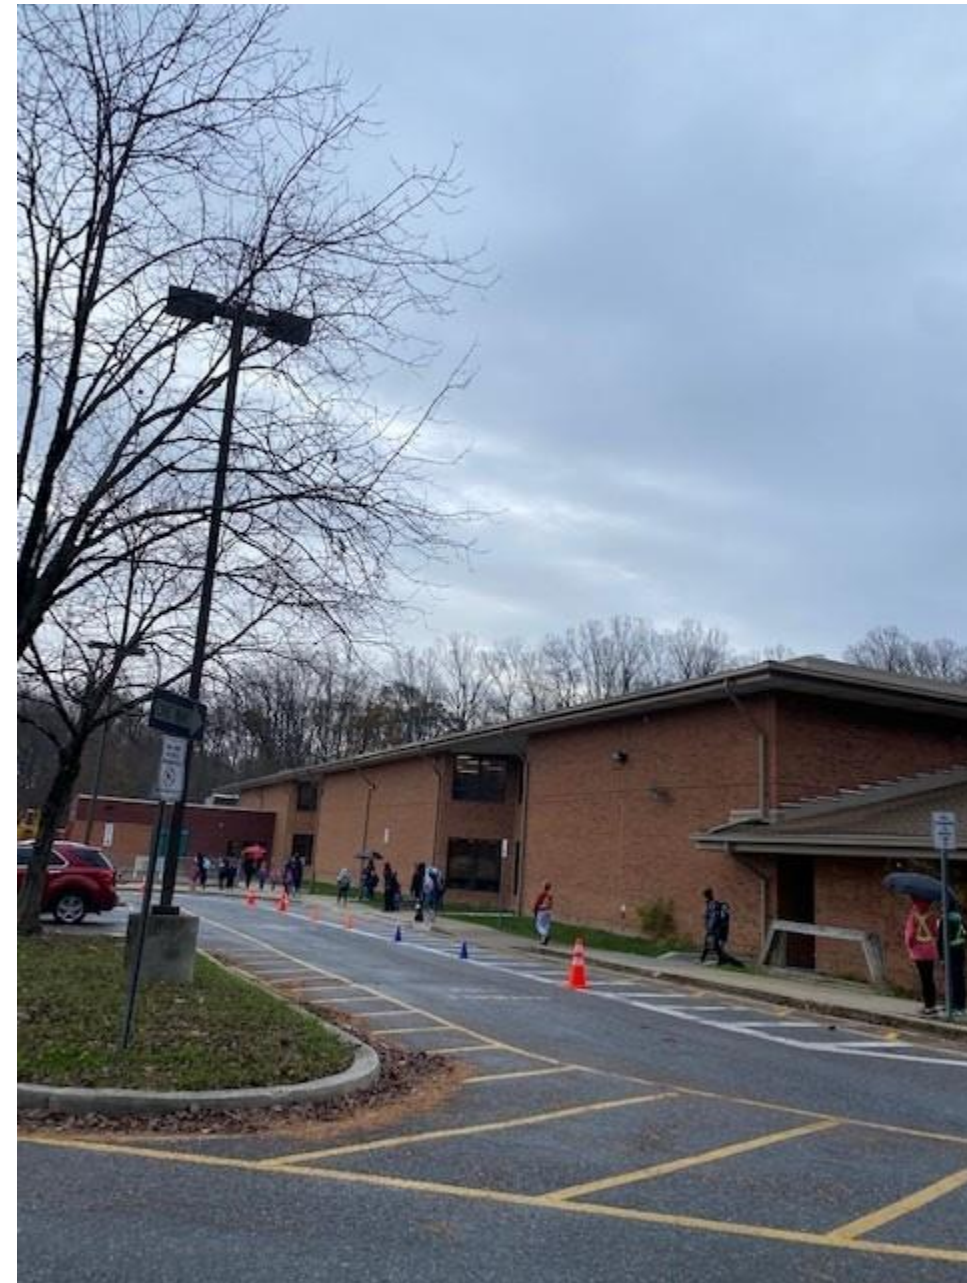
Walkers being dismissed for the day, heading towards the path to Chelmsford Drive.

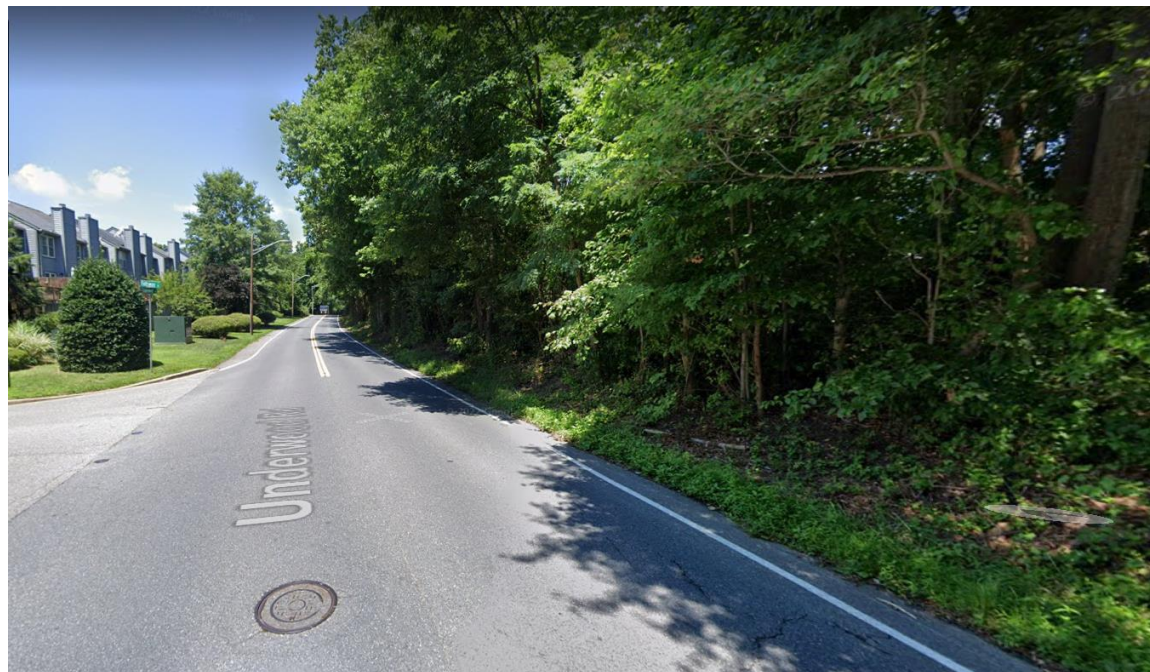
View of Underwood Road via Google Maps

While few houses currently exist east of Underwood Road, lack of pedestrian and bicycle facilities on this road would present a barrier to active transportation if future development occurs. For long-term planning, the County could explore adding sidewalks and bike lanes or a shared use path on Underwood Road.

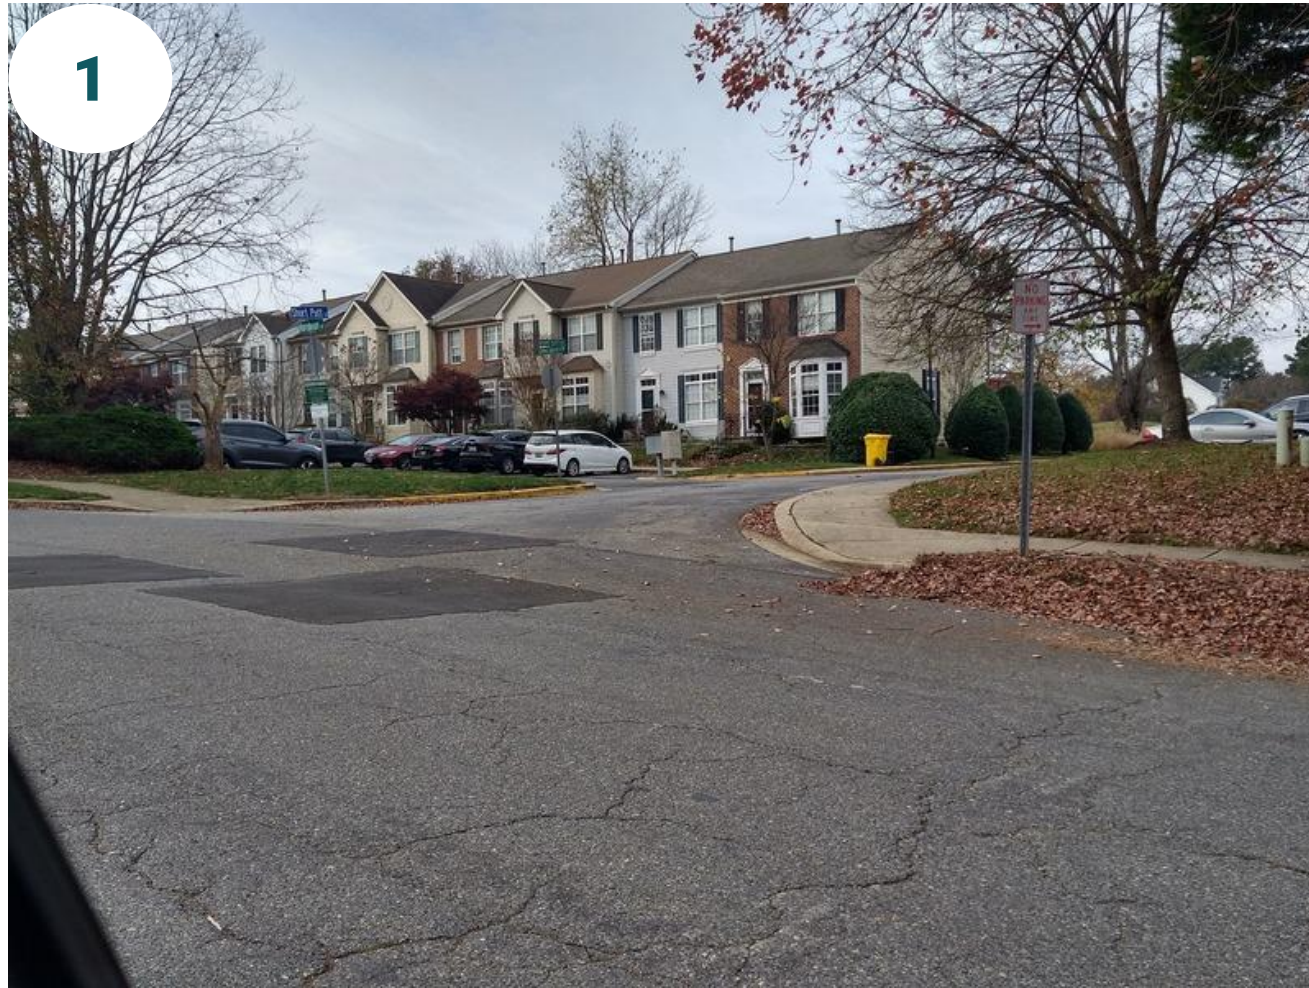
The intersection of Hornbeam Drive and Hightee Court – part of recommendation corridor.

Map ID	Location	Facility Type	Issue	Recommendation	Potential Cost	Timeframe*
1	Hornbeam Dr (Hightee Ct to Chelmsford Dr) (Along key student walking route)	1a. Curb Ramp	All curb ramps lack detectable warning surfaces	Reconstruct or repair existing ramps for the side street crossings of Hightee Ct/Short Putt Ct, Kemper Rd, Dog Leg Ct	\$40,000	Medium
		1b. Crosswalk	Crossings of side streets are unmarked No stop bars across side streets	Install new standard crosswalks for the side street crossings of Hightee Ct/Short Putt Ct, Kemper Rd, and Dog Leg Ct, Mark new stop bars	\$2,000	Short
2	Chelmsford Dr (near Riedel Rd) (Along key student walking route)	Sidewalk	Gap in sidewalk network on south side of Chelmsford Dr	Install new sidewalk**	\$28,585	Long
3	Chelmsford Dr (Riedel Rd to Thistle Brooke Ct) (Along key student walking route, Inside school zone)	School Zone Signs and Pavement Markings	SCHOOL pavement marking, school zone sign, and school zone speed limit sign missing	Expand school zone and enhance signage per MdMUTCD part 7 - Install new SCHOOL pavement marking - Install new school zone signs (begin/end) - Install and new school zone speed limit sign. Consider reducing school zone speed limit to 20mph	\$1,000 \$1,000 \$500	Short

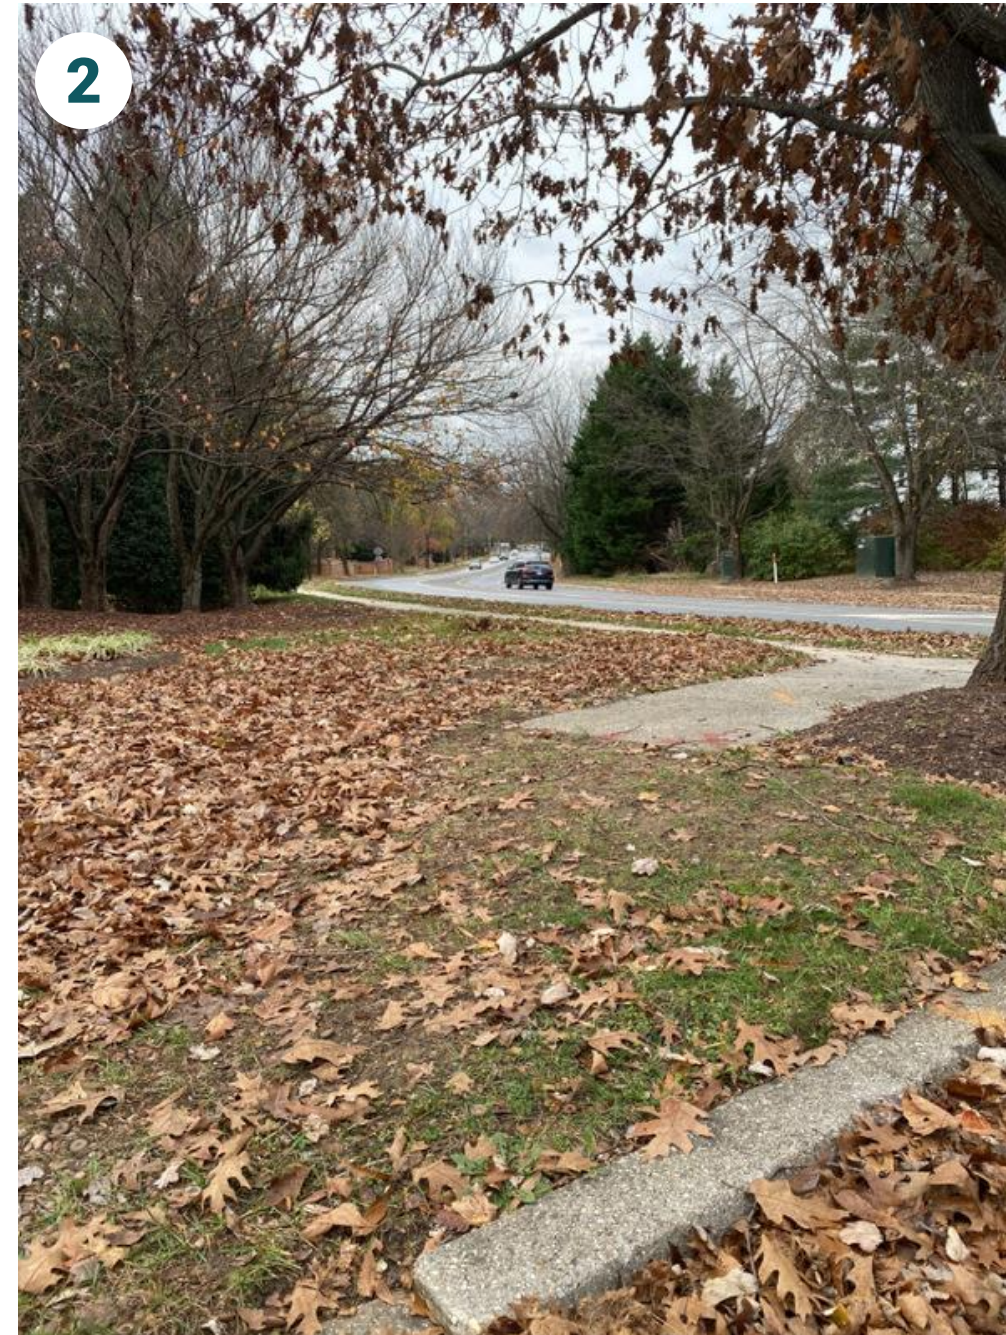
There are sidewalks present on all roads within the walk zone, with one small gap on Chelmsford Drive just east of Riedel Road.

A gap in the sidewalk on Chelmsford Drive near Riedel Road.

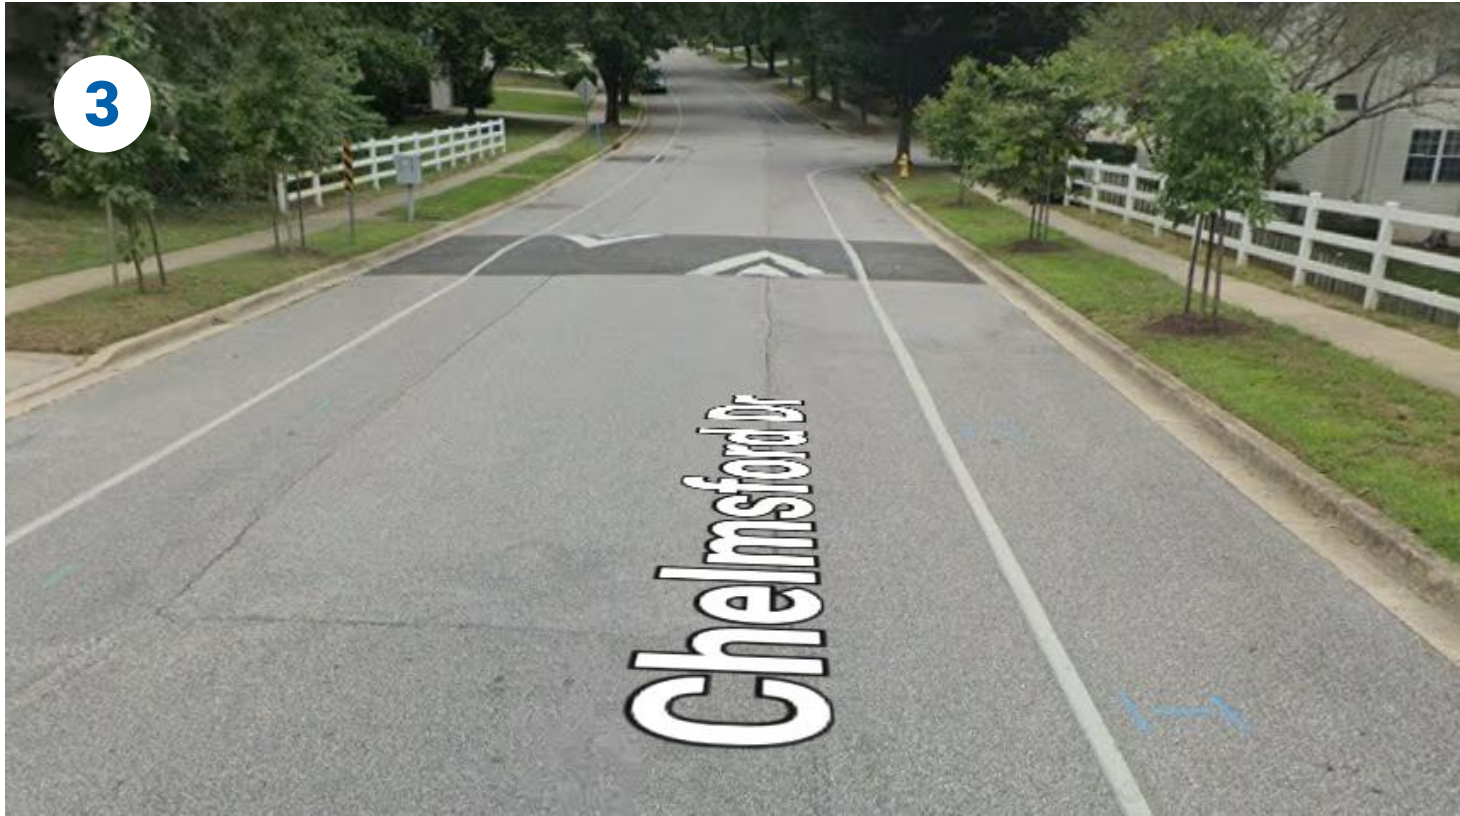
A speed bump on Chelmsford Drive approaching the intersection with Hornbeam Drive

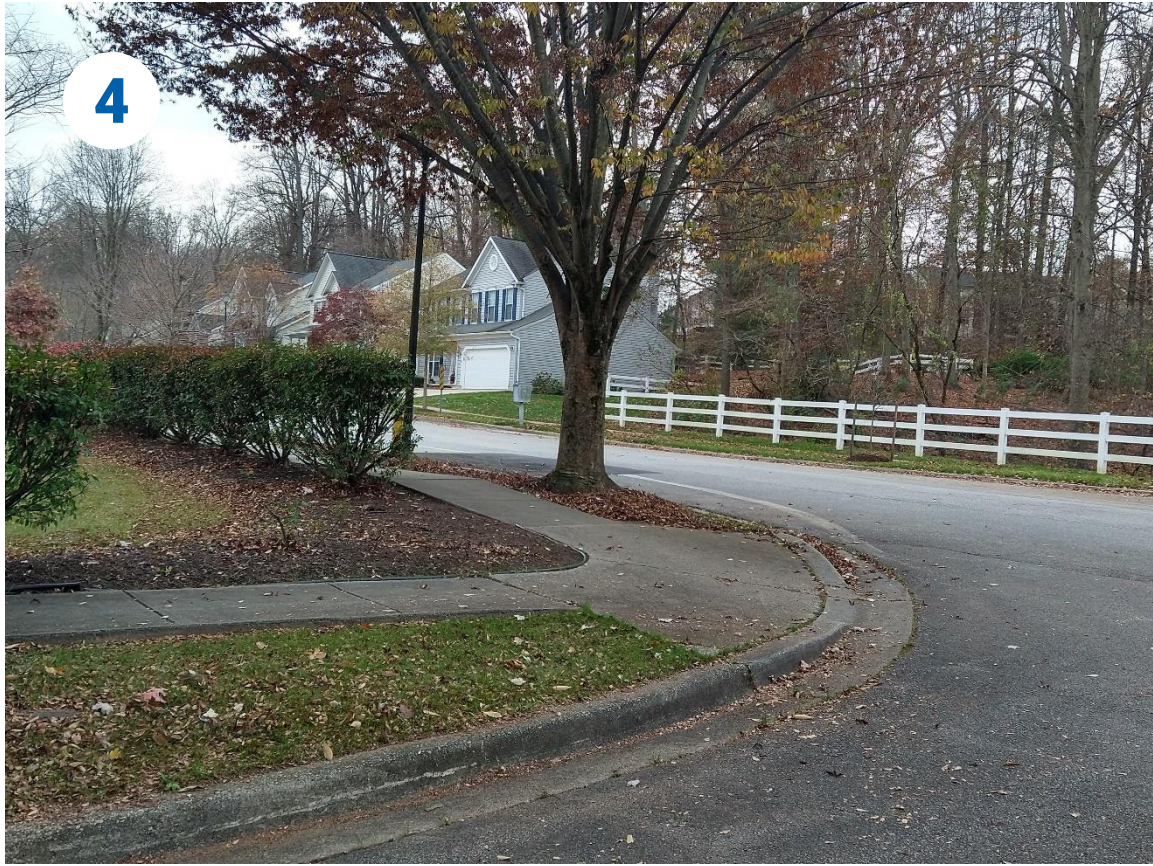
Many of the side streets intersecting with Chelmsford Drive lack marked crosswalks and detectable warning surfaces on the curb ramps.

Map ID	Location	Facility Type	Issue	Recommendation	Potential Cost	Timeframe*
4	Chelmsford Dr (Hornbeam Dr to Thistle Brooke Ct) (Along key student walking route, Inside school zone)	4a. Crosswalk	Crossings of side streets are unmarked or faded No stop bars across side streets	Install new standard crosswalks for the side street crossings of Tuffed Moss Ct, Christa Ln, and Thistle Brooke Ct/Houndhill Ct), Mark new stop bars	\$2,000	Short
		4b. Curb ramp	All curb ramps lack detectable warning surfaces	Reconstruct or repair existing ramps at location of new crosswalks and at northeast corner of Chelmsford Dr	\$3,200	Medium
5	Southwest corner of school building	Bicycle rack	Existing wave rack does not allow locking of frame	Replace existing rack with inverted U rack	\$175/per (quantity TBD)	Short
6	Tilghman Dr (Kent Fort Ln to Yorktown Ct) (Along key student walking route, Inside school zone)	6a. Speed Management	Observed motor vehicles appear to exceed speed limit	Conduct a speed study to consider speed management measures or other modifications.	N/A	Long

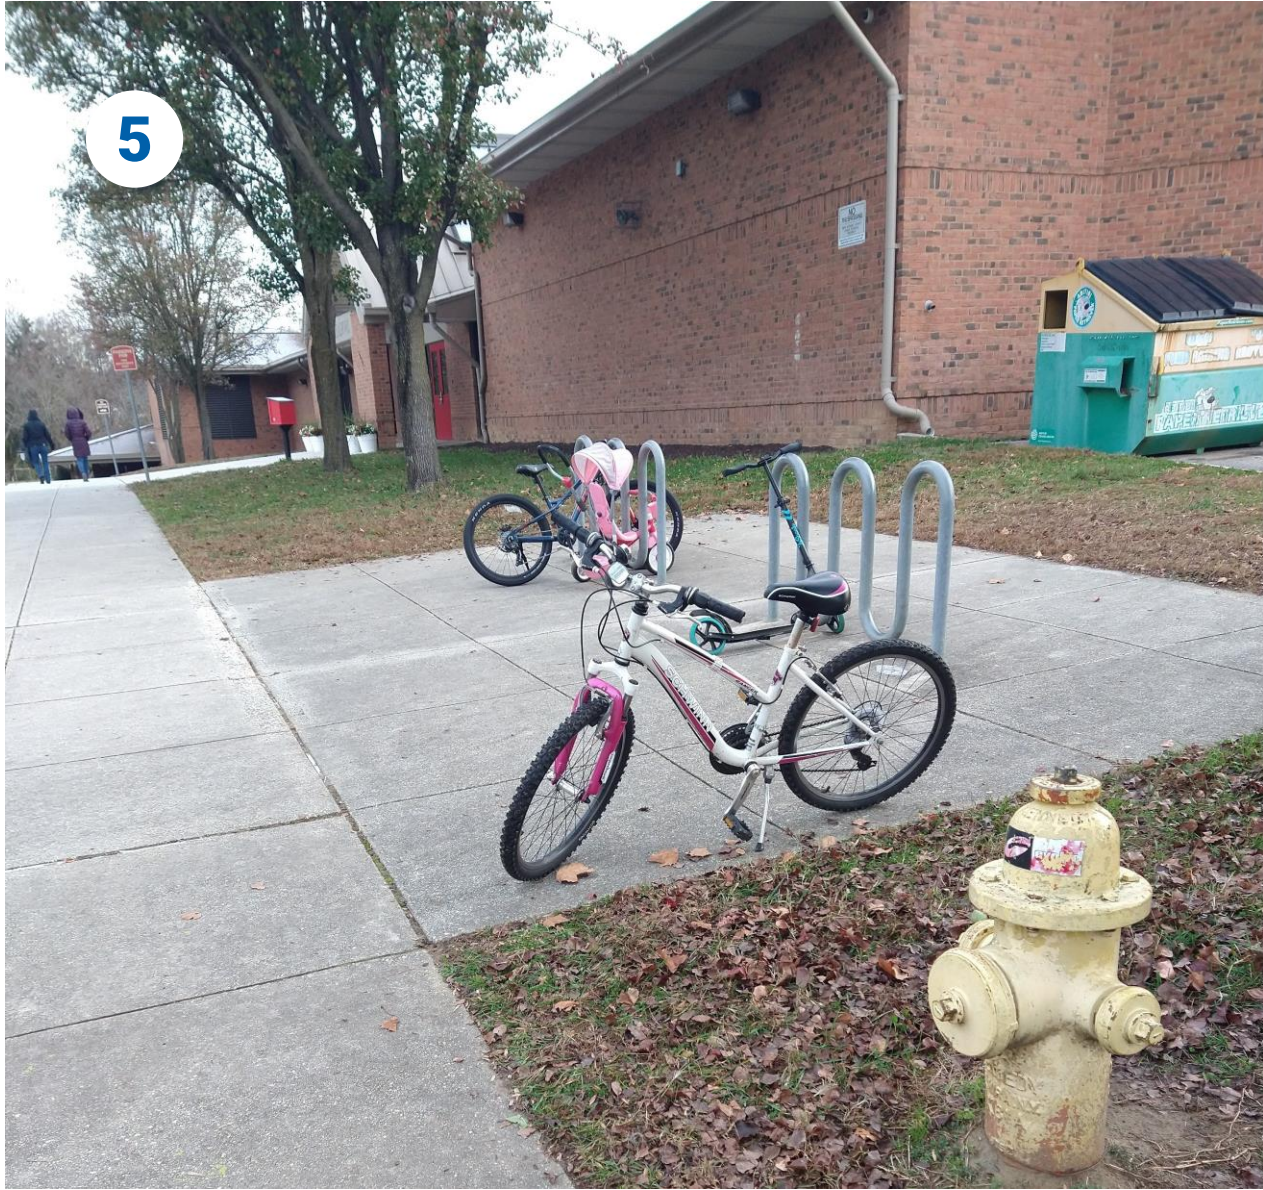
Bike rack on the school campus.

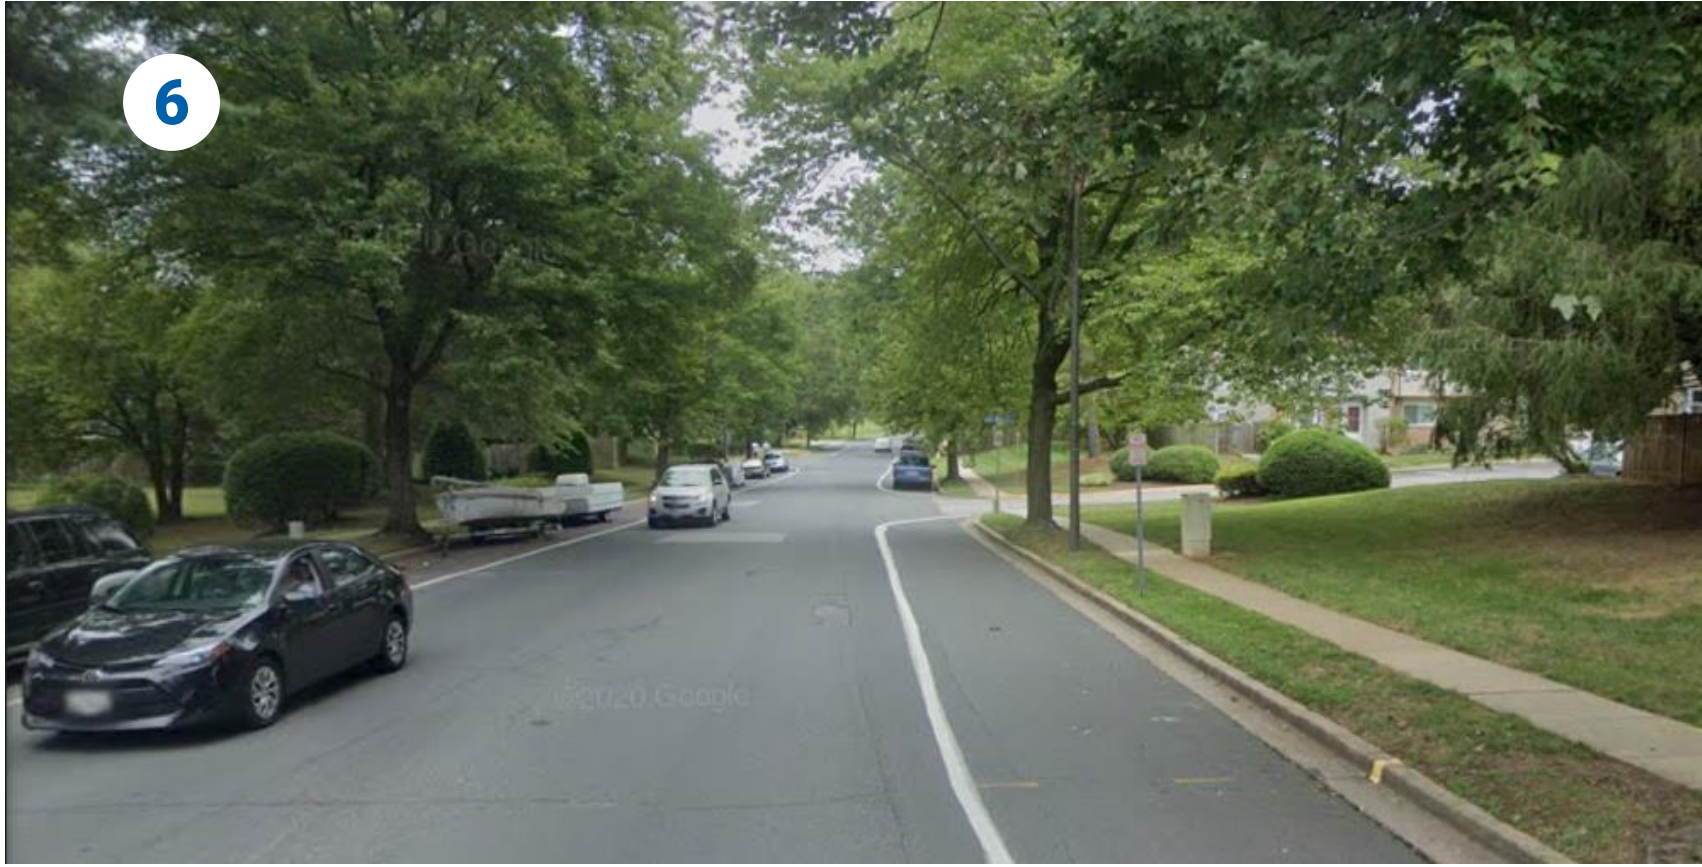
Tilghman Drive approaching Crofton Meadows Elementary School.

6b. School Zone Signs and Pavement Markings	SCHOOL pavement marking, school zone sign, and school zone speed limit sign missing	Enhance existing school zone signage per MdMUTCD part 7. - Install new SCHOOL pavement marking - Install new school zone sign (begin/end) - Install new school zone speed limit sign.	\$1,000 \$1,000 \$500	Short

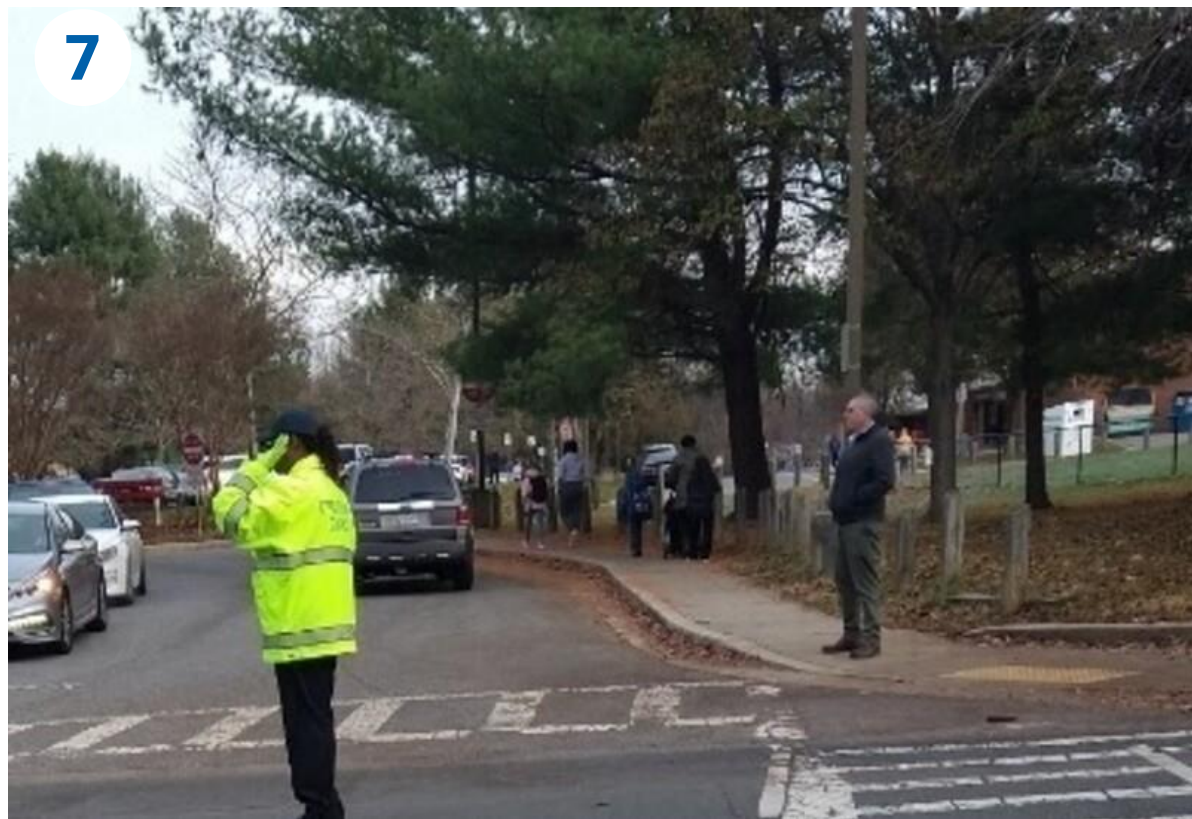
The sidewalk along the school driveway.

Map ID	Location	Facility Type	Issue	Recommendation	Potential Cost	Timeframe*
7	School Driveway (Along key student walking route, On school campus)	Sidewalk	Sidewalk too narrow along east side of school driveway and lacks buffer from road/school driveway which channels both bus and parent vehicles during arrival and dismissal.	Widen sidewalk	\$1,600	Long
8	Tilghman Dr (Grason Ln to Howard Chapel Ct) (Along key student walking route, Inside school zone)	8a. Crosswalk	Crossings at side streets are unmarked No stop bars across side streets.	Install new standard crosswalks for the side street crossings of Grason Ln, Fendall Ct/Kent Fort Ln, Mt Airy Ct/Holly Hilly Ln, Mt. Airy Ct, New Windsor Ct (east and west), Fallsway Dr/Yorktown Ct, Forest Hill Ct/Lake Grove Ln, Forest Hill Ln/Remington Dr, Howard Chapel Turn, Remington Dr/Howard Chapel Ct Mark new stop bars	\$8,500	Short
		8b. Curb Ramp	Ramps at side streets lack detectable warning surfaces (also at crossing of Tilghman Dr at Riedel Rd) Note that County GIS data shows most curb ramps are ADA compliant.	Reconstruct or repair existing ramps at location of new crosswalks	\$144,000	Medium

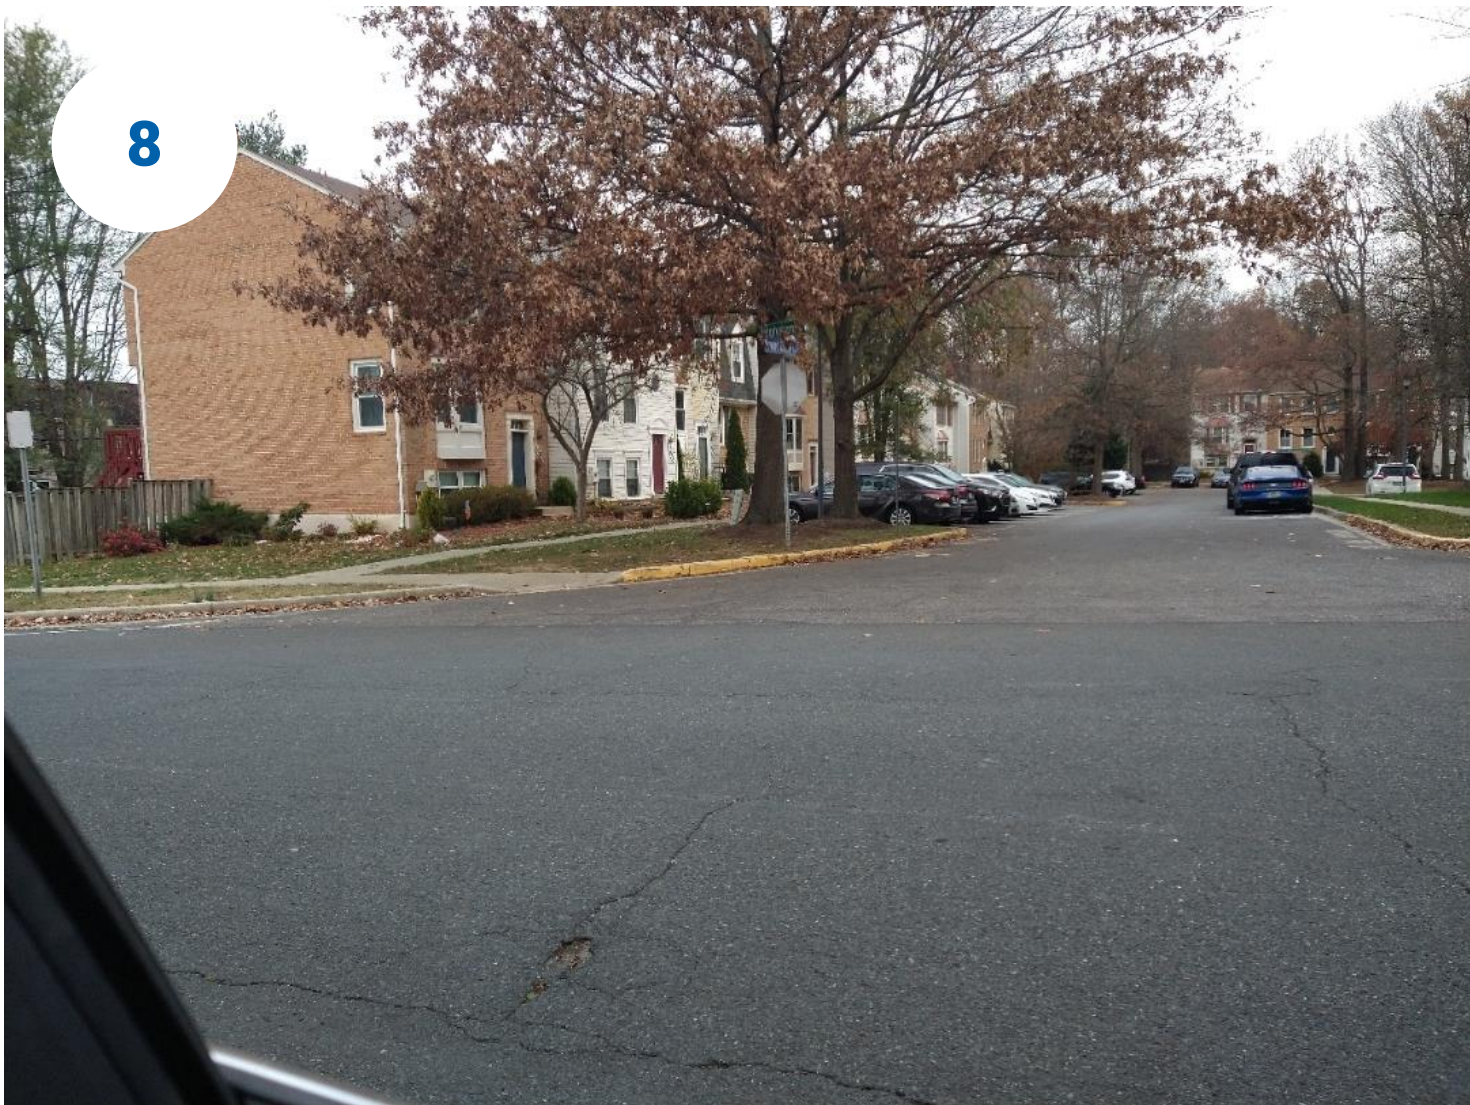
Tilghman Drive at Howard Chapel Court – part of recommendation corridor.

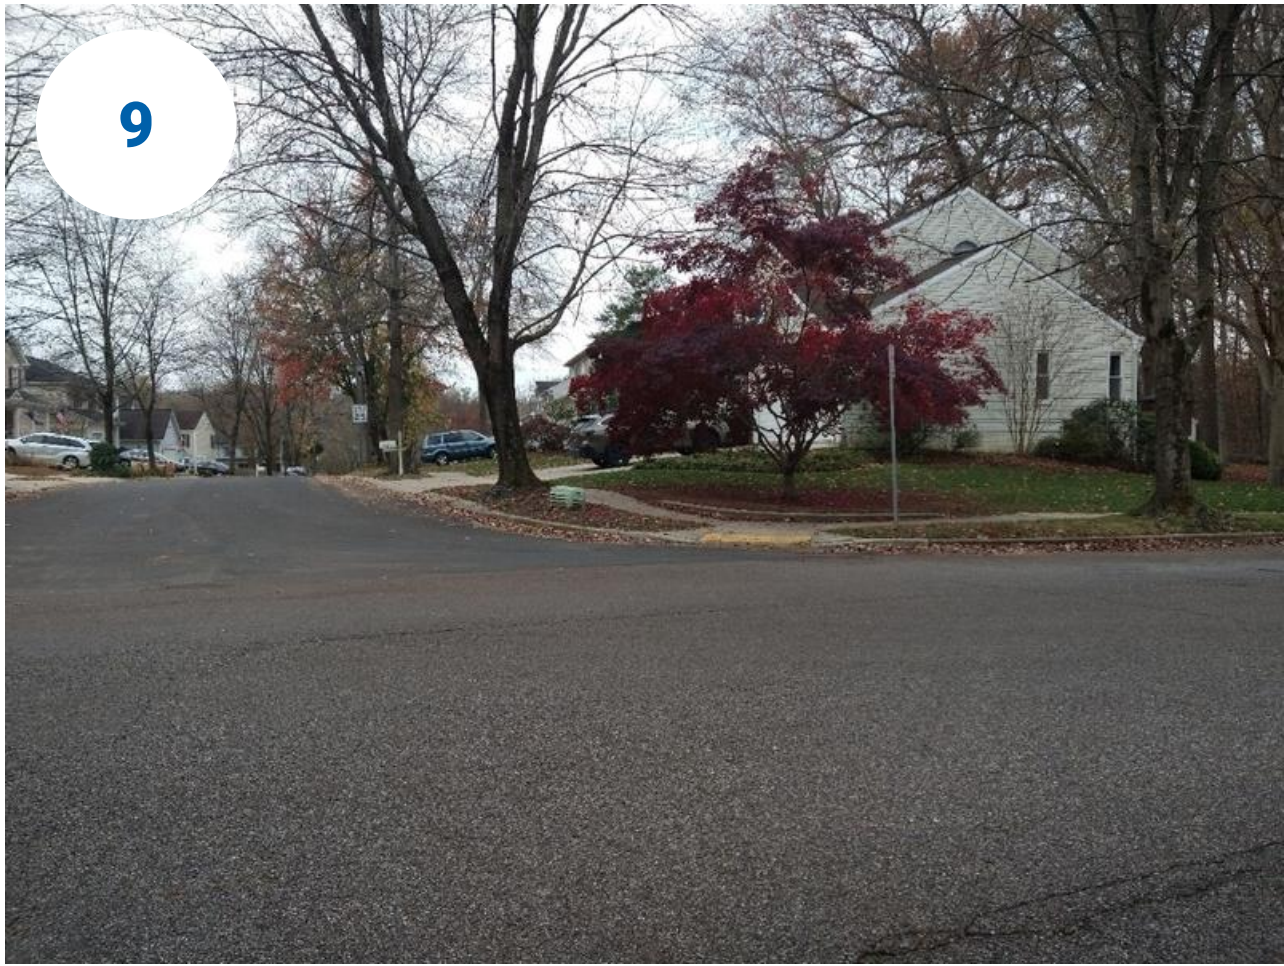
Fallsway Drive at Harewood Lane – part of recommendation corridor.

Map ID	Location	Facility Type	Issue	Recommendation	Potential Cost	Timeframe*
9	Fallsway Dr (Whites Fetty Pl to Lake Grove Ln) (Along key student walking route)	9a. Crosswalk	Crossings of side streets are unmarked No stop bar	Install new standard crosswalk, Mark new stop bars for the side street crossings of Whites Ferry Pl, Log Mill Pl, Ingleside Ct/Log Ln, Harewood Ln, Jones Fall Ct, Linkwood Ln (east/west), Aberdeen Dr, Cambridge Dr, Jason Ct, Lake Grove Ln	\$5,000	Short
		9b. Curb ramp	Ramps lack detectable warning surface	Reconstruct or repair existing ramps at Whites Ferry Pl, Log Mill Pl, Log Ln, Jones Fall Ct, Cambridge Dr, Jason Ct, Lake Grove L	\$56,000	Medium
10	Aberdeen Dr & Aberdeen Ct (Crash hotspot)	Other intersection or crossing issues	Crossing of Aberdeen Dr long	Install median crossing island	\$3,000	Long
11	Cambridge Dr (Bellefield Ct to parking lot near Aberdeen Dr) (Along key student walking route)	11a. Crosswalk	Crossings of parking lots are unmarked No stop bar	Install new standard crosswalks, Mark new stop bars for the side street crossings of Bellefield Court and parking lot entrances	\$2,000	Short

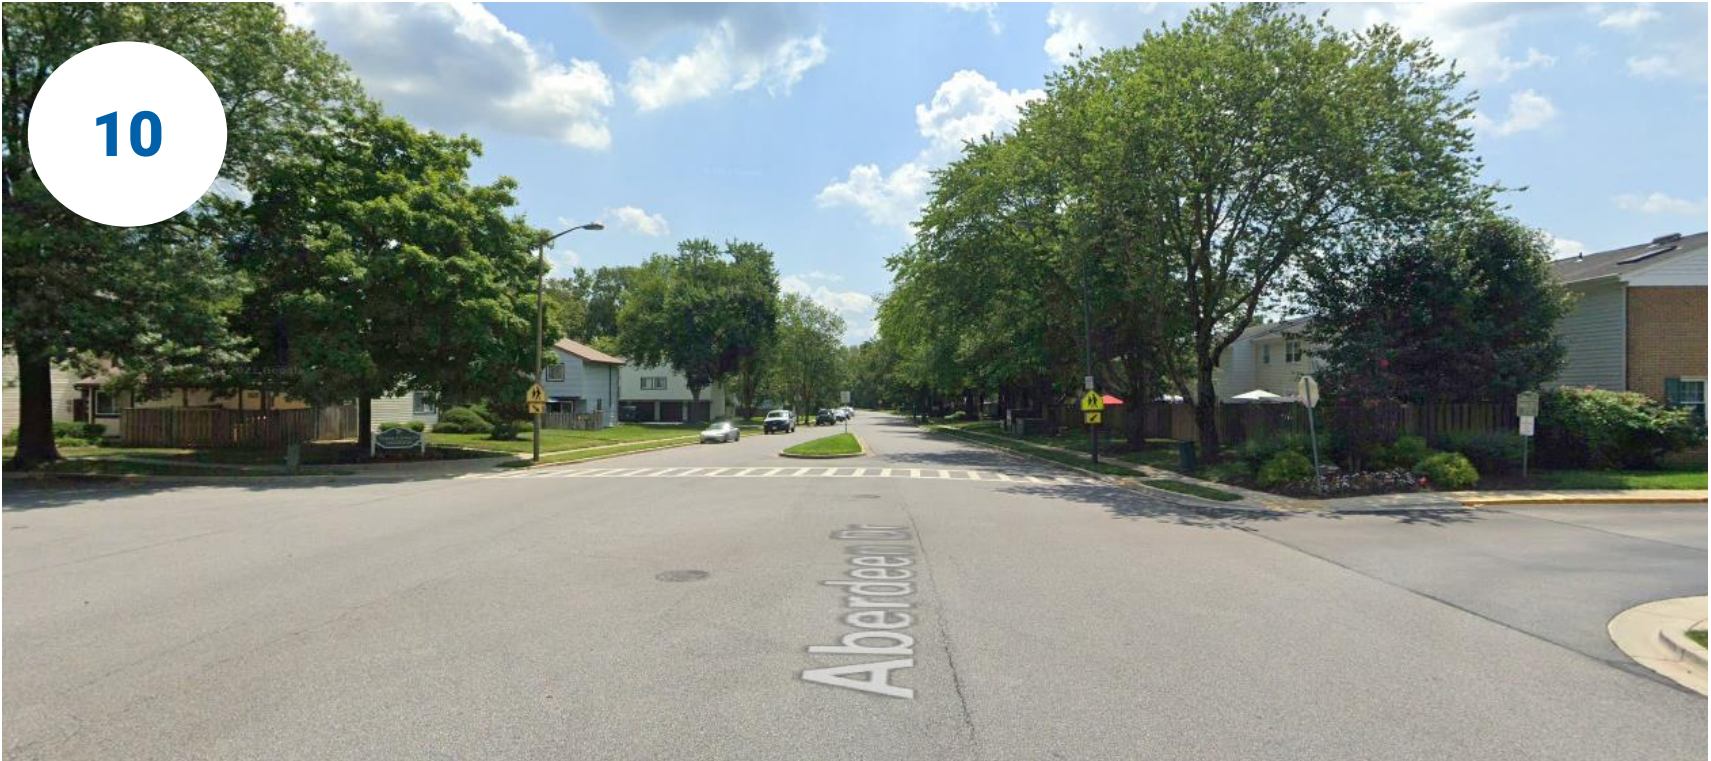
The intersection of Aberdeen Drive and Aberdeen Court, where the existing crosswalk can be seen.

Map ID	Location	Facility Type	Issue	Recommendation	Potential Cost	Timeframe*
12	Aberdeen Dr (Fallsway Dr to County library driveway) (Along key student walking route)	Crosswalk	Crossings of side streets are unmarked No stop bar	Install new standard crosswalks and Mark new stop bars at the library driveway, the E Bancroft Ln driveway, and the side streets of: Aberdeen Ct/Aberdeen Cir, Aberdeen Cir, Leisure Way, Kingsgate Dr, Cambridge Dr, Brian Ct, Denton Ct, Elkridge Ct/Chamberlain Ct for the side street crossings of Aberdeen Ct/Aberdeen Cir, Leisure Way, Kingsgate Dr, Cambridge Dr, Denton Ct, Elkridge Ct	\$6,000	Short
13	Path between Log Mill Ct and Log Ln	Other Issues	Existing goat path/desire line between Log Ln and Log Mill Ct indicates usage. Formalizing the path would allow Log Mill Ct to move within the school walk zone.	Pave existing informal path between Log Mill Ct and Log Ln.	\$6.120	Long

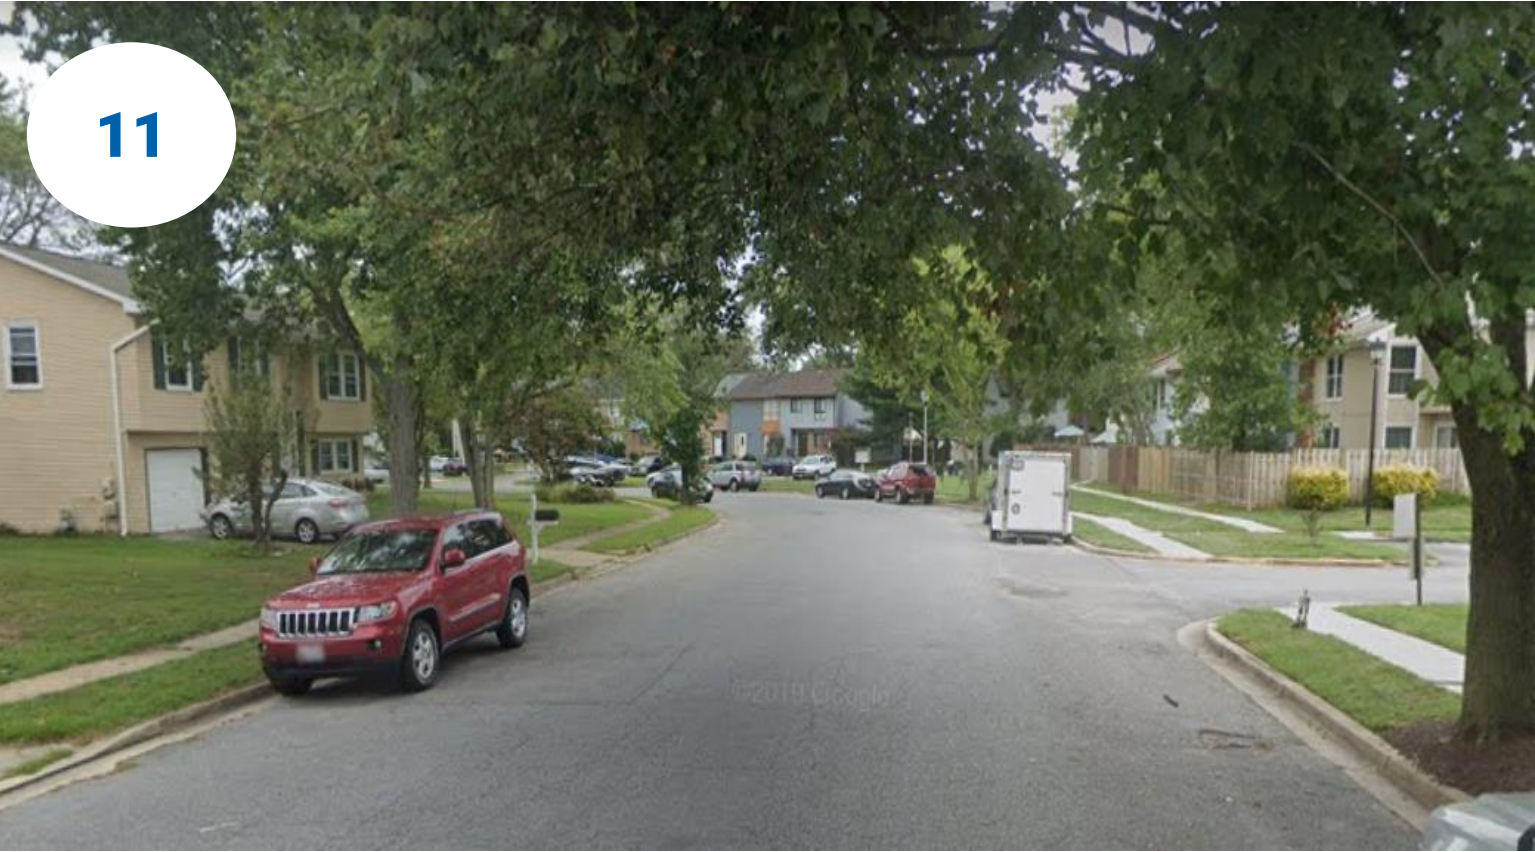
Townhouse parking lot entrance off Cambridge Drive – part of recommendation corridor.
