Crofton Meadows Elementary School Safe Routes to School Accessibility Study: Existing Conditions and Recommendations

August 17, 2023

Anne Arundel Safe Routes to School Accessibility Study

Crofton Meadows Elementary Accessibility Study

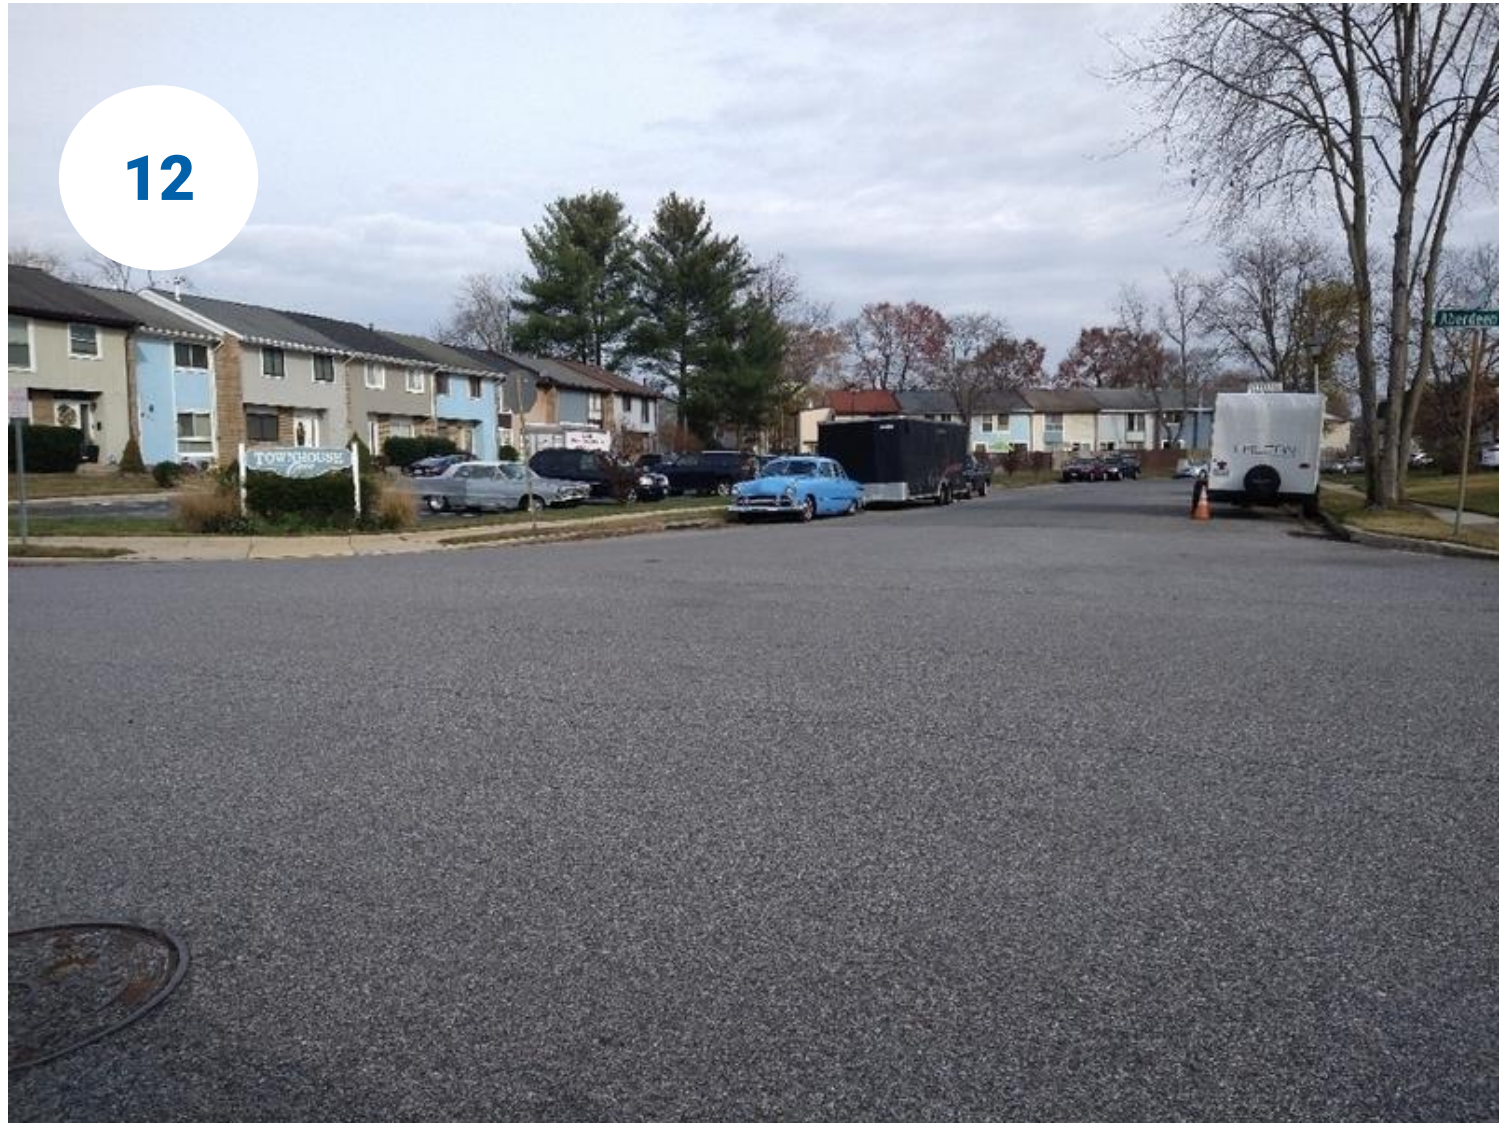
Aberdeen Drive at Cambridge Drive– part of recommendation corridor.

Map ID	Location	Facility Type	Issue	Recommendation	Potential Cost	Timeframe*
12	Aberdeen Dr (Fallsway Dr to County library driveway) (Along key student walking route)	Crosswalk	Crossings of side streets are unmarked No stop bar	Install new standard crosswalks and Mark new stop bars at the library driveway, the E Bancroft Ln driveway, and the side streets of: Aberdeen Ct/Aberdeen Cir, Aberdeen Cir, Leisure Way, Kingsgate Dr, Cambridge Dr, Brian Ct, Denton Ct, Elkridge Ct/Chamberlain Ct for the side street crossings of Aberdeen Ct/Aberdeen Cir, Leisure Way, Kingsgate Dr, Cambridge Dr, Denton Ct, Elkridge Ct	\$6,000	Short
13	Path between Log Mill Ct and Log Ln	Other Issues	Existing goat path/desire line between Log Ln and Log Mill Ct indicates usage. Formalizing the path would allow Log Mill Ct to move within the school walk zone.	Pave existing informal path between Log Mill Ct and Log Ln.	\$6.120	Long
